**2019 Cowichan Lake Pumping
Weekly Report #1
- Pre-Pumping Surveys, Initiation
of Pumping and Monitoring
September 1 – 7, 2019**

Catalyst Paper Corporation
8451 Hay Rd
Crofton, BC V0R 1K5

EDI Environmental Dynamics Inc.
208A – 2520 Bowen Road
Nanaimo, BC V9T 3L3

19N0163
September 2019

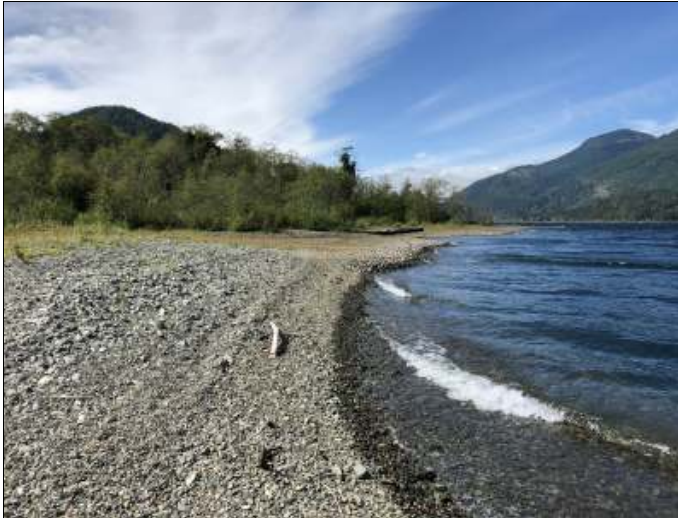
Photo 1. Looking west at the Cowichan Lake shoreline near Nixon Creek. Aug 29, 2019.

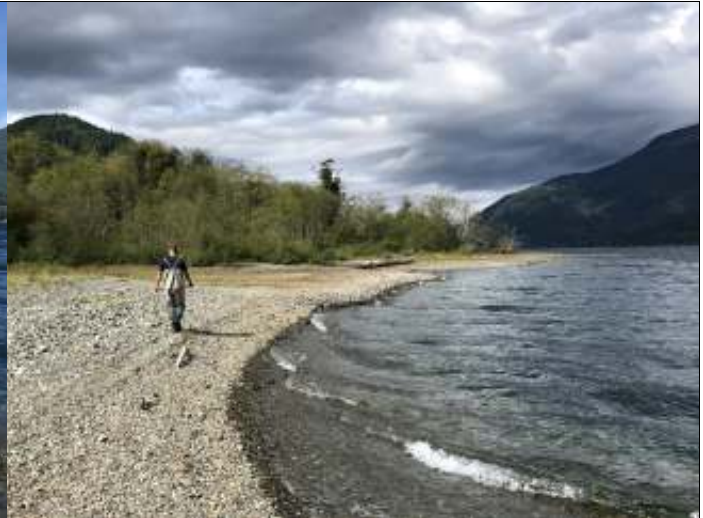
Photo 2. Looking west at the Cowichan Lake shoreline near Nixon Creek. Sep 3, 2019.

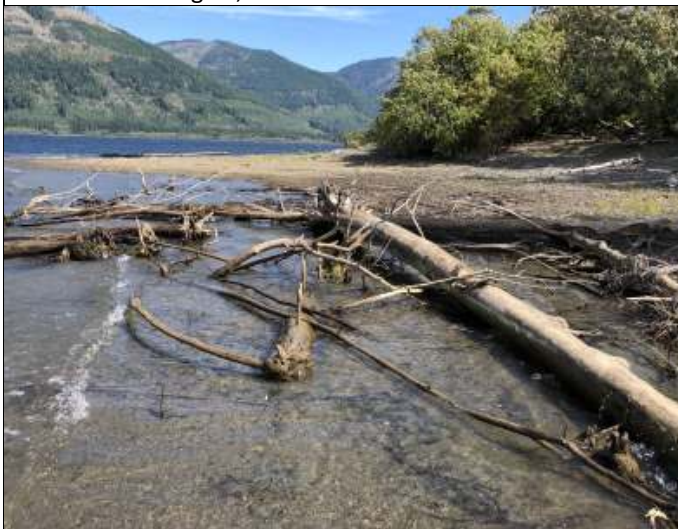
Photo 3. Looking east at the Cowichan Lake shoreline near Nixon Creek. Aug 29, 2019.

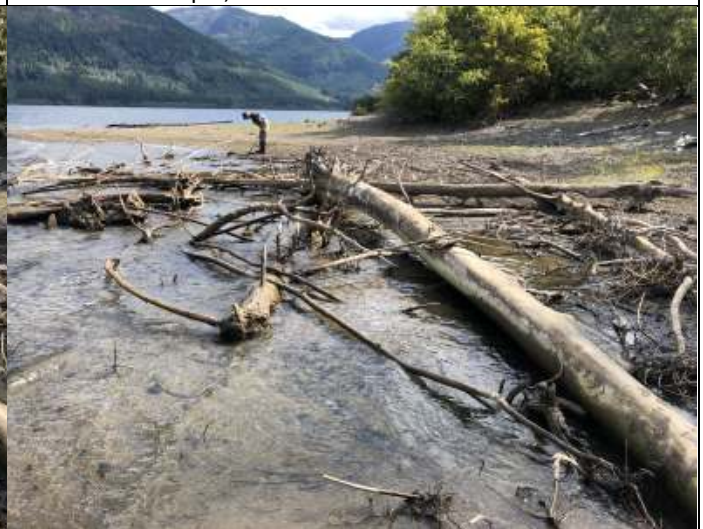
Photo 4. Looking east at the Cowichan Lake shoreline near Nixon Creek. Sep 3, 2019.

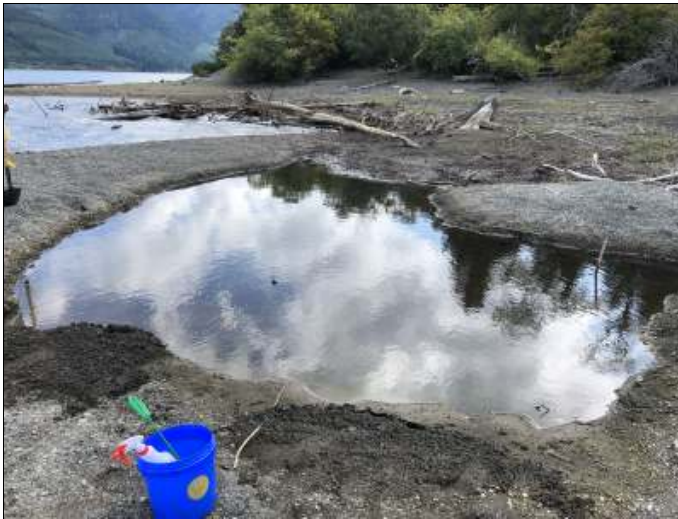
Photo 5. Isolated pool on the lake shoreline near Nixon Cr. Sep 3, 2019.

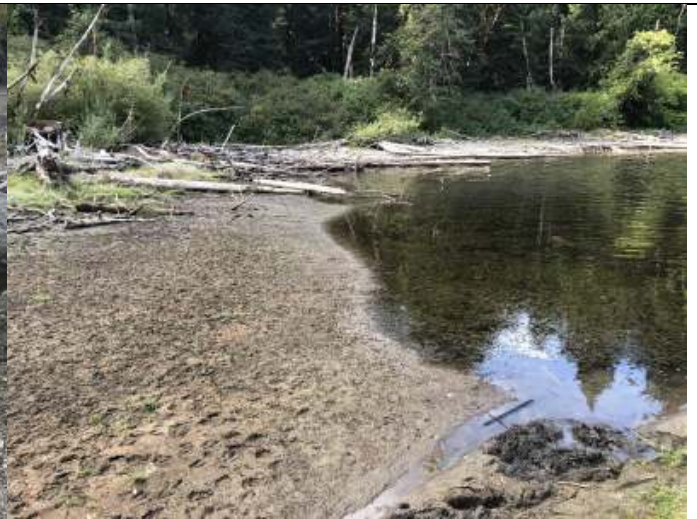
Photo 6. Substrate dominated by organics near the Float House – Nixon Cr. Sep 3, 2019.

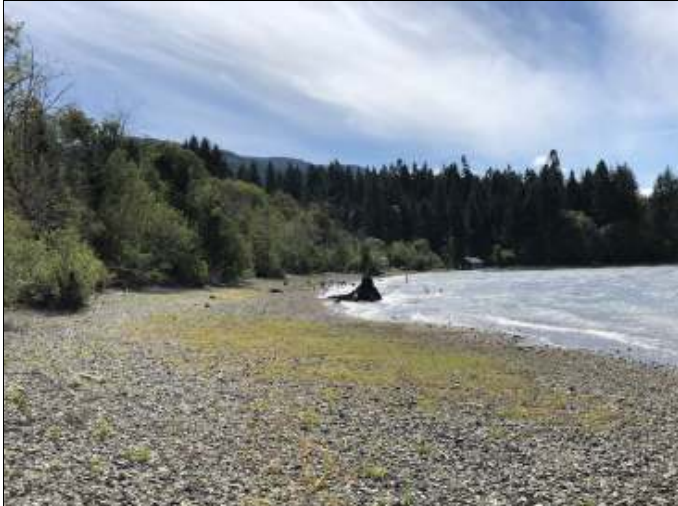
Photo 7. Looking southwest at the lake shoreline near the Nixon Creek float house. Aug 29, 2019.

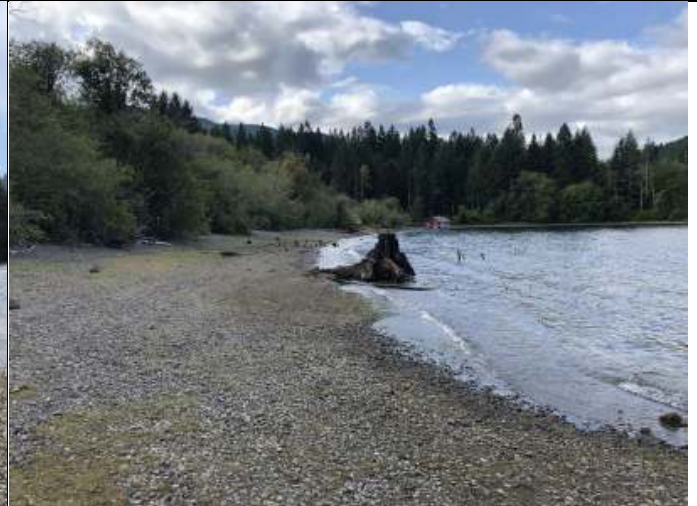
Photo 8. Looking southwest at the lake shoreline near the Nixon Creek float house. Sep 3, 2019.

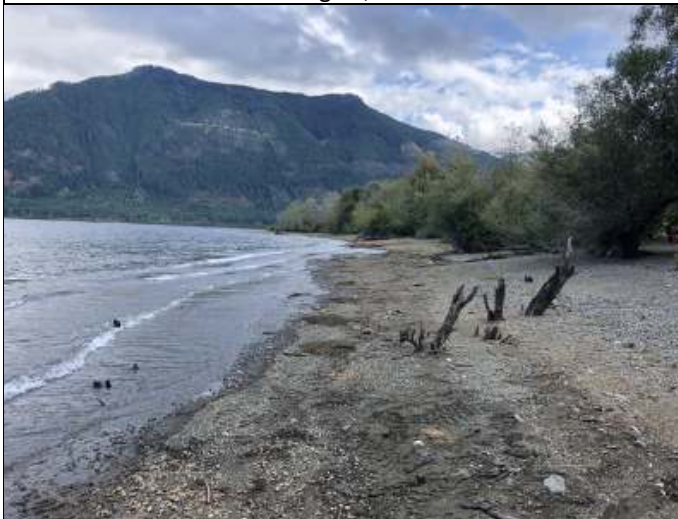
Photo 9. Looking southwest at the lake shoreline near the Nixon Creek float house. Aug 29, 2019.

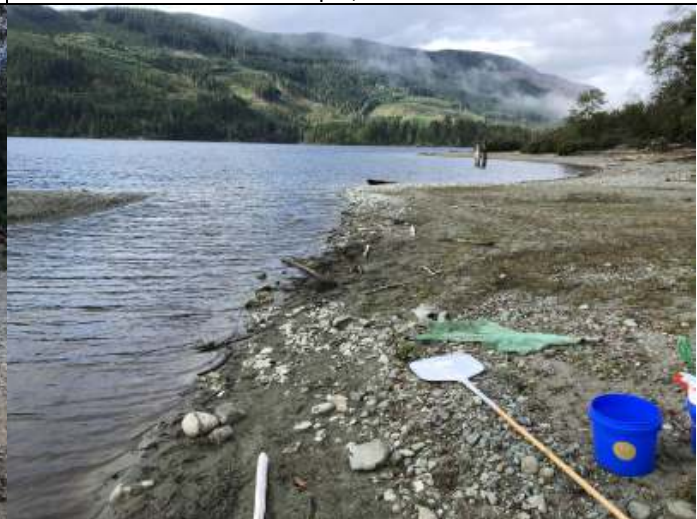
Photo 10. Lake section that may become isolated on the lake shoreline near the Shaw Creek. Sep 3, 2019.

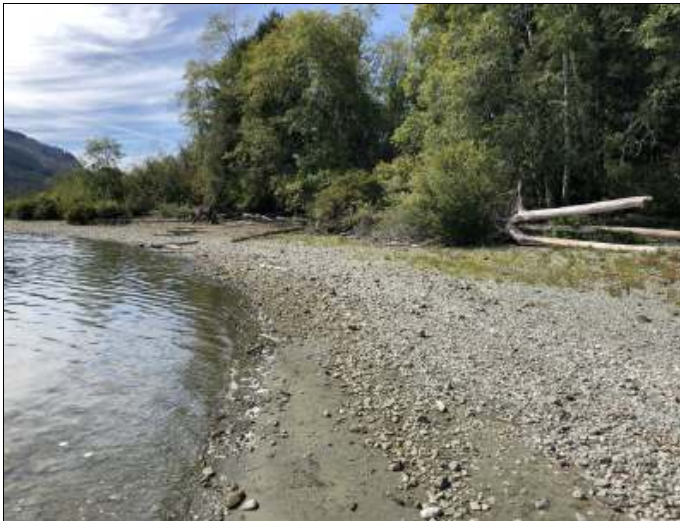
Photo 11. Looking east at the lake shoreline near Shaw Creek. Aug 28, 2019.

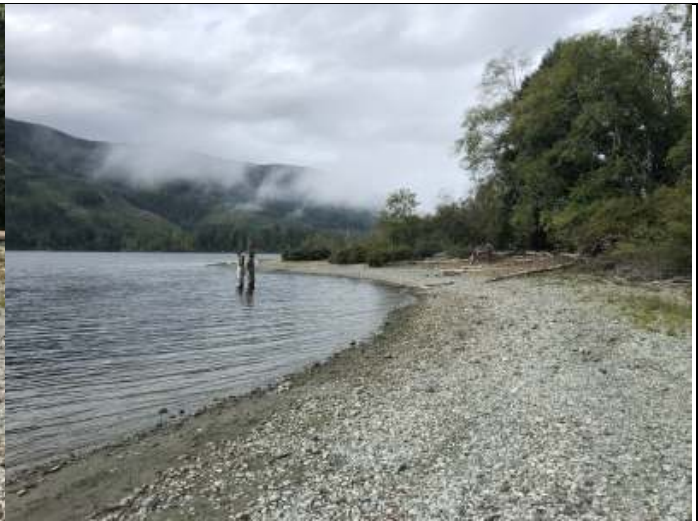
Photo 12. Looking east at the lake shoreline near Shaw Creek. Sep 3, 2019.

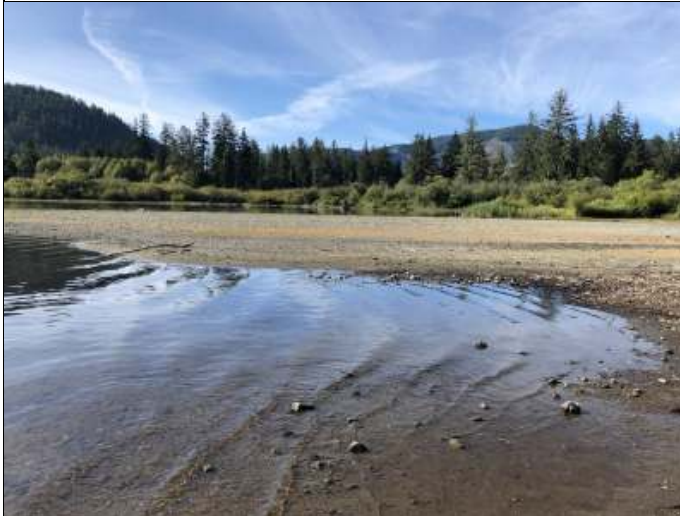
Photo 13. Looking west at the lake shoreline near Robertson Creek. Aug 28, 2019.

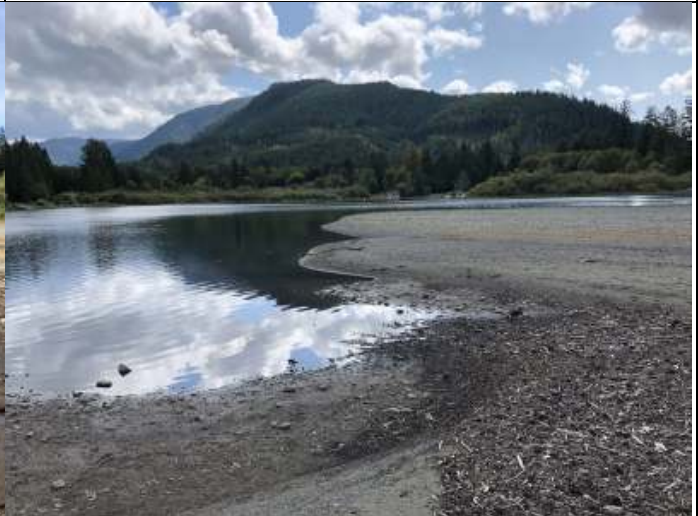
Photo 14. Looking west at the lake shoreline near Robertson Creek. Sep 3, 2019.

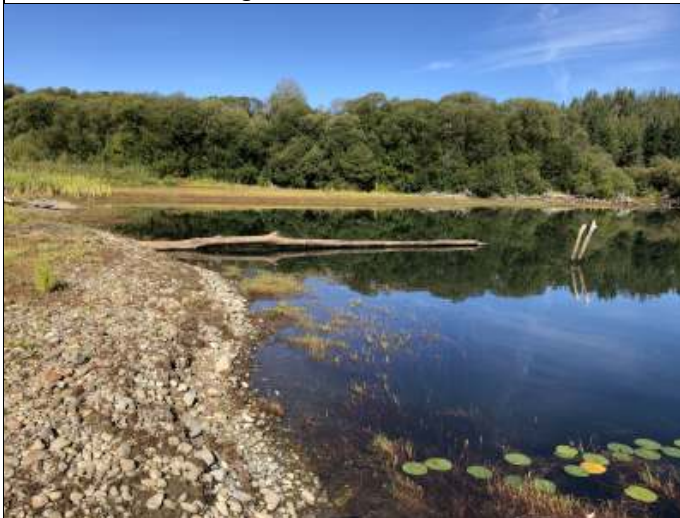
Photo 15. Looking east at the lake shoreline near Robertson

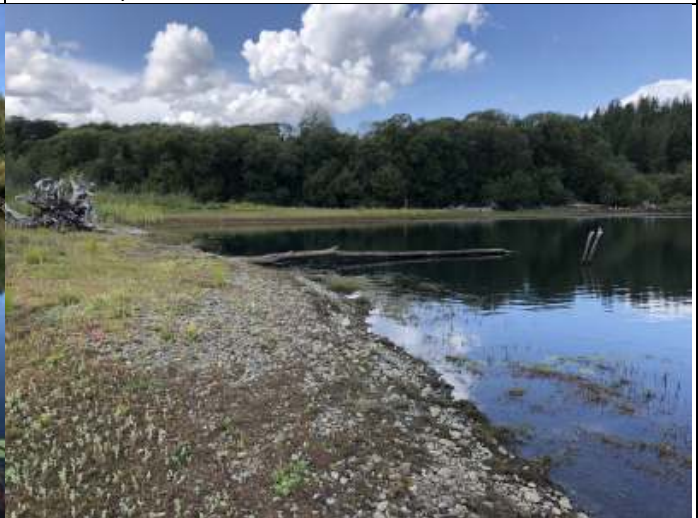
Photo 16. Looking east at the lake shoreline near Robertson

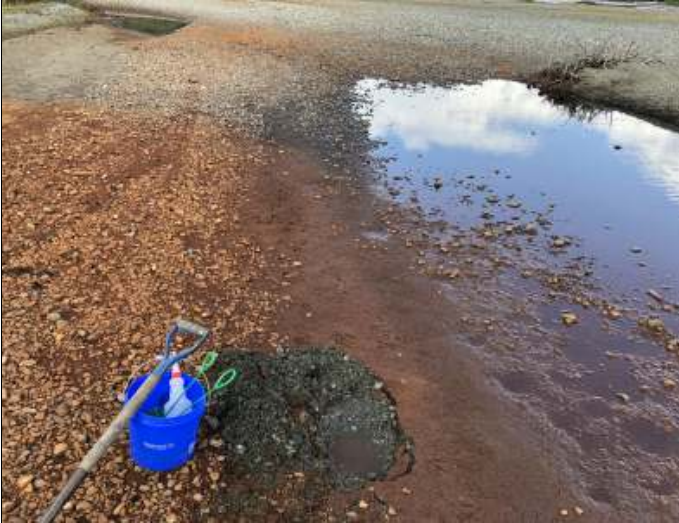
Photo 17. Sampling for Cowichan lamprey on the lake shoreline near Robertson Cr. Sep 3, 2019.

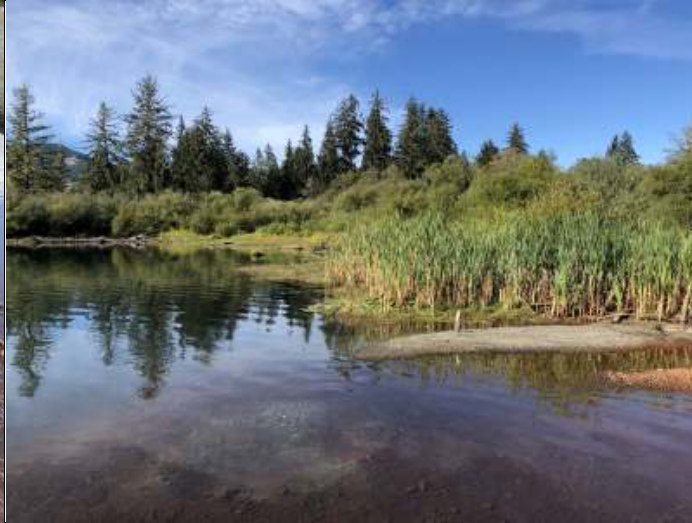
Photo 18. Looking south at the vegetated lake shoreline near Robertson Creek. Aug 28, 2019.

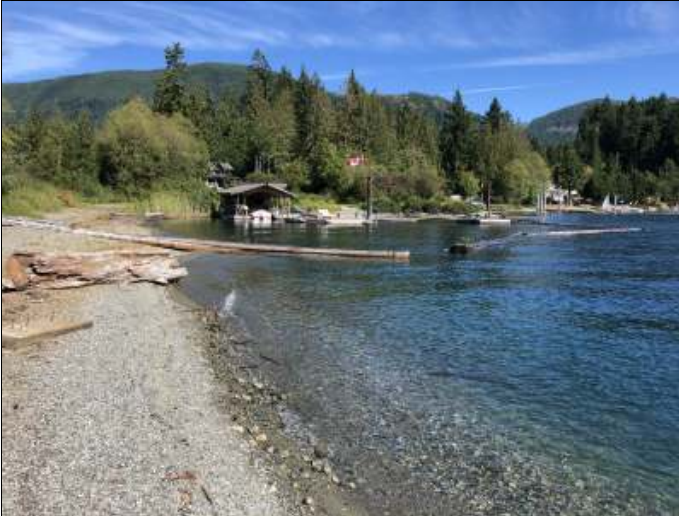
Photo 19. Looking north at the lake shoreline near Meade Creek. Aug 28, 2019.

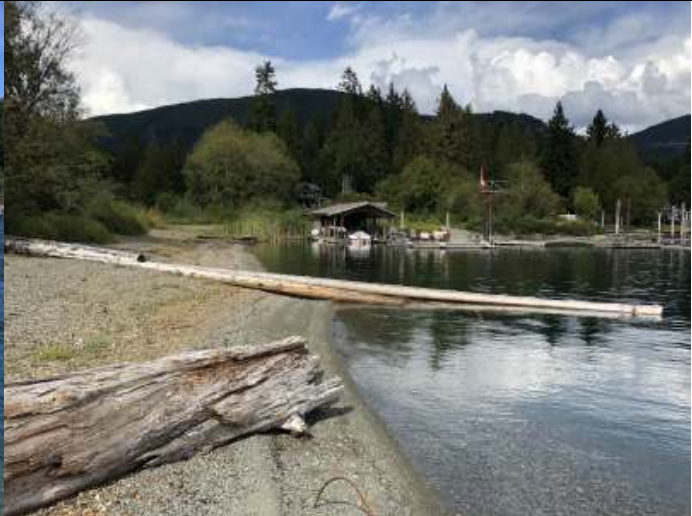
Photo 20. Looking north at the lake shoreline near Meade Creek. Sep 3, 2019.

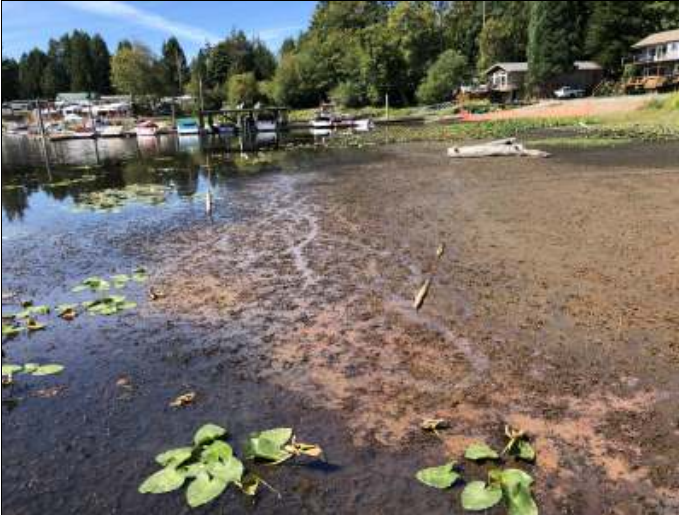
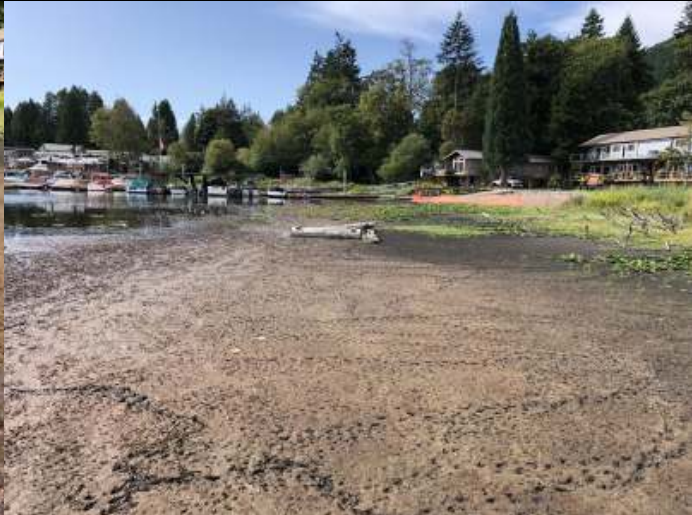
Photo 21. Looking east at the lake shoreline near Utility Creek. Aug 28, 2019.

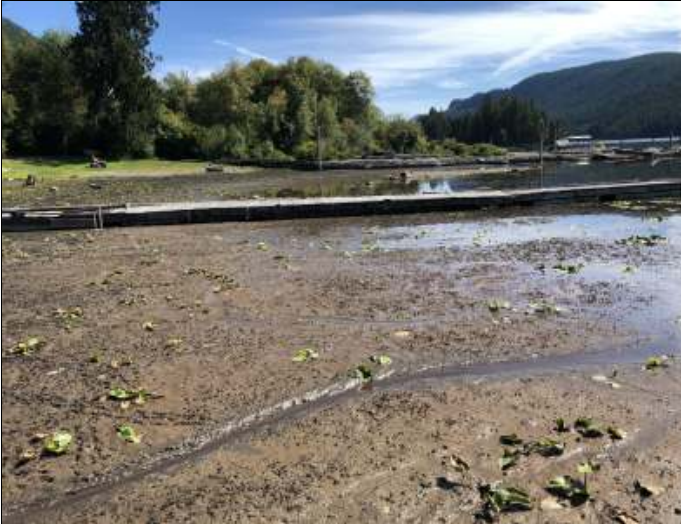
Photo 22. Looking east at the lake shoreline near Utility Creek. Sep 3, 2019.

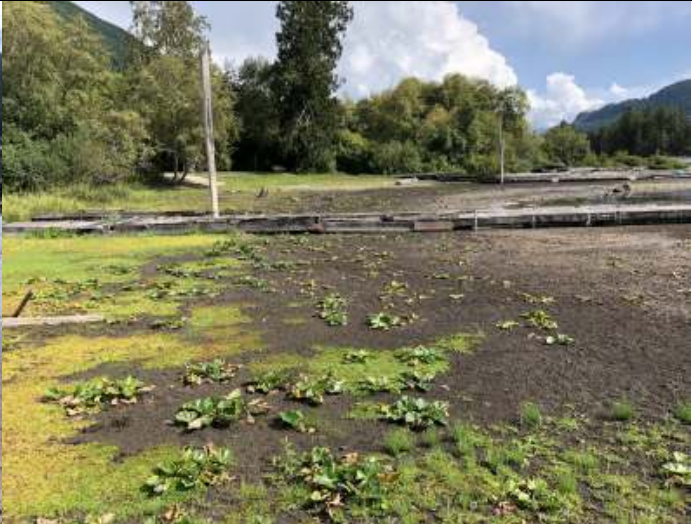
Aquatic plants at Utility and Miracle creeks were completely exposed to air prior to pumping beginning. Stress in plants has been observed at the two locations. Some aquatic plants have completely emerged at Robertson Creek since the pumping started, but the extent of affected habitat was very small (approximately 1 m²).

Photo 23. Looking west at aquatic plants in exposed mud flats on the lake shoreline near Utility Creek. Aug 28, 2019.

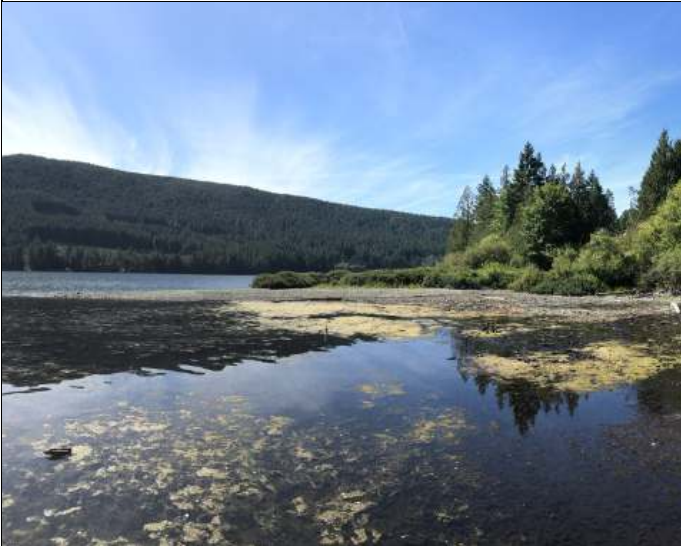
Photo 24. Looking west at aquatic plants in exposed mud flats on the lake shoreline near Utility Creek. Sep 3, 2019.

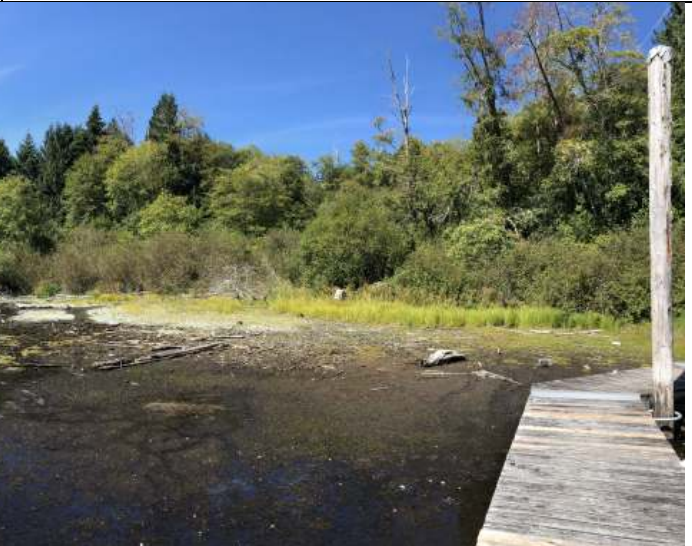
Photo 25. Looking west at the lake shoreline - mud flats and riparian vegetation near Miracle Creek. Aug 28, 2019.

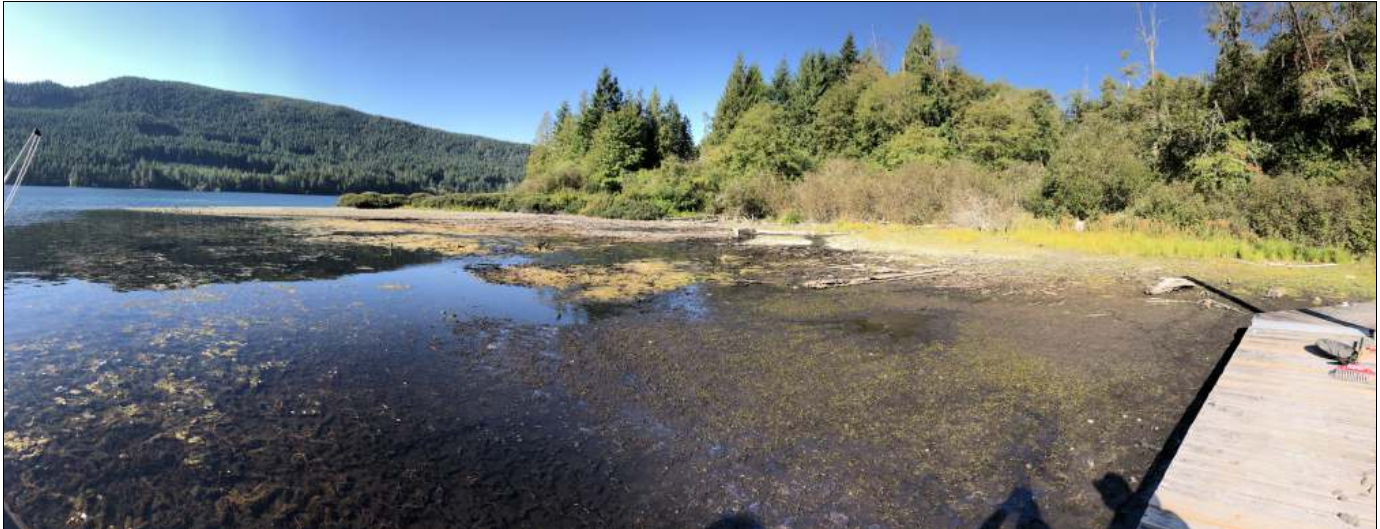
Photo 26. Looking west at the lake shoreline - mud flats and riparian vegetation near Miracle Creek. Sep 6, 2019.

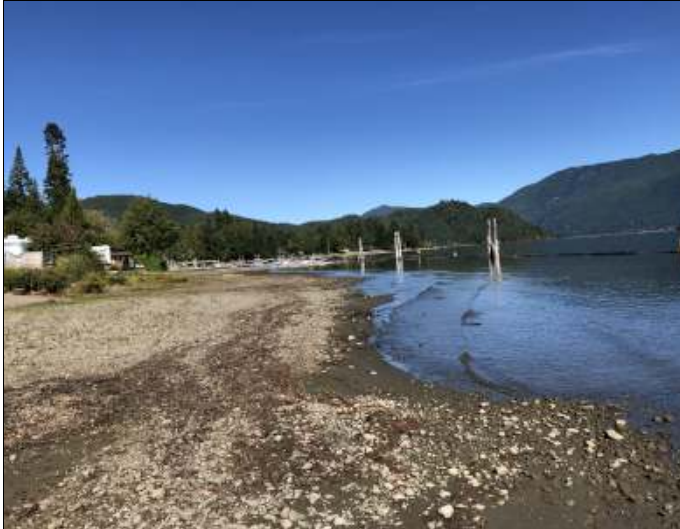
Photo 27. Looking west at the lake shoreline near Sutton Creek. Aug 28, 2019.

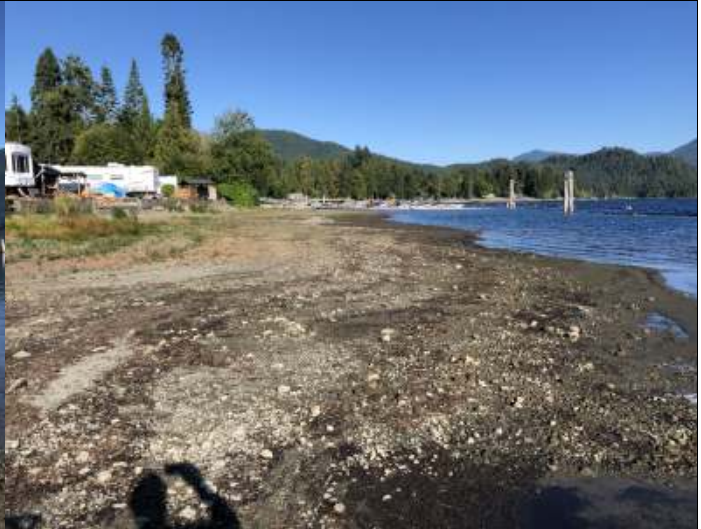
Photo 28. Looking west at the lake shoreline near Sutton Creek. Sep 6, 2019.

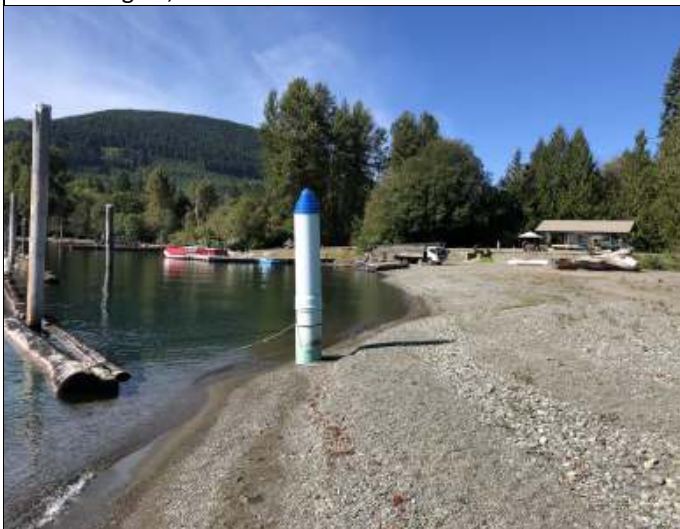
Photo 29. Looking east at the lake shoreline near Sutton

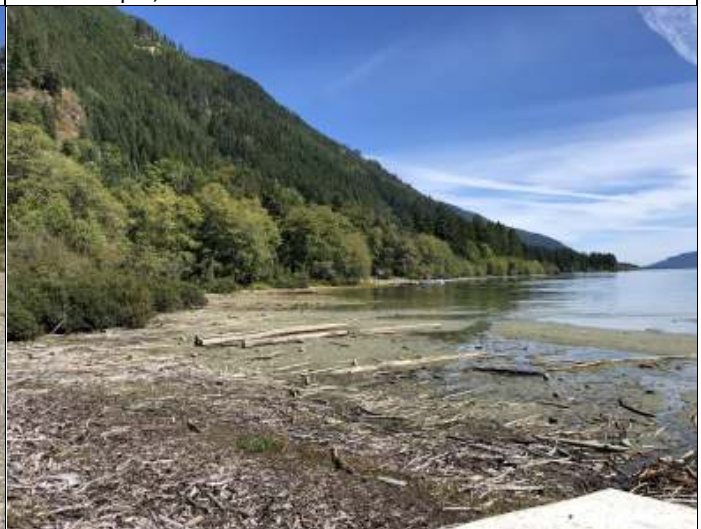
Photo 30. Looking east at the lake shoreline near Hawse
