**2019 Cowichan Lake Pumping  
Weekly Report #2  
September 8 – 13, 2019**

Catalyst Paper Corporation  
8451 Hay Rd  
Crofton, BC V0R 1K5

**EDI Environmental Dynamics Inc.**  
208A – 2520 Bowen Road  
Nanaimo, BC V9T 3L3

19N0163  
September 2019

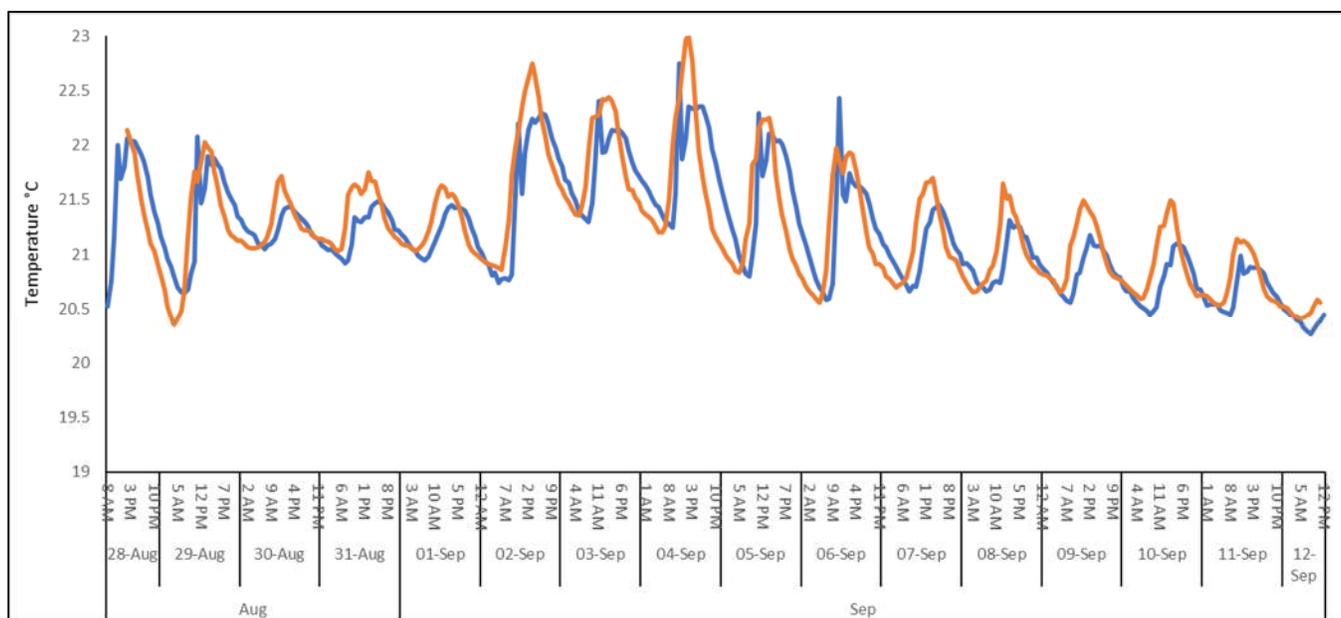
**Figure 1. Hourly average temperature recorded in Cowichan Lake (orange) and Cowichan River (blue) from August 28 to September 12, 2019.**

On August 28, 2019, two HOBO V2 model temperature loggers were installed at the two sample sites to monitor temperature variations continuously, at 15 minute intervals. Temperature data were downloaded on September 12, 2019. Temperature data indicates a clear diurnal pattern in the littoral zone of the lake and river, and the water in the lake was, in general, warmer than the water in the river at the monitoring locations. Minimum/maximum temperature values in the lake and river for the period of August 28 – September 12 were 20.4°C/23.0°C and 20.3°C /22.7°C, respectively.

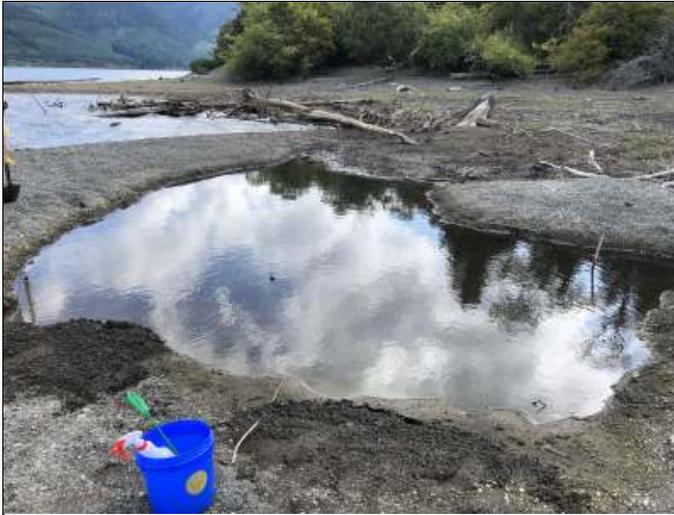
**Photo 5.** Isolated pool on the lake shoreline near Nixon Creek. Sep 3, 2019.

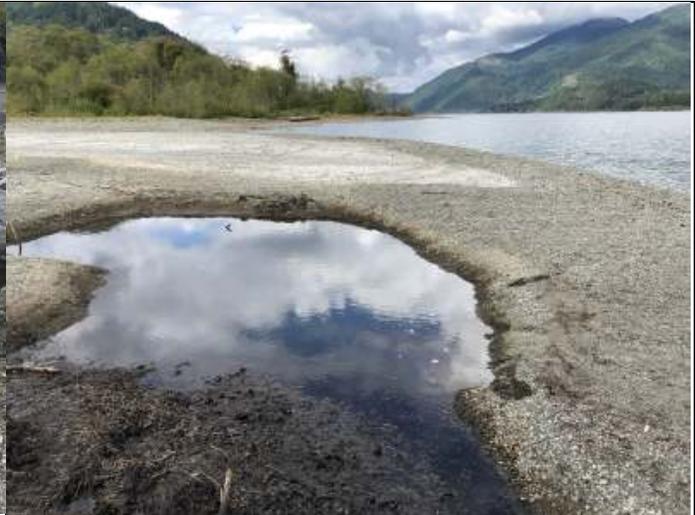
The predetermined lamprey sites were sampled using the digging method. Lamprey larvae were found below the water level (in the substrate) in an isolated pool of approximately 6 m in diameter and 0.5 m deep located near Nixon Creek. Based on water characteristics (D/O=5.50 mg/l; 66.2% saturation; T=19.7°C), potential risk of injury to fish during the salvage procedures, rainfall forecast, and water temperature in the lake (T=22.5°C), it was decided for the time being the lamprey were in suitable habitat and were not at risk of stranding. They were therefore not salvaged. As the water level in this pool is likely influenced by the lake water level, the pool will be monitored on a weekly basis to ensure it remains an appropriate habitat to resident lamprey larvae.

**Photo 6.** Isolated pool on the lake shoreline near Nixon Creek. Found to contain lamprey. Sep 10, 2019.

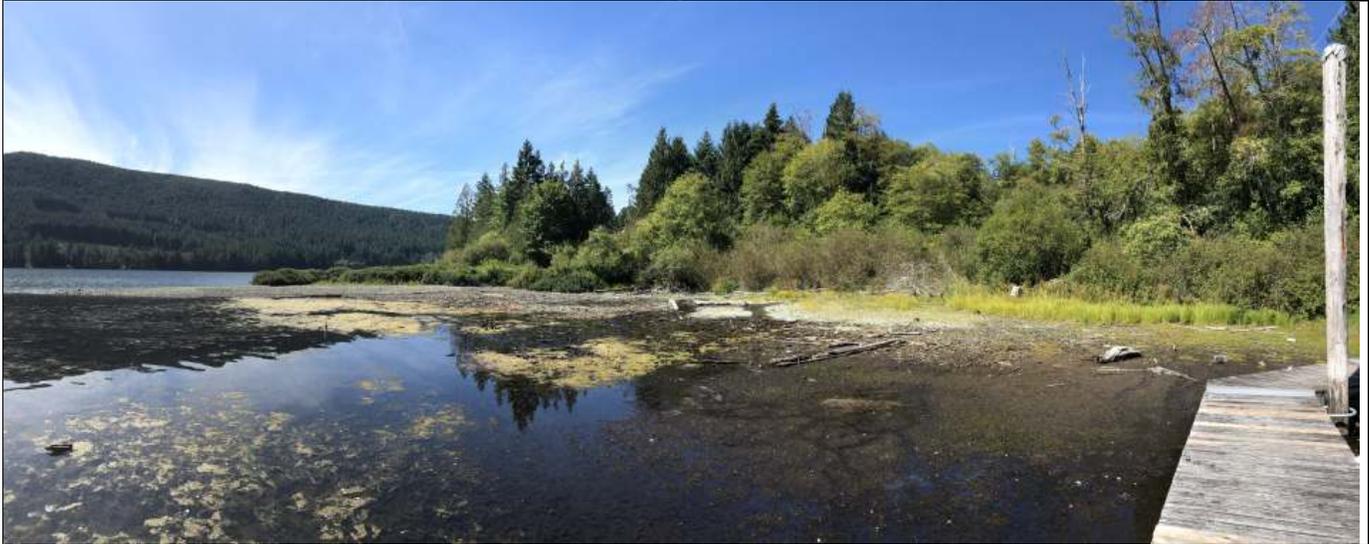
Aquatic plants at Utility and Miracle creeks were completely exposed to air prior to pumping beginning. Stress in plants has been observed at the two locations. The area of emerged aquatic plants at Robertson Creek remained small during this period.

**Photo 19.** Looking west at the lake shoreline - mud flats and riparian vegetation near Miracle Creek. Aug 28, 2019.

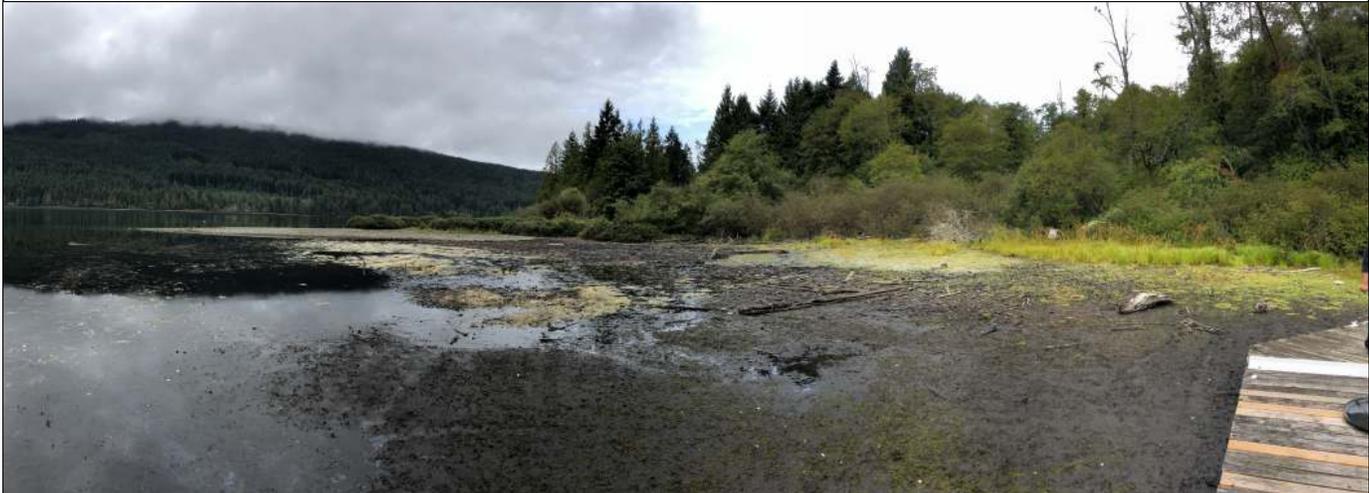
**Photo 20.** Looking west at the lake shoreline - mud flats and riparian vegetation near Miracle Creek. Sep 10, 2019.

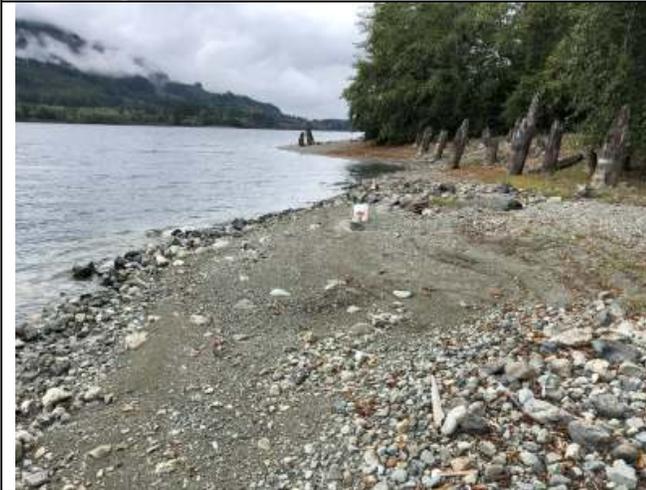
No flow was observed in Little Shaw Creek and its habitat at the lake confluence was considered poor for lamprey rearing, i.e. compacted cobbles and shallow layer of sand. This area will not be surveyed any further.

**Photo 25.** Looking west at the lake shoreline near Little Shaw Creek. Sep 11, 2019.

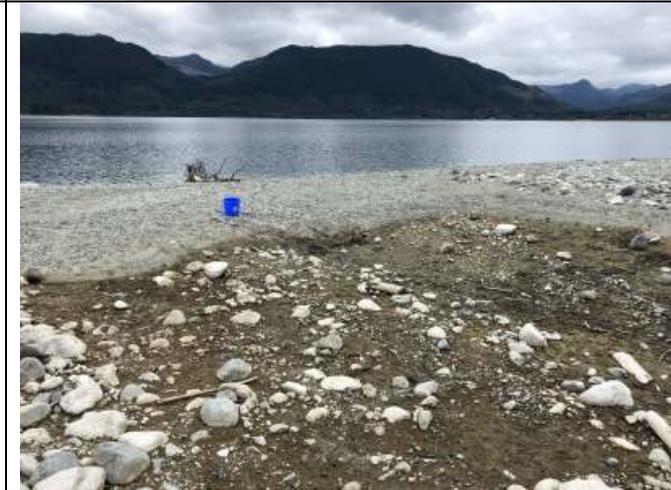
commencing. Lamprey larvae were found in a dry side-channel of McKay Creek, approximately 7 m away from the lake waterline. Digging in this site found the groundwater to be approximately 5 cm below the surface. A total of 19 lamprey individuals ranging from 20 mm to 100 mm were salvaged from an area of approximately 0.5 m<sup>2</sup>. No mortalities were recorded during the salvage process and all individuals were released in a nearby area of the lake characterised by small gravels, large sand, and organics. Sampling continued upstream in the dewatered channel until groundwater was approximately >0.25 m below the surface. Lamprey were not found in any upstream areas.

**Photo 26.** Looking south at the confluence area of McKay Creek and Cowichan Lake. Lamprey salvaged from area beside bucket. Sept. 11, 2019.

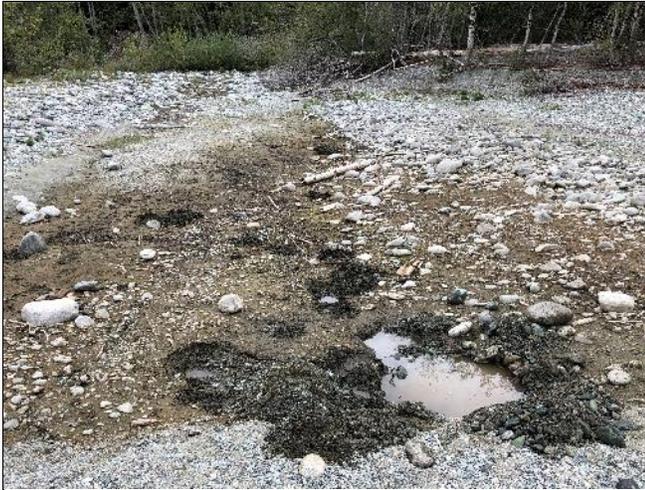
**Photo 27.** Looking north at the confluence area of McKay Creek and Cowichan Lake. Lamprey salvaged from wetted area in foreground. Dark soil represents areas inspected by digging. Sept. 11, 2019

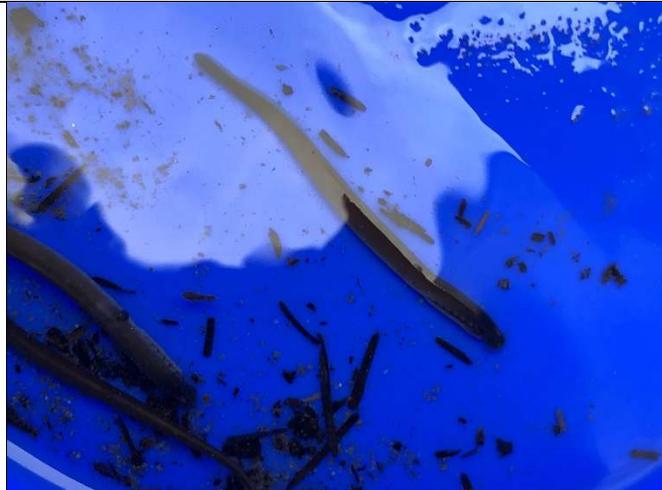
**Photo 28.** Lamprey salvaged from McKay Creek area. Sept. 11, 2019
