**2019 Cowichan Lake Pumping
Weekly Report #3
September 14 – 20, 2019**

Catalyst Paper Corporation
8451 Hay Rd
Crofton, BC V0R 1K5

EDI Environmental Dynamics Inc.
208A – 2520 Bowen Road
Nanaimo, BC V9T 3L3

19N0163
September 2019

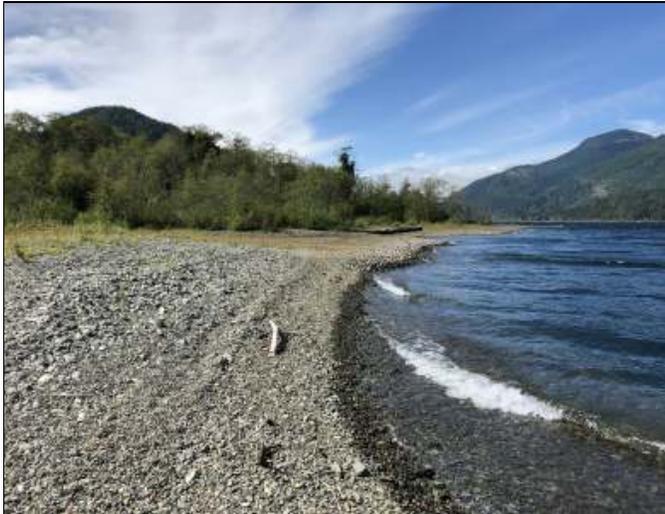
Photo 1. Looking west at the Cowichan Lake shoreline near Nixon Creek. Aug 29, 2019.

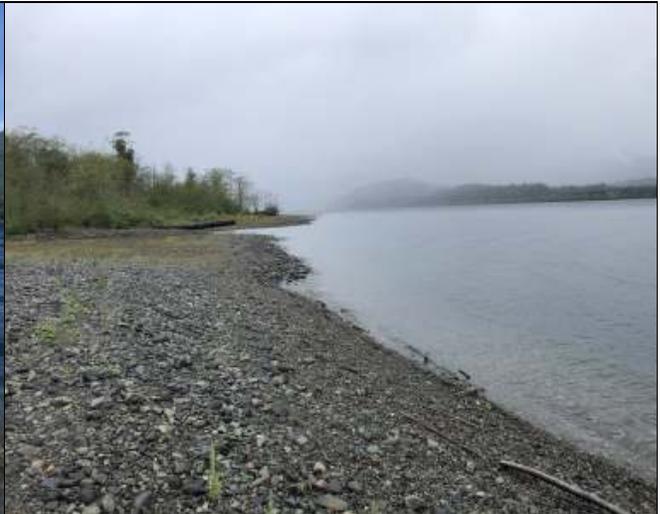
No significant signs of stress or die-off in trees or shrubs within the lake riparian area were observed to date. The lake water line increased due to recent precipitation events and flooded all areas with aquatic and semi-aquatic plants that became exposed during the pumping operations.

Photo 2. Looking west at the Cowichan Lake shoreline near Nixon Creek. Sep 17, 2019.

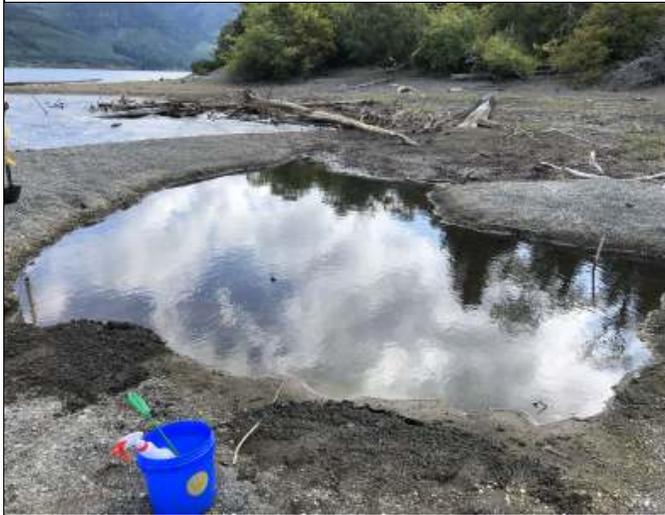
Photo 3. Isolated pool on the lake shoreline near Nixon Creek. Sep 3, 2019.

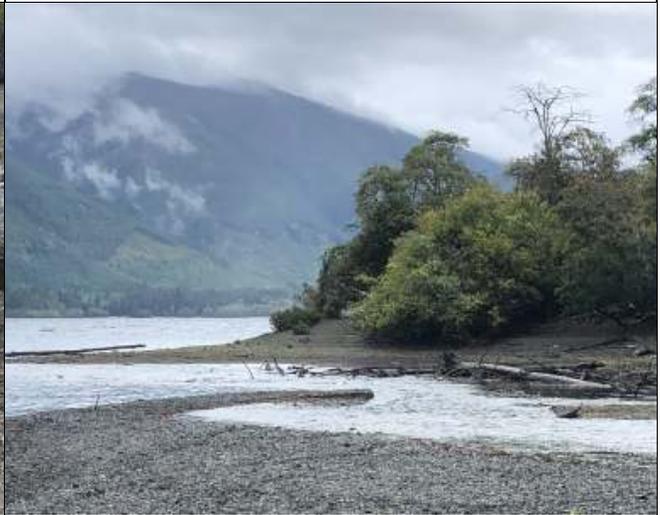
Because previously dewatered areas or isolated pools along the shoreline were submerged or directly connected to the lake, no sampling or salvage activities for Cowichan lamprey occurred during this reporting period. Lamprey larvae found in a previously isolated pool at Nixon Creek had direct access to the lake via the stream, which was flowing during the site visit.

Photo 4. Nixon Creek flowing over the previously isolated pool found to contain lamprey. Sep 17, 2019.

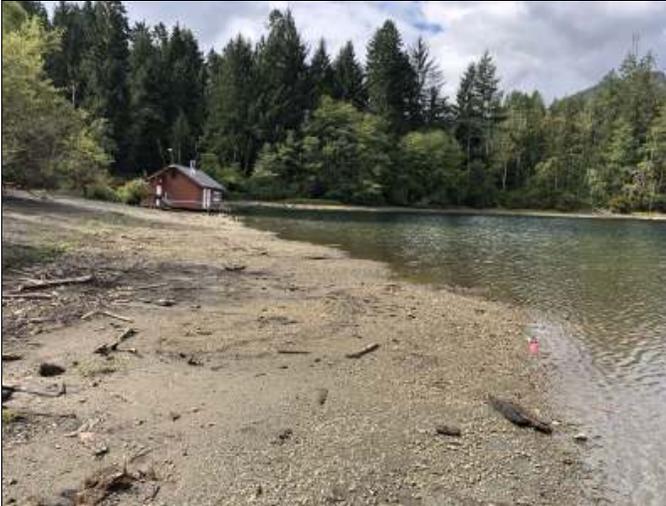
Photo 5. Looking southwest at the lake shoreline near the Nixon Creek float house. Aug 29, 2019.

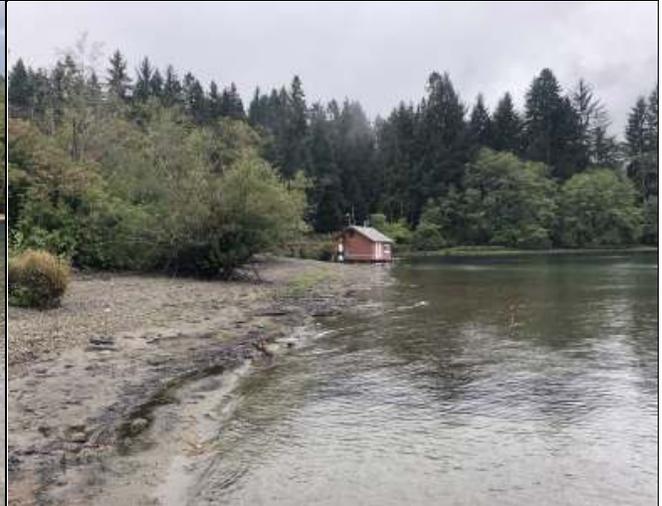
Photo 6. Looking southwest at the lake shoreline near the Nixon Creek float house. Sep 17, 2019.

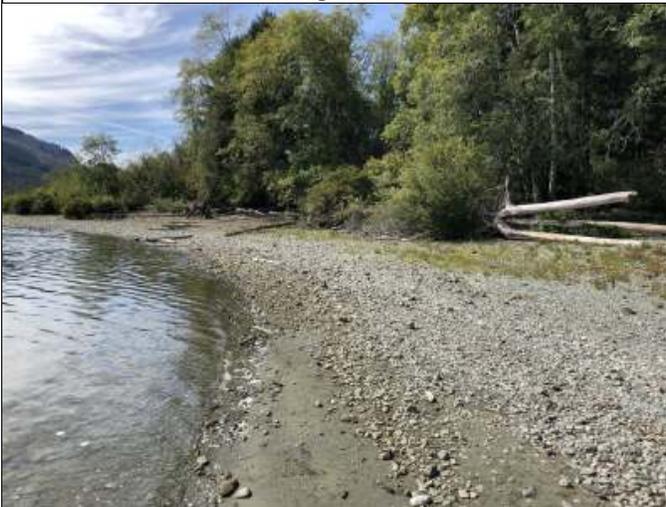
Photo 7. Looking east at the lake shoreline near Shaw Creek. Aug 28, 2019.

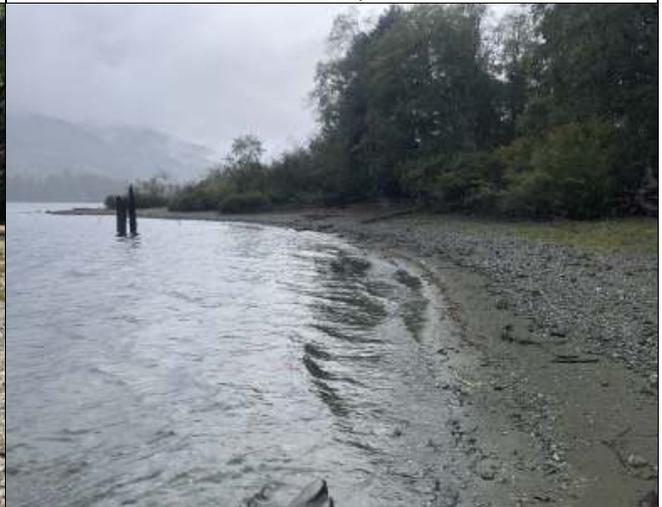
Photo 8. Looking east at the lake shoreline near Shaw Creek. Sep 17, 2019.

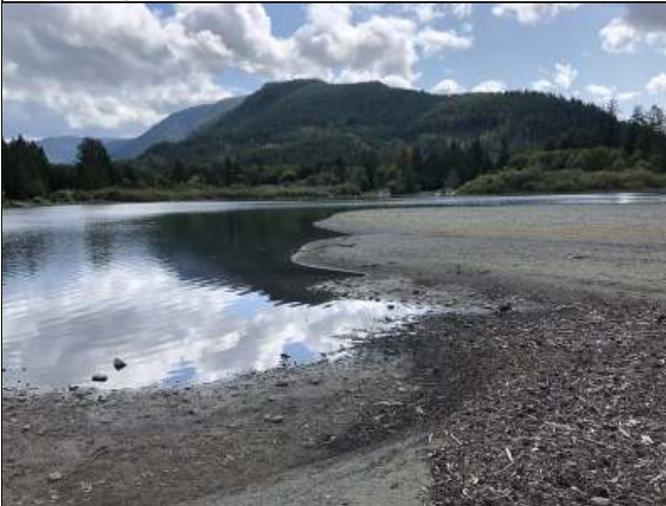
Photo 9. Looking west at the lake shoreline near Robertson Creek. Sep 3, 2019.

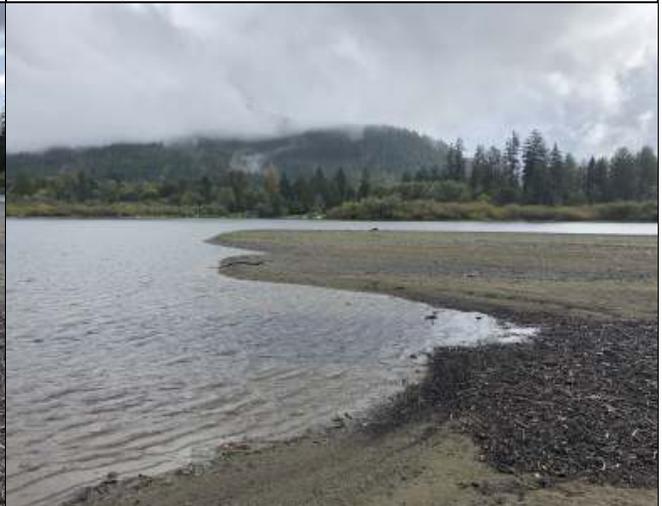
Photo 10. Looking west at the lake shoreline near Robertson Creek. Sep 17, 2019.

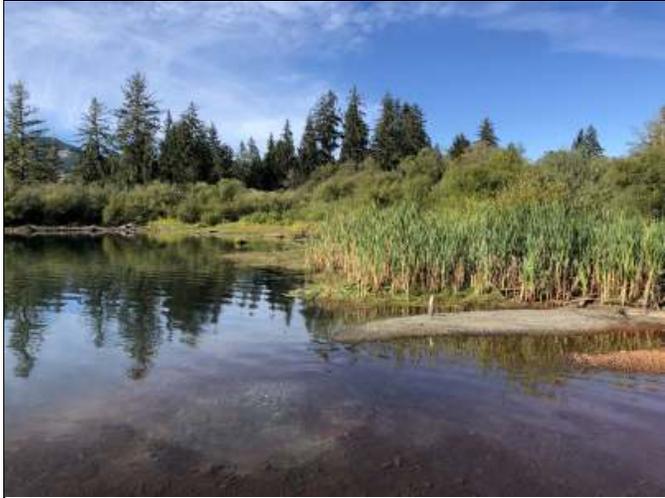
Photo 11. Looking south at the vegetated lake shoreline near Robertson Creek. Aug 28, 2019.

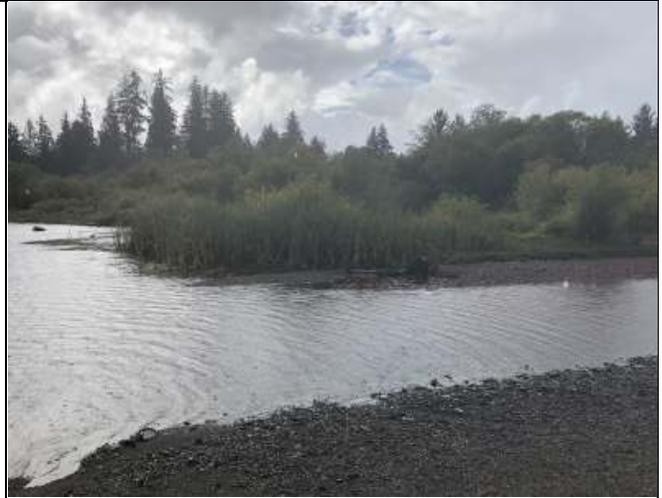
Photo 12. Looking south at the vegetated lake shoreline near Robertson Creek. Sep 17, 2019.

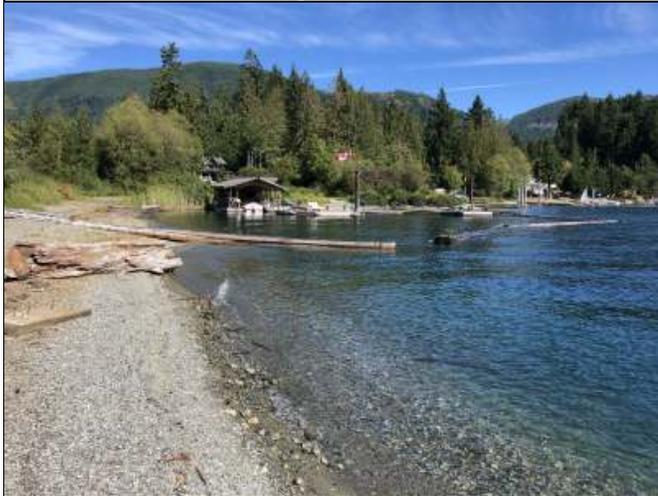
Photo 13. Looking north at the lake shoreline near Meade Creek. Aug 28, 2019.

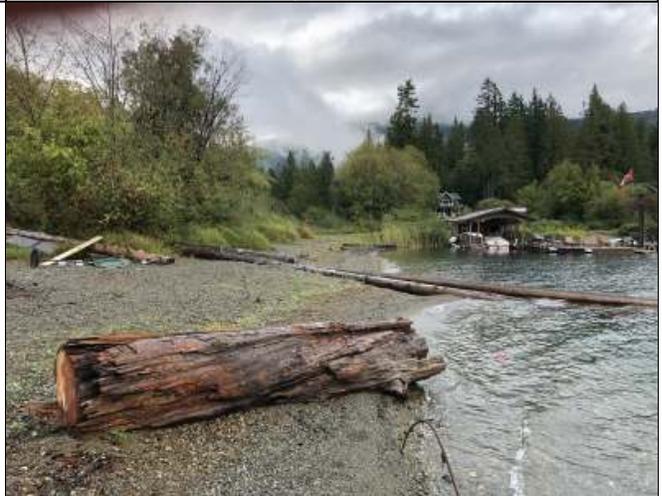
Photo 14. Looking north at the lake shoreline near Meade Creek. Sep 10, 2019.

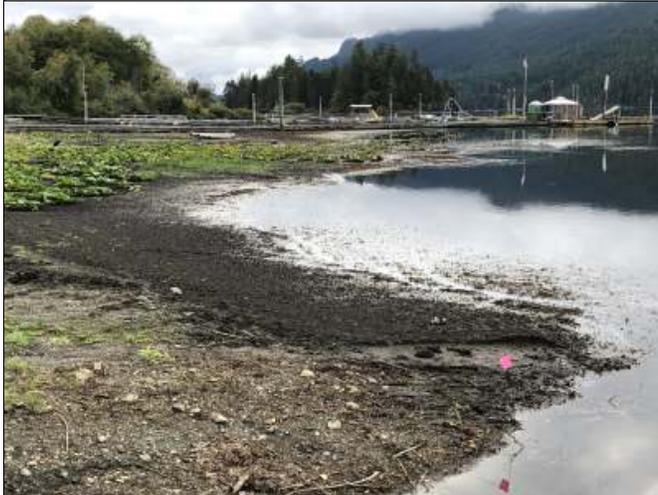
Photo 15. Looking west at the lake shoreline near Utility Creek. Sep 10, 2019.

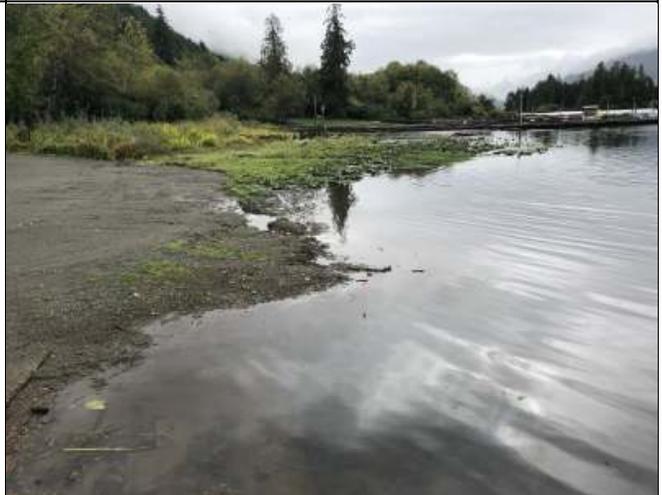
Photo 16. Looking west at the lake shoreline near Utility Creek. Sep 17, 2019.

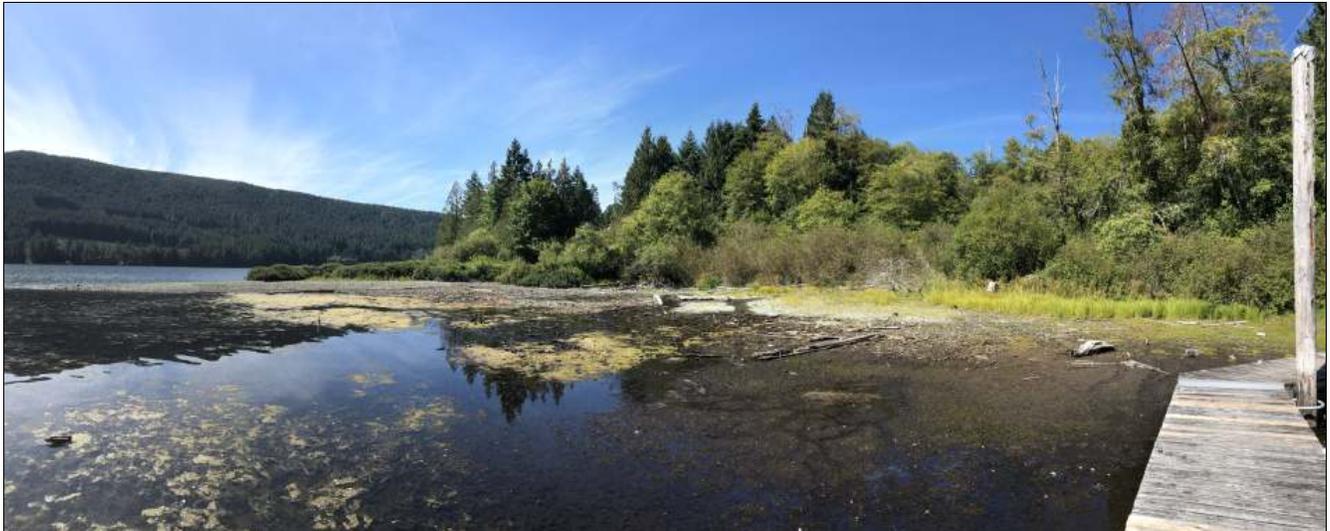
Photo 17. Looking west at the lake shoreline - mud flats and riparian vegetation near Miracle Creek. Aug 28, 2019.

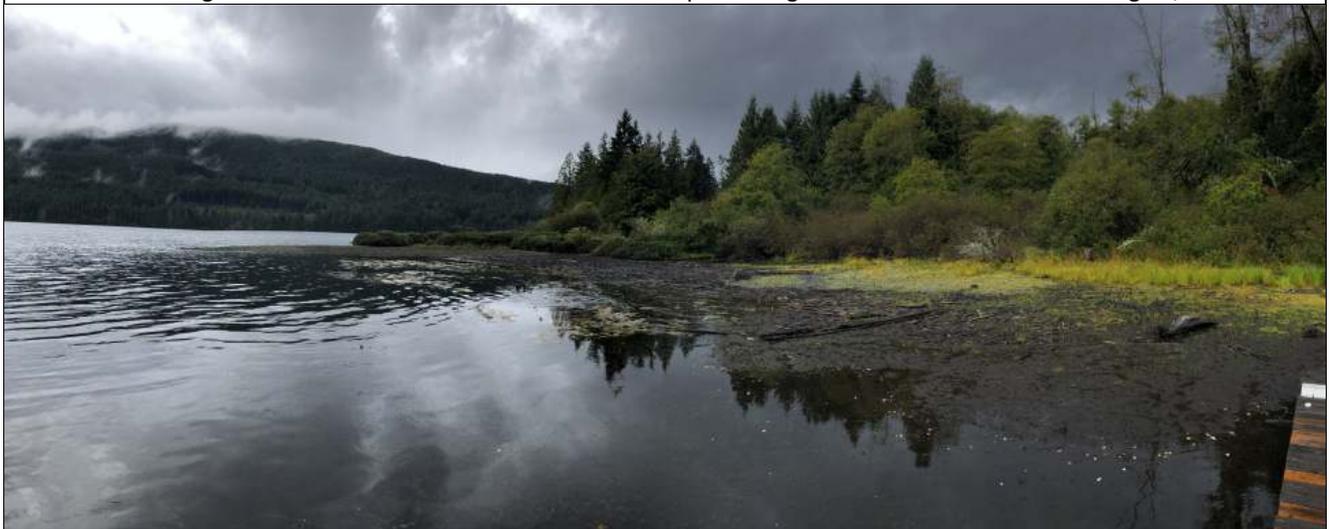
Photo 18. Looking west at the lake shoreline - mud flats and riparian vegetation near Miracle Creek. Sep 17, 2019.

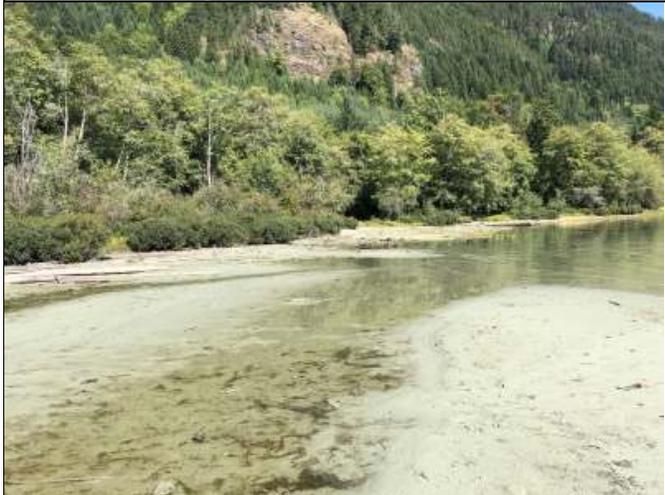
Photo 19. Looking east at the lake shoreline near Hawse Bay. Aug 28, 2019.

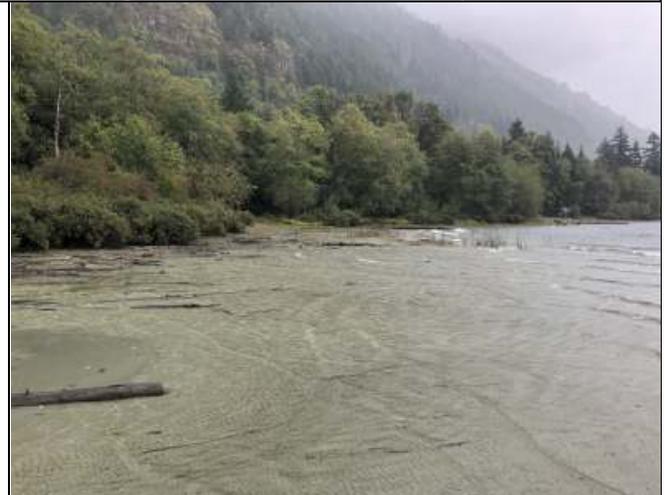
Photo 20. Looking east at the lake shoreline near Hawse Bay. Sep 17, 2019.

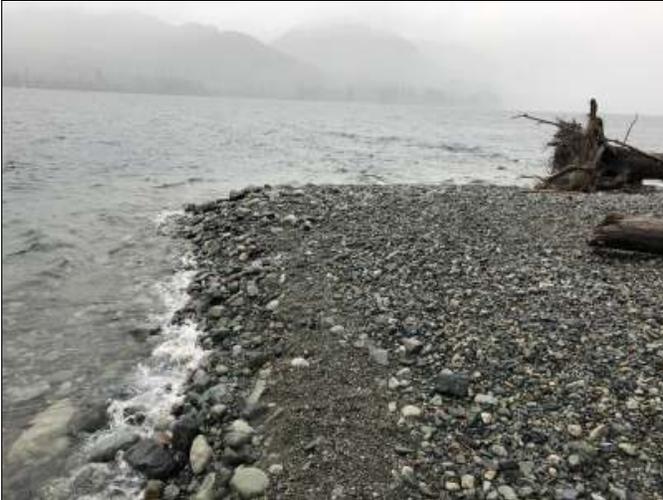
Photo 21. Looking southwest at the lake shoreline near Cottonwood Creek. Sep 17, 2019.

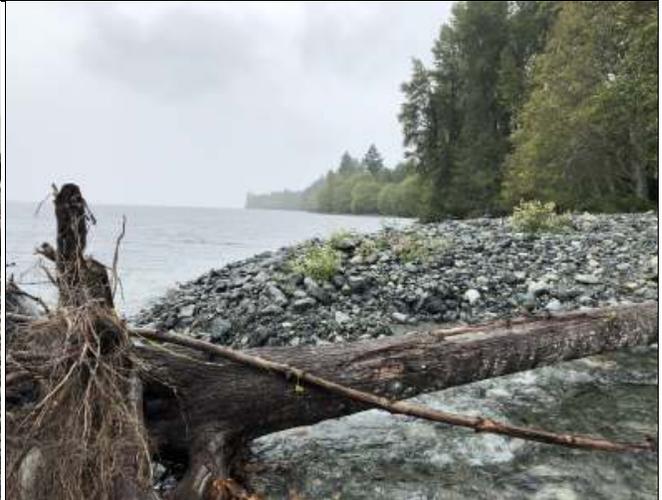
Photo 22. Looking west at the lake shoreline near Cottonwood Creek. Sep 17, 2019.

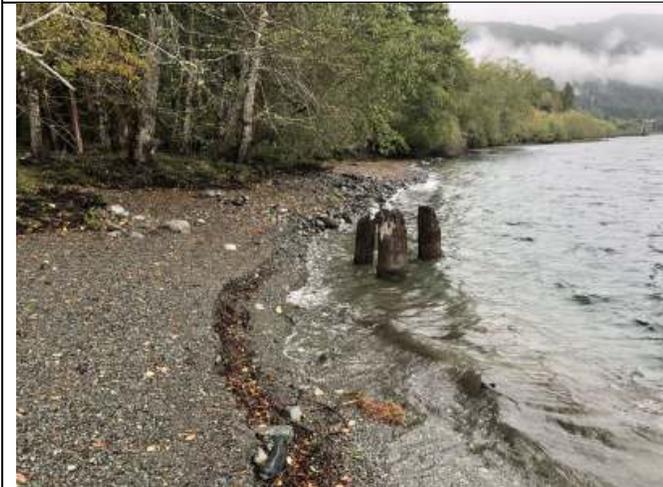
Photo 27. Looking east at the lake shoreline near Cottonwood Creek. Sep 17, 2019.

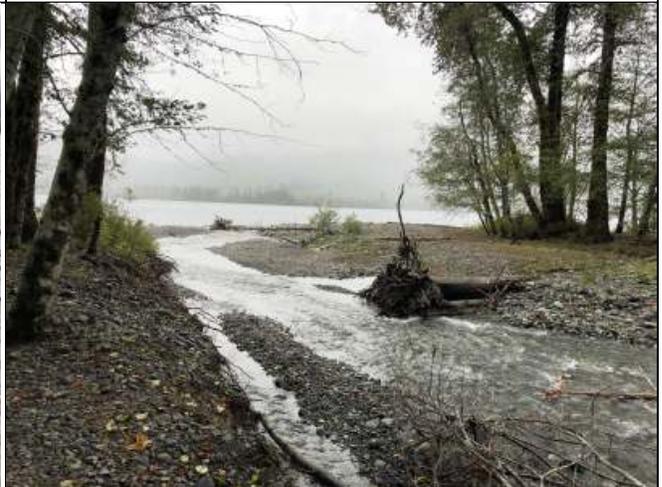
On September 17, potential stranding locations for lamprey were assessed at the confluence of Cottonwood Creek and Cowichan Lake as well. At that site, the spawning habitat for lamprey was considered limited and the rearing habitat was lacking as the substrate in the confluence zone was dominated by cobble size rocks and large gravels with very little to no organics.

Photo 28. Looking south at the confluence of Cottonwood Creek and Cowichan Lake. Sep 17, 2019.
