Cowichan Watershed Society

September 24, 2018,
Presentation by Brian Houle

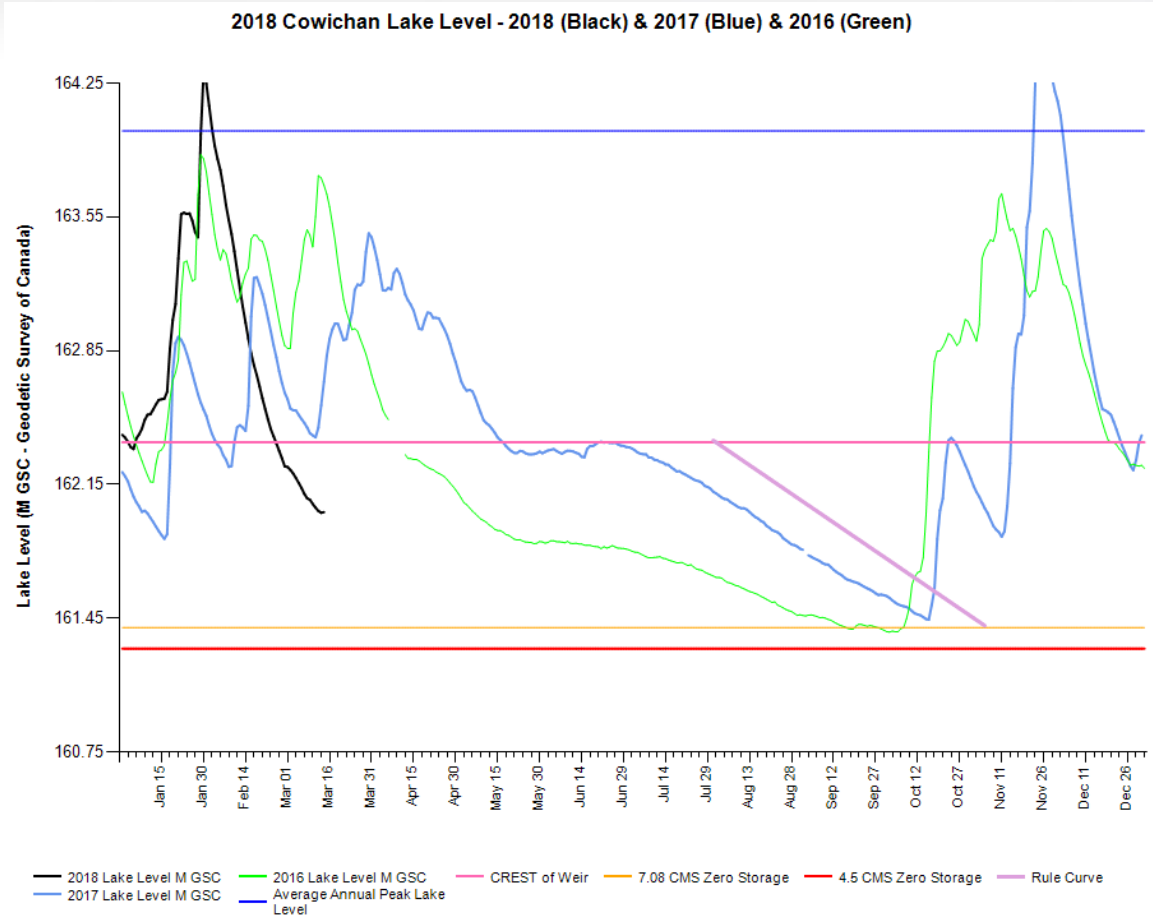
2018 began with very dry February & March resulting in lake level dropping to very low levels in March – early control requested and approved (& then not needed) see next slide

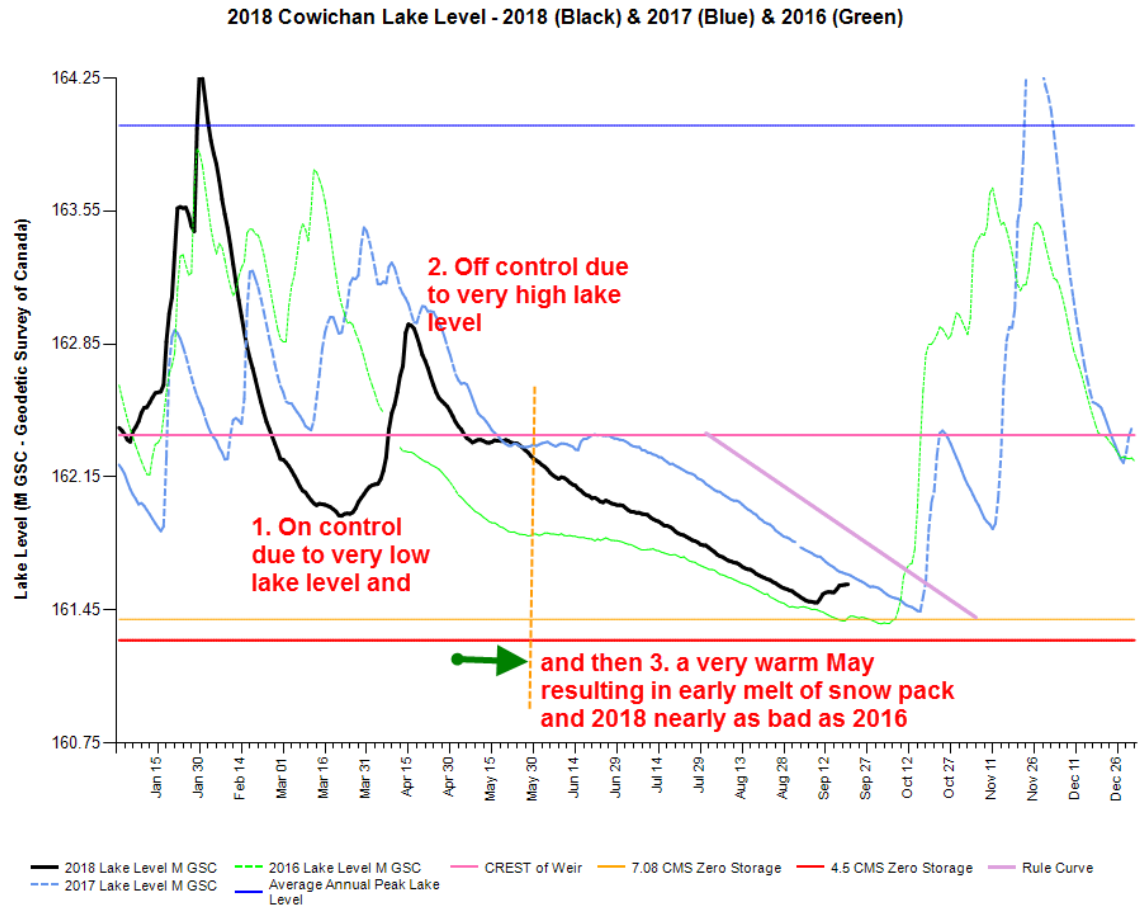
2018 began with as much snow as 2017 but early melt of snow pack resulted in a difficult year – 4.5 cms again in 2018

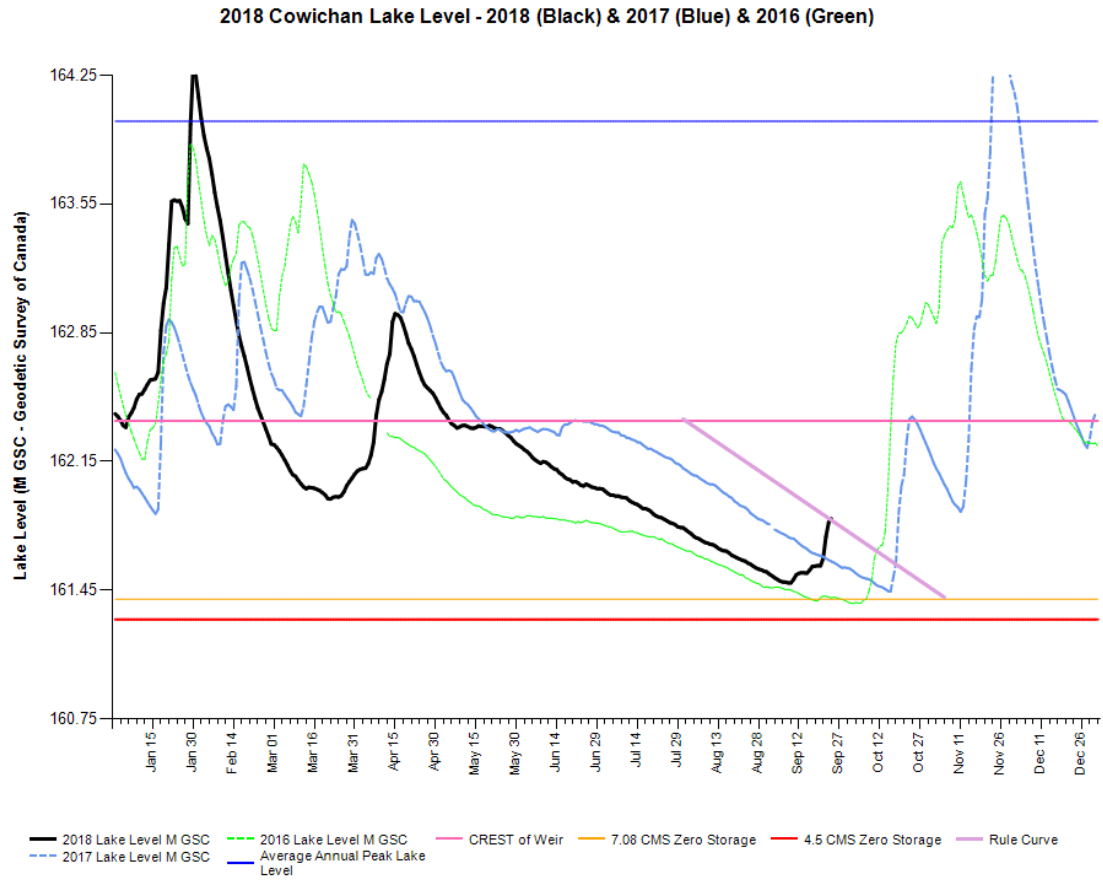
2018 (black line) showing three recent rainfall events with this past weekend bringing enough rainfall to fill lake to rule curve lake level. Added water level has resulted in release from lake rising from 4.5 cms to 7 cms – the license minimum flow

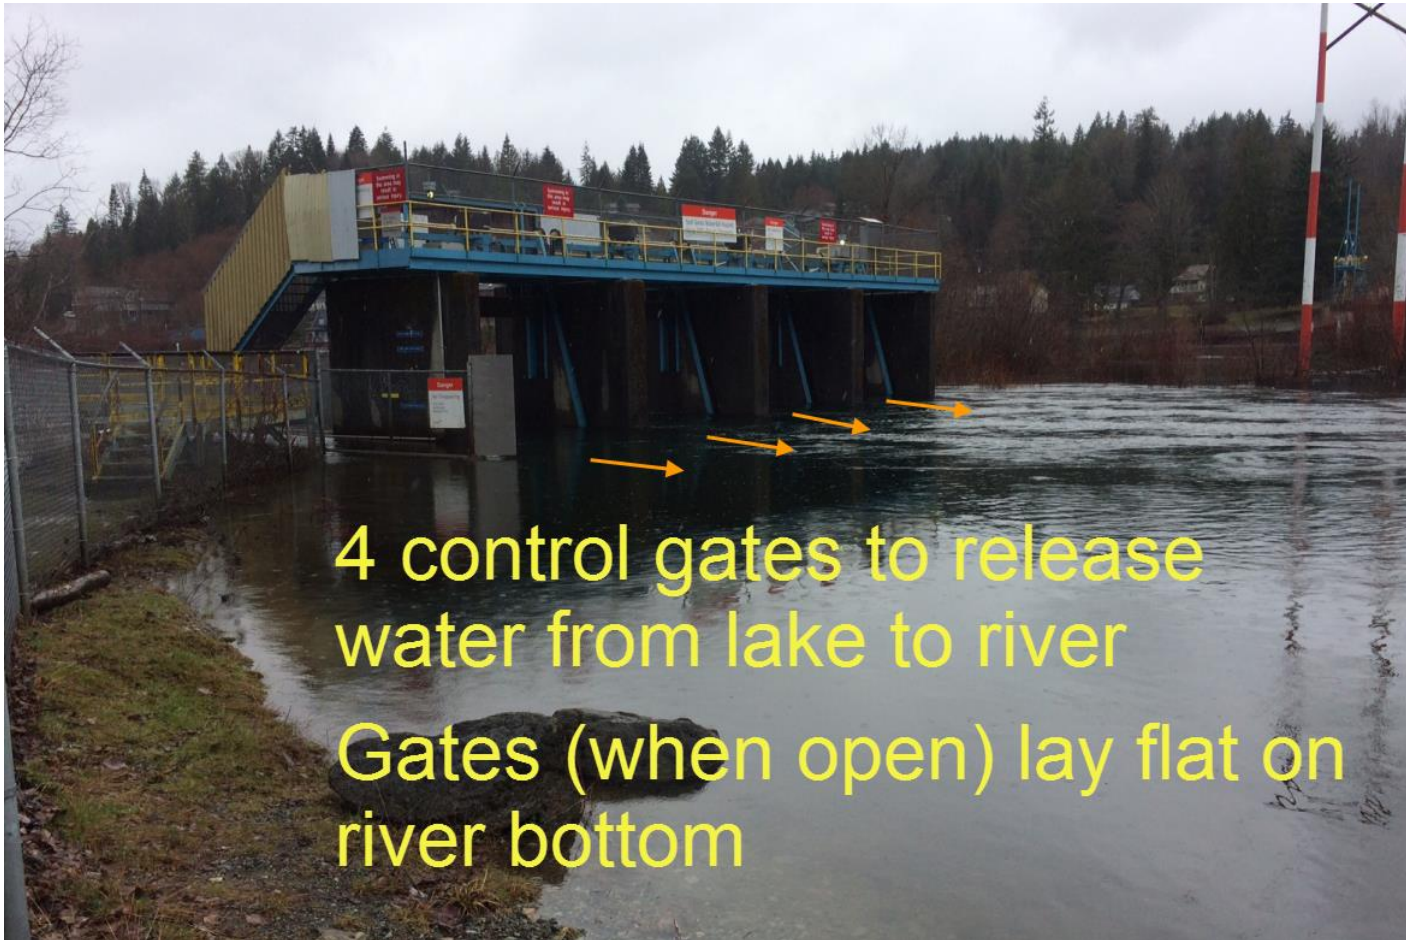
Cowichan Lake Weir, Boat Lock, Spill Gate Control Structure and Fish Ladder

- Photo from South side – showing 4 control gates – fish ladder not visible at South end.
- 2 photos showing boat lock structure – where boats navigate through – at North end of weir
- 3 photos of the weir or dam showing how high winter lake levels rise above this structure. The pinch point below Green Dale Trestle constricts river flow and results in higher lake levels - high winter lake levels not related to structures of boat lock, weir and 4 control gates.

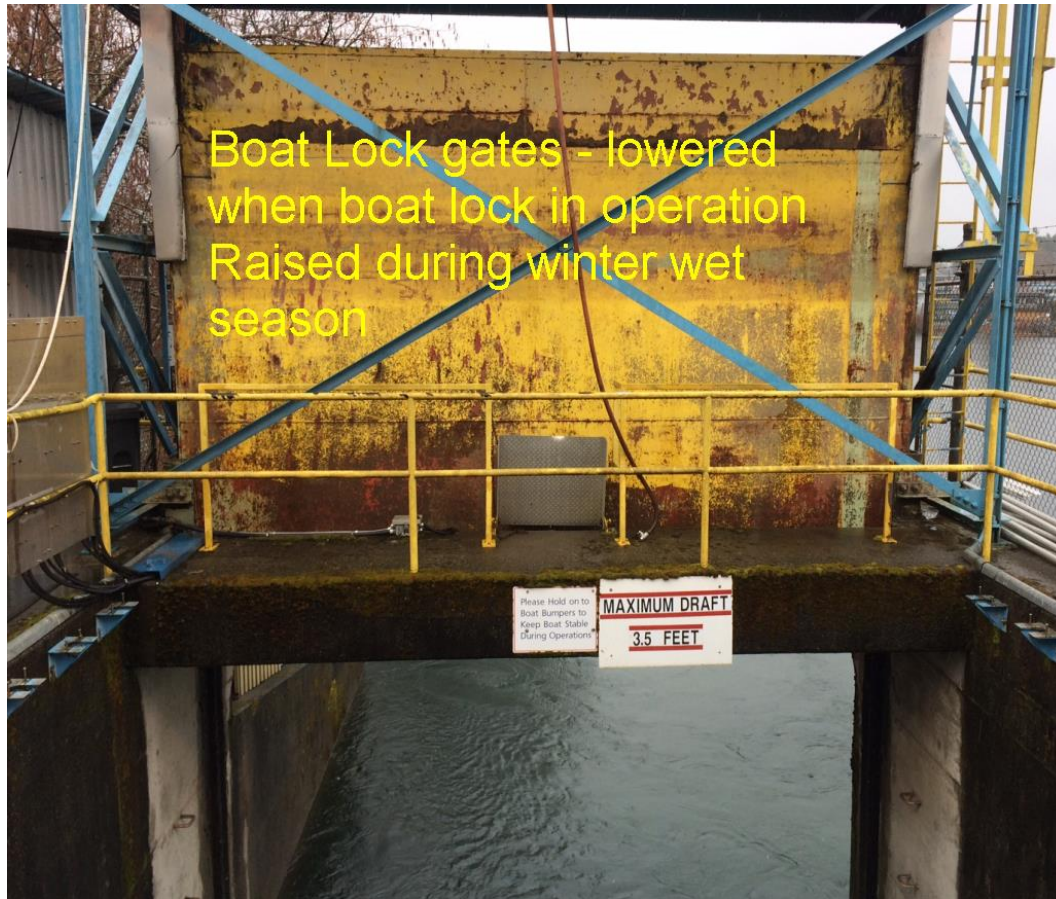
Winter season boat lock gates are raised

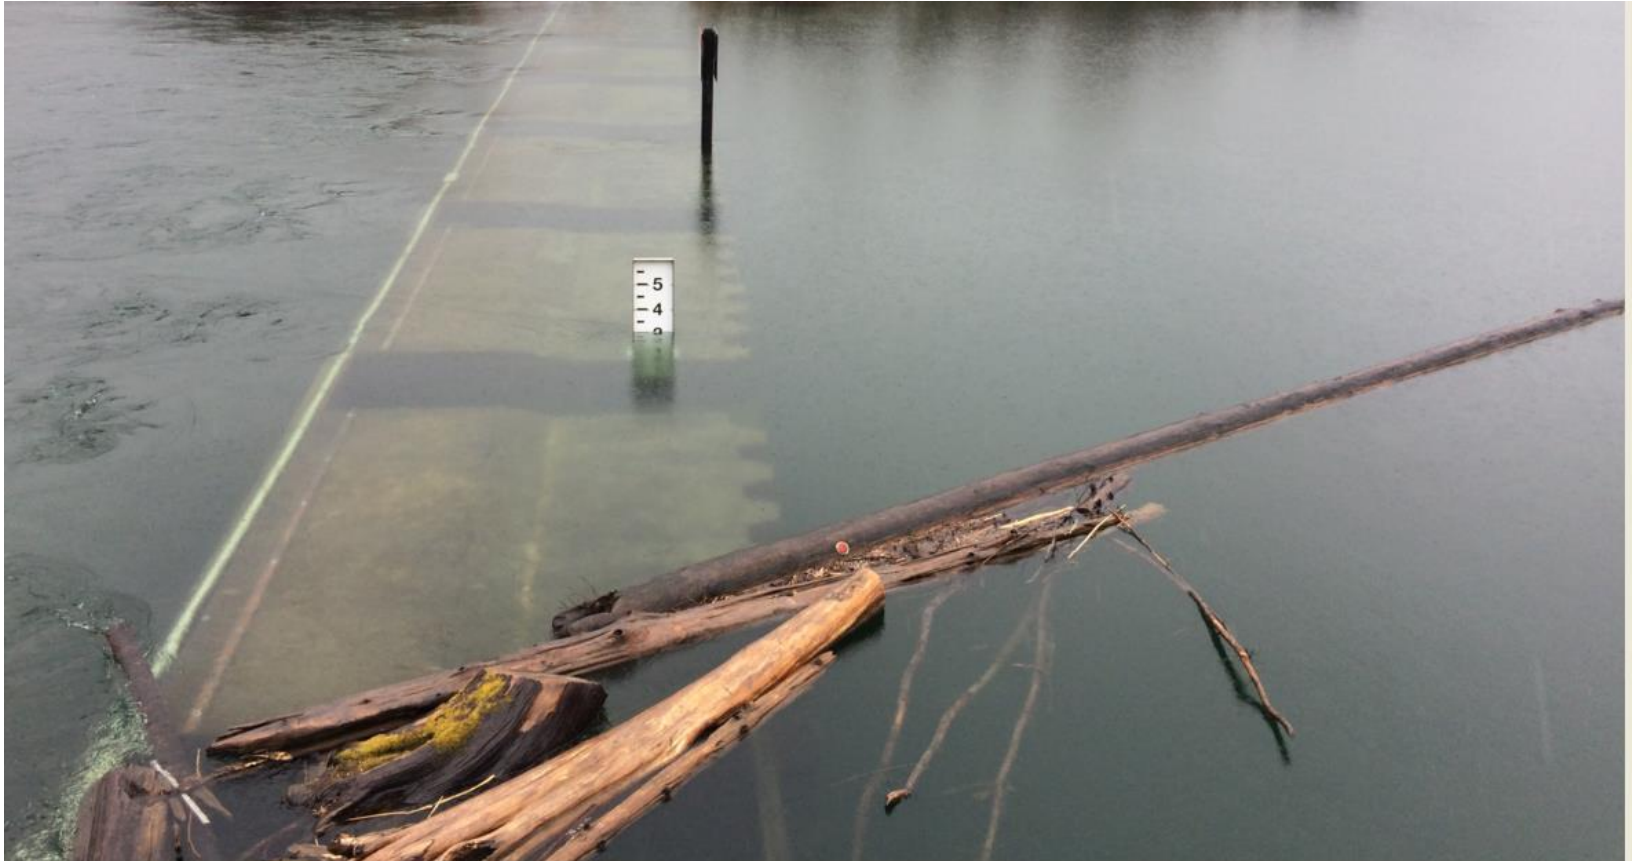
During winter wet season (off control) boater traffic free to navigate to/from lake and river via open channel through boat lock

With high lake levels, weir submerged

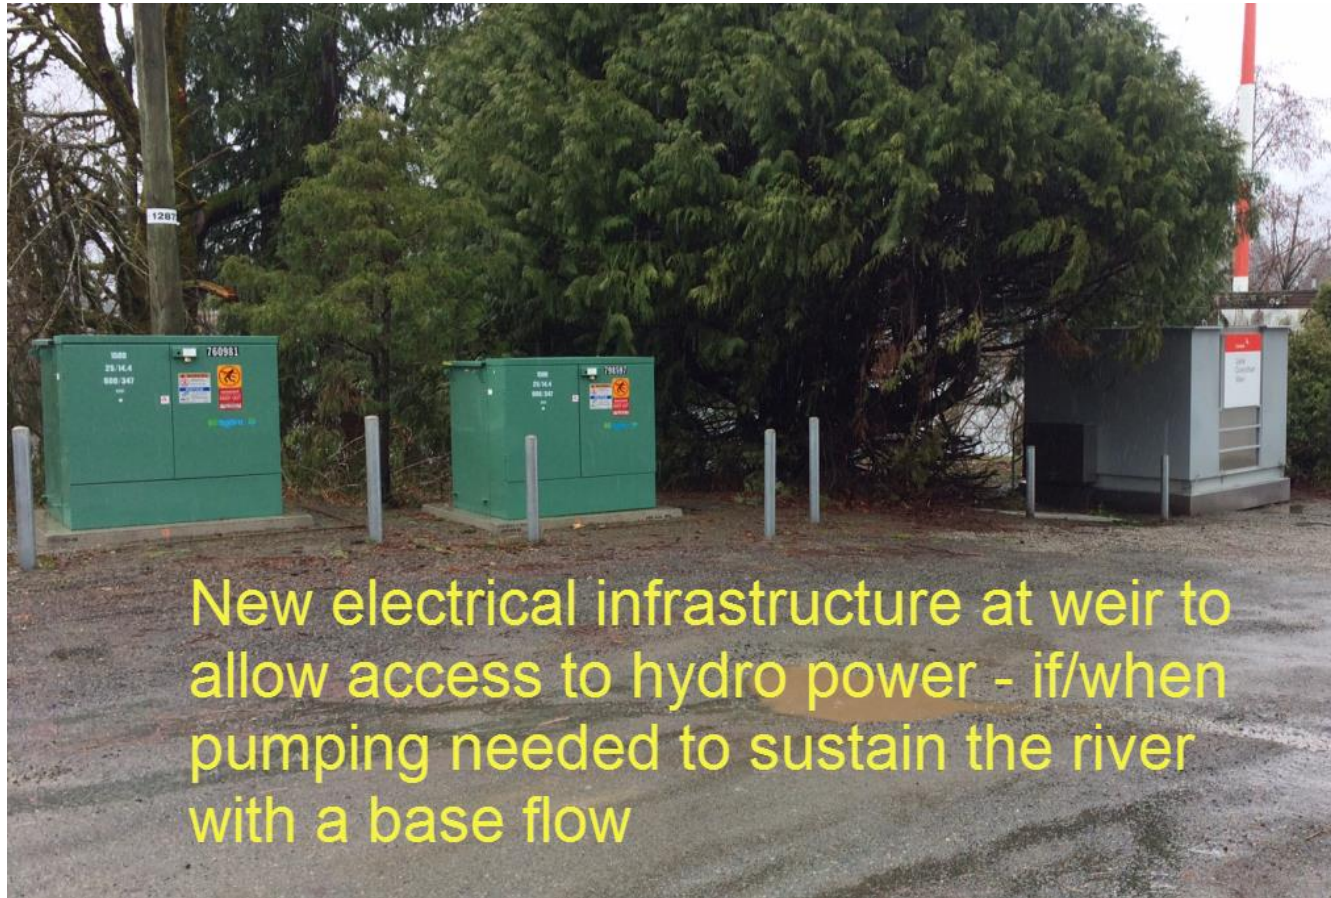
New electrical infrastructure for pumps

New electrical infrastructure at weir to allow access to hydro power - if/when pumping needed to sustain the river with a base flow

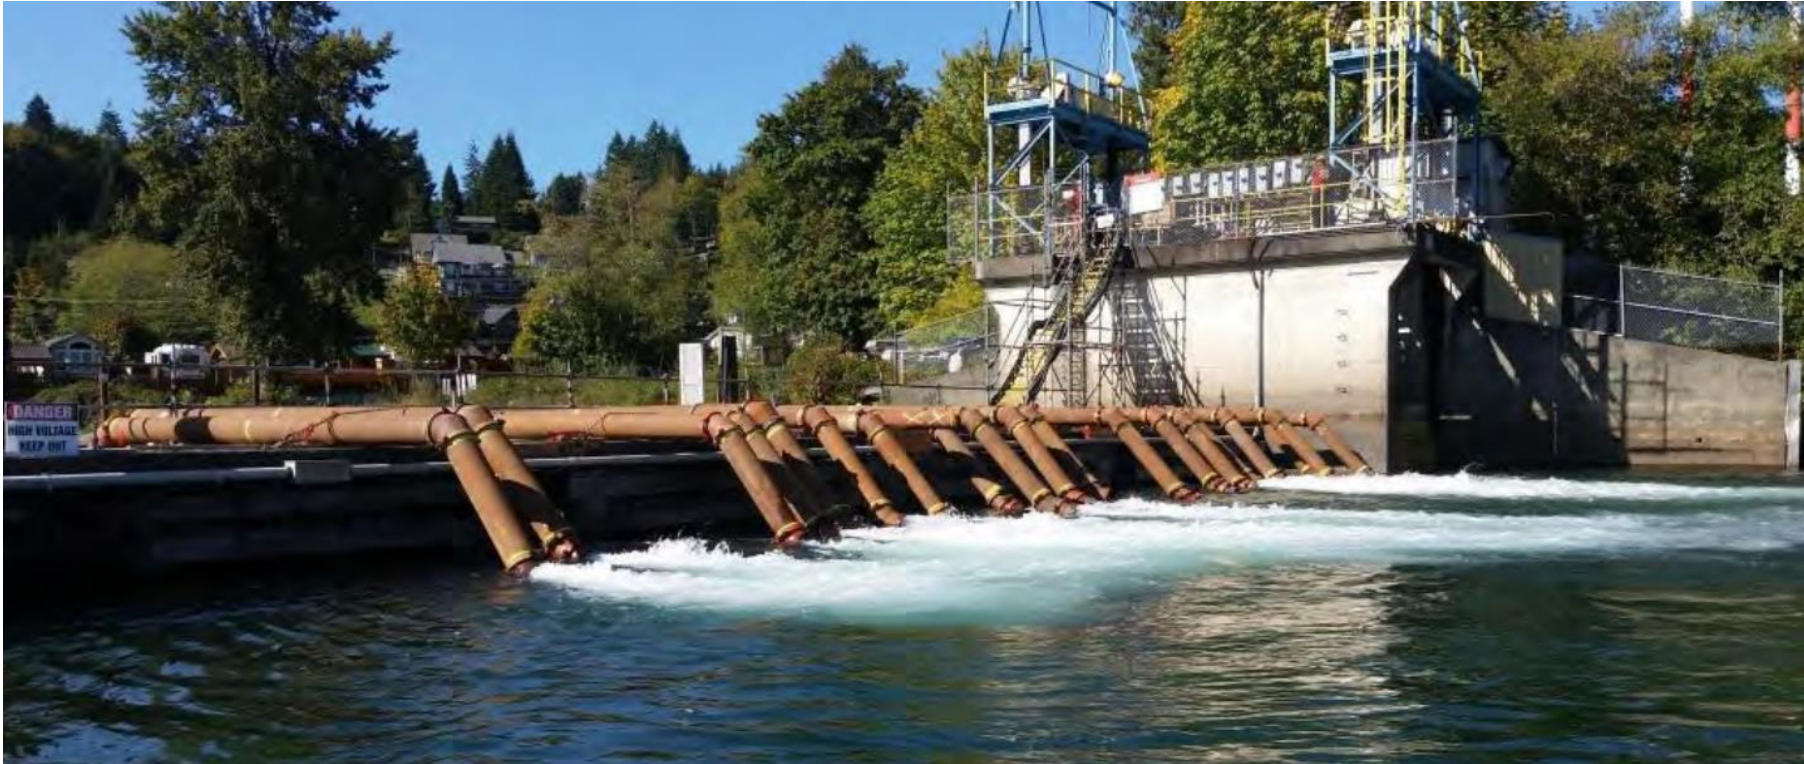
While 20 pumps were trialed, 15 pumps required for base flow of 4.5 cms

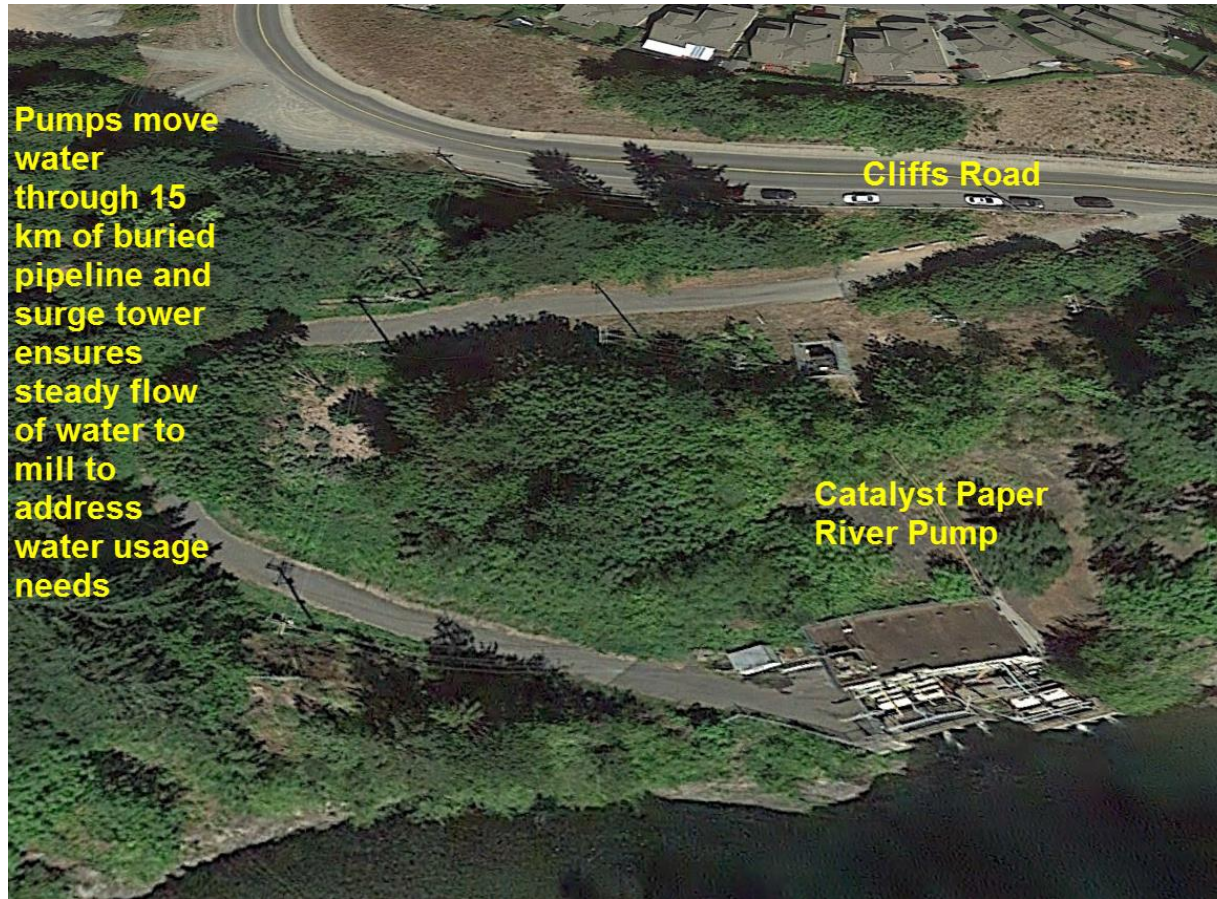
Catalyst Paper River Pump House

- Located on North side of River on Cliffs Road
- 7 installed pumps – 6 electrically connected and operable / one spare installed pump
- Pumps operated to meet demand for water at mill – starting and stopping pumps to meet water use needs
- Surge Tower just to North (West of Duncan Hospital) and pumps sustain water feed to mill
- 15 km pipeline to deliver water to mill filtration water treatment plant

The pump house on Cowichan River is accessed from Cliffs Road

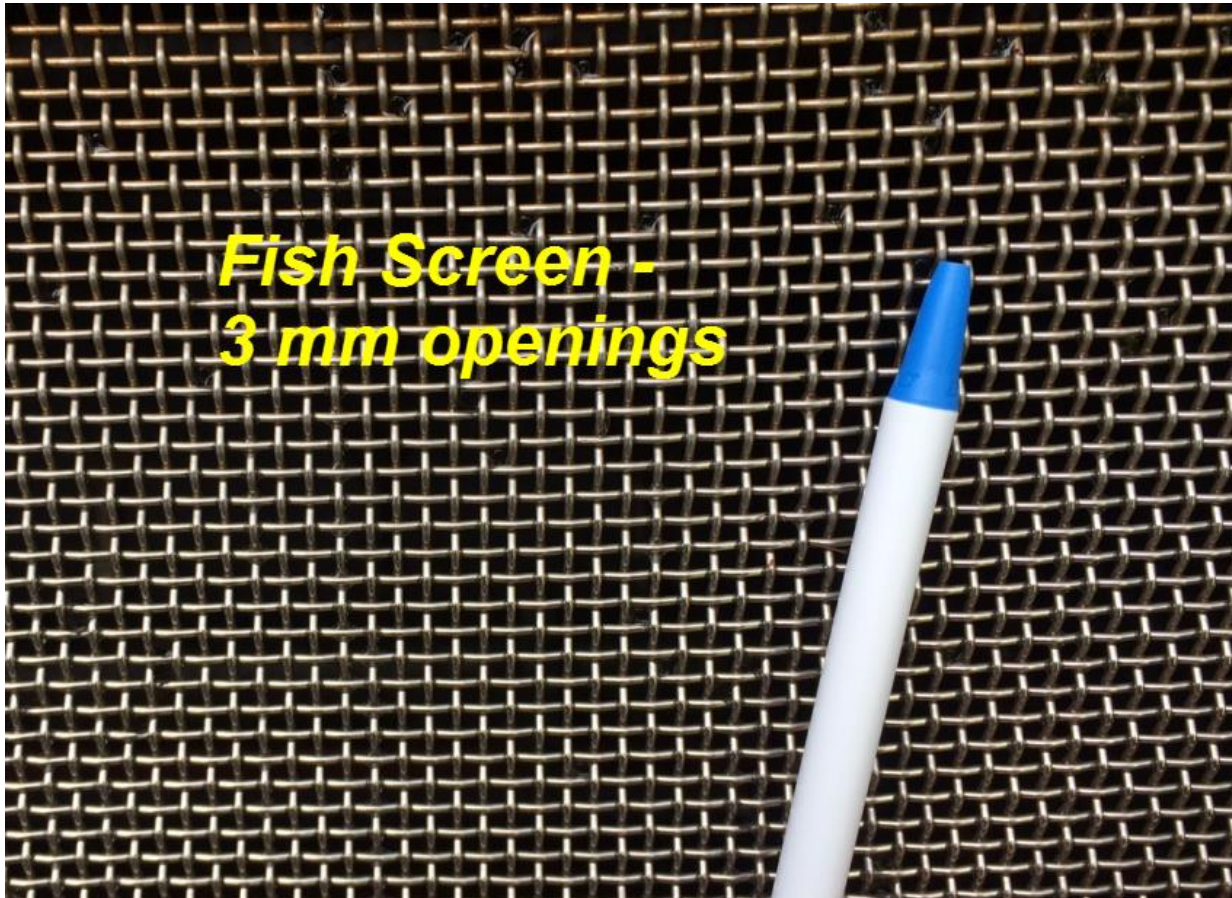
Fine screen – fish cannot pass through

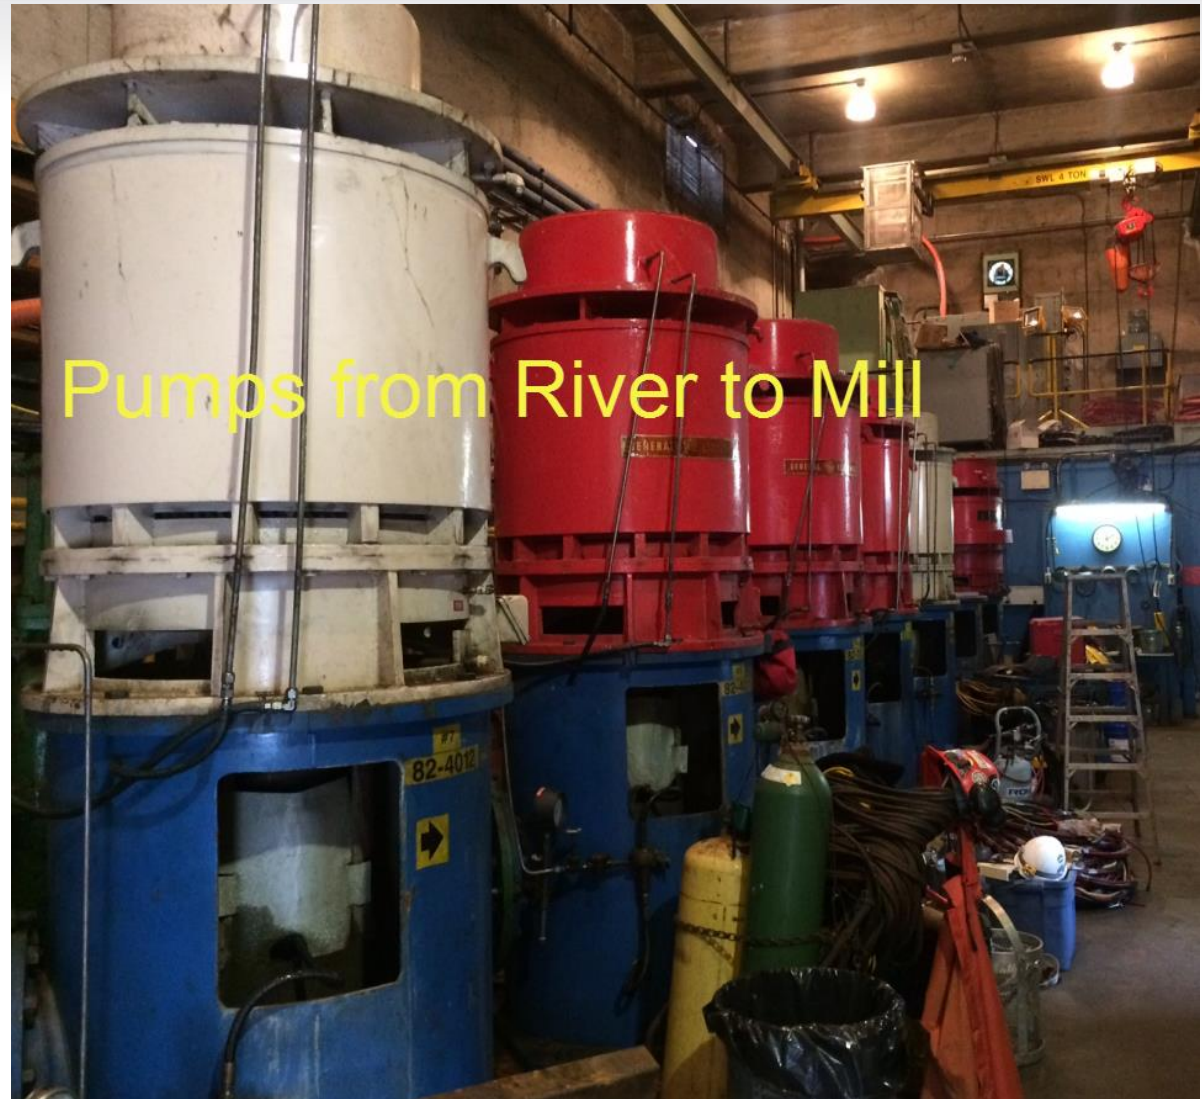
Pump House
equipped with
7 pumps

Shown are
the motors

Long vertical
shafts down
to water level
where pumps
are located
