Cowichan Weir Operations Review of 2015 and Review of 2016 year to date Conditions

February 29, 2016, Cowichan Watershed Board Meeting
CVRD Council Chambers - Duncan

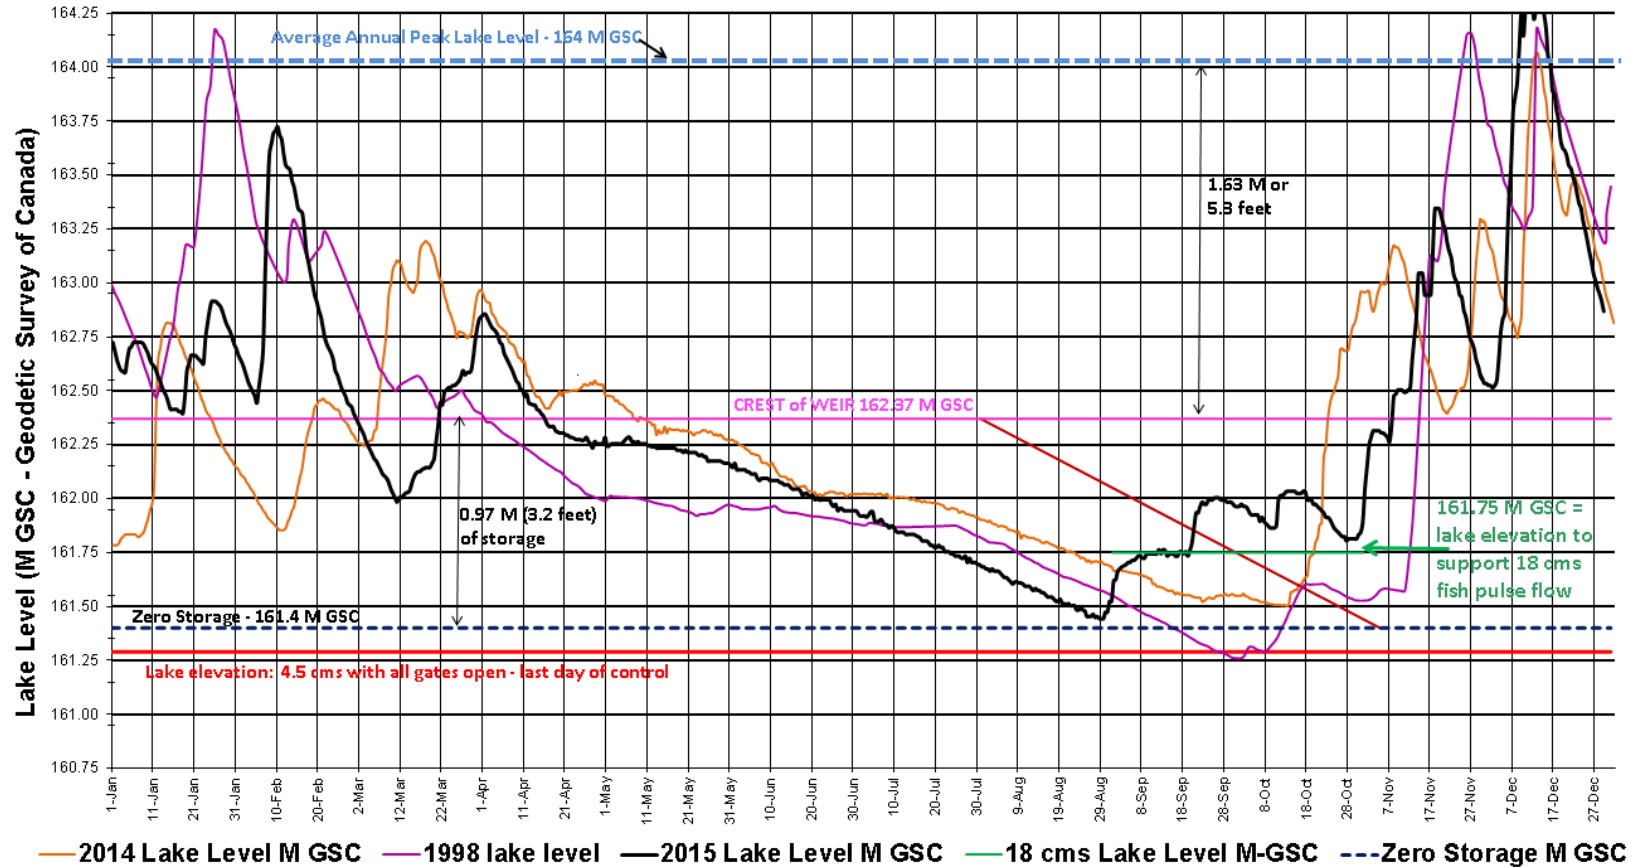
Without Aug 31 rainfall event in 2015, pumping needed on about Sept 17 to sustain 4.5 cms

Cowichan Lake Level - 2015 (black) & 1998 (Purple) & 2014 (orange)

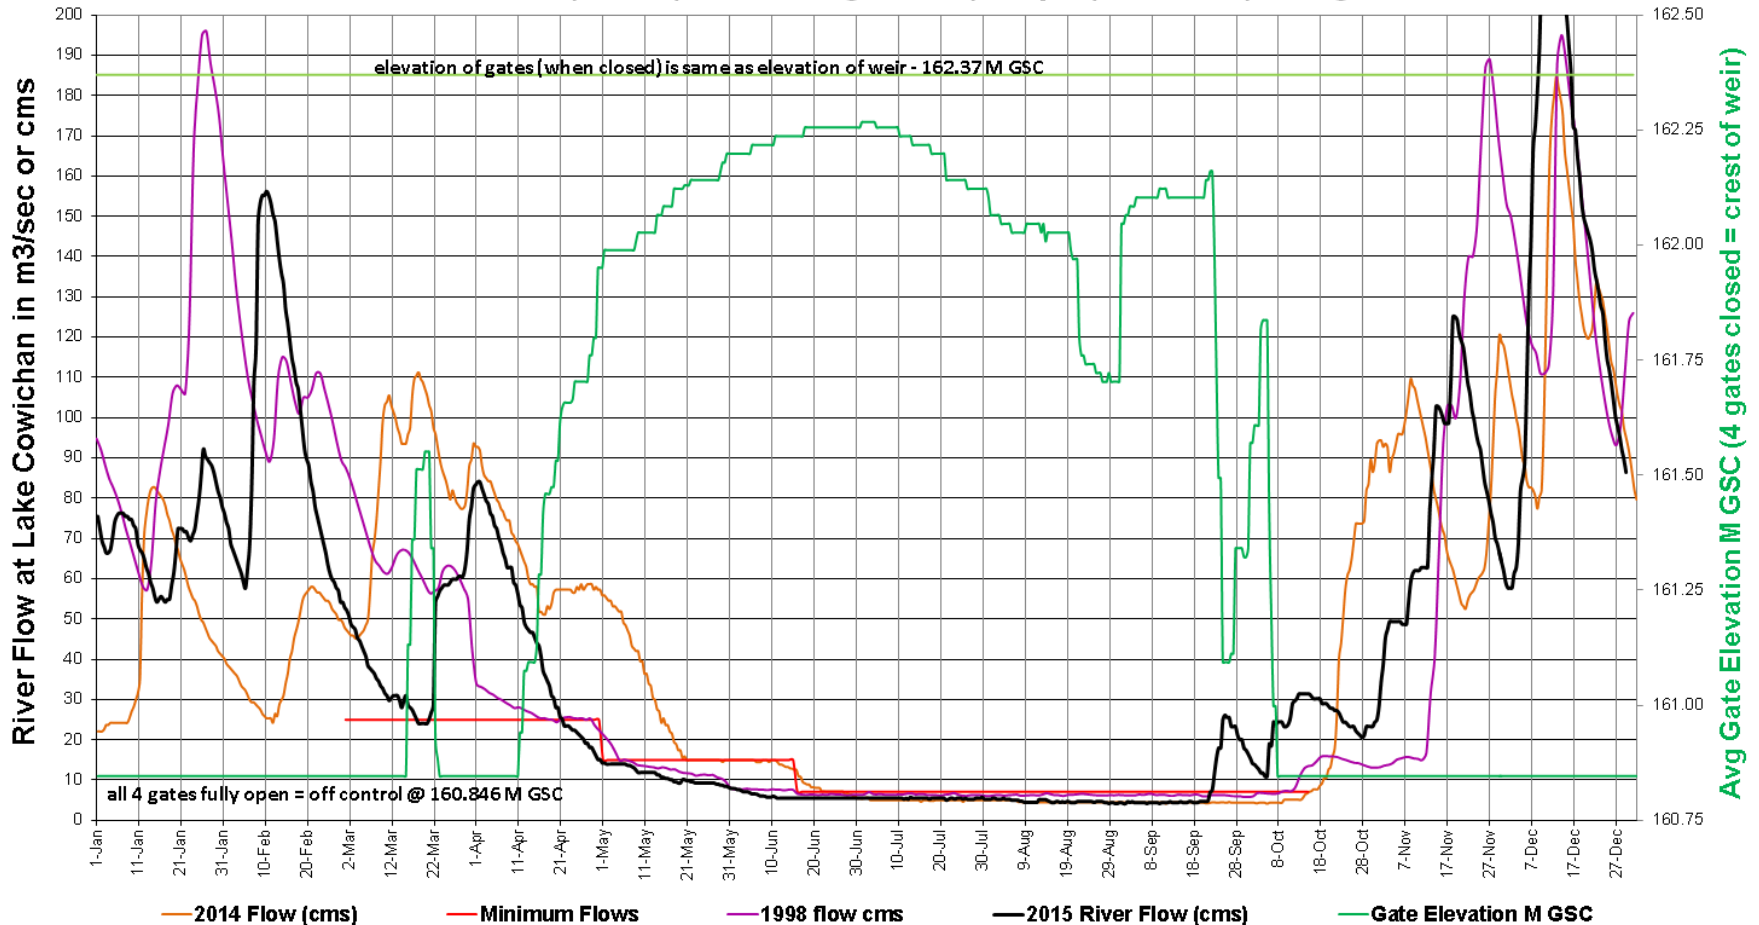
In 2015 river flows lowered to 4.5 cms on August 8, as it was done in 2014

2015 Cowichan River Flow (black) Including 1998 (Purple) & 2014 (orange)

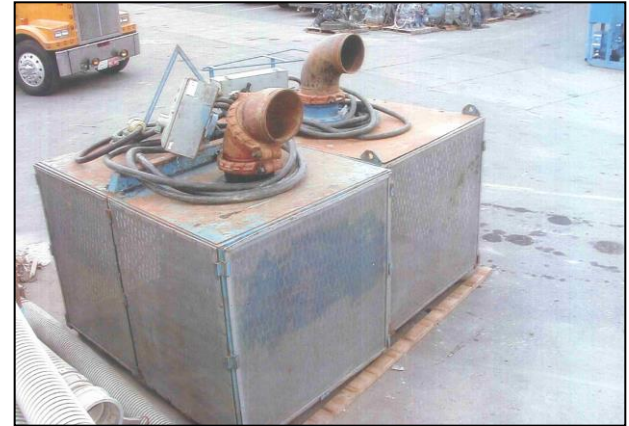
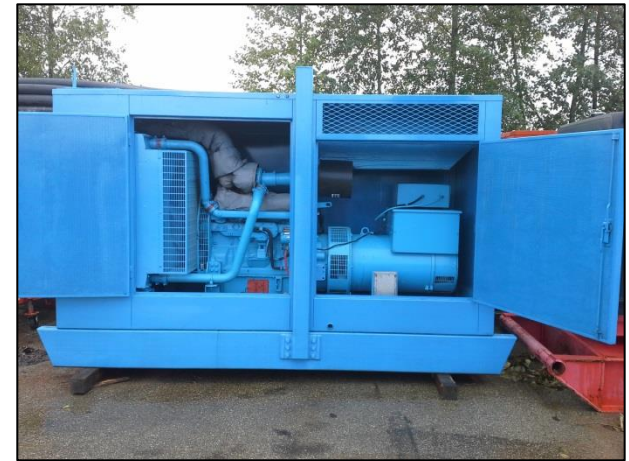
Section 8 Pump-out proposed layout

- Worst case, last ditch approach to save river
- \$1 million estimated cost
- Installation of floating pumps
 - move water over the weir
 - operate for no more than 49 days lowering the lake by no more than 23 inches
 - fish screens on intakes
 - powered by soundproofed diesel generators on shore with full spill containment
- Independent environmental professional would monitor lake levels and impacts and report to regulator

Catalyst preference is Generators on North side

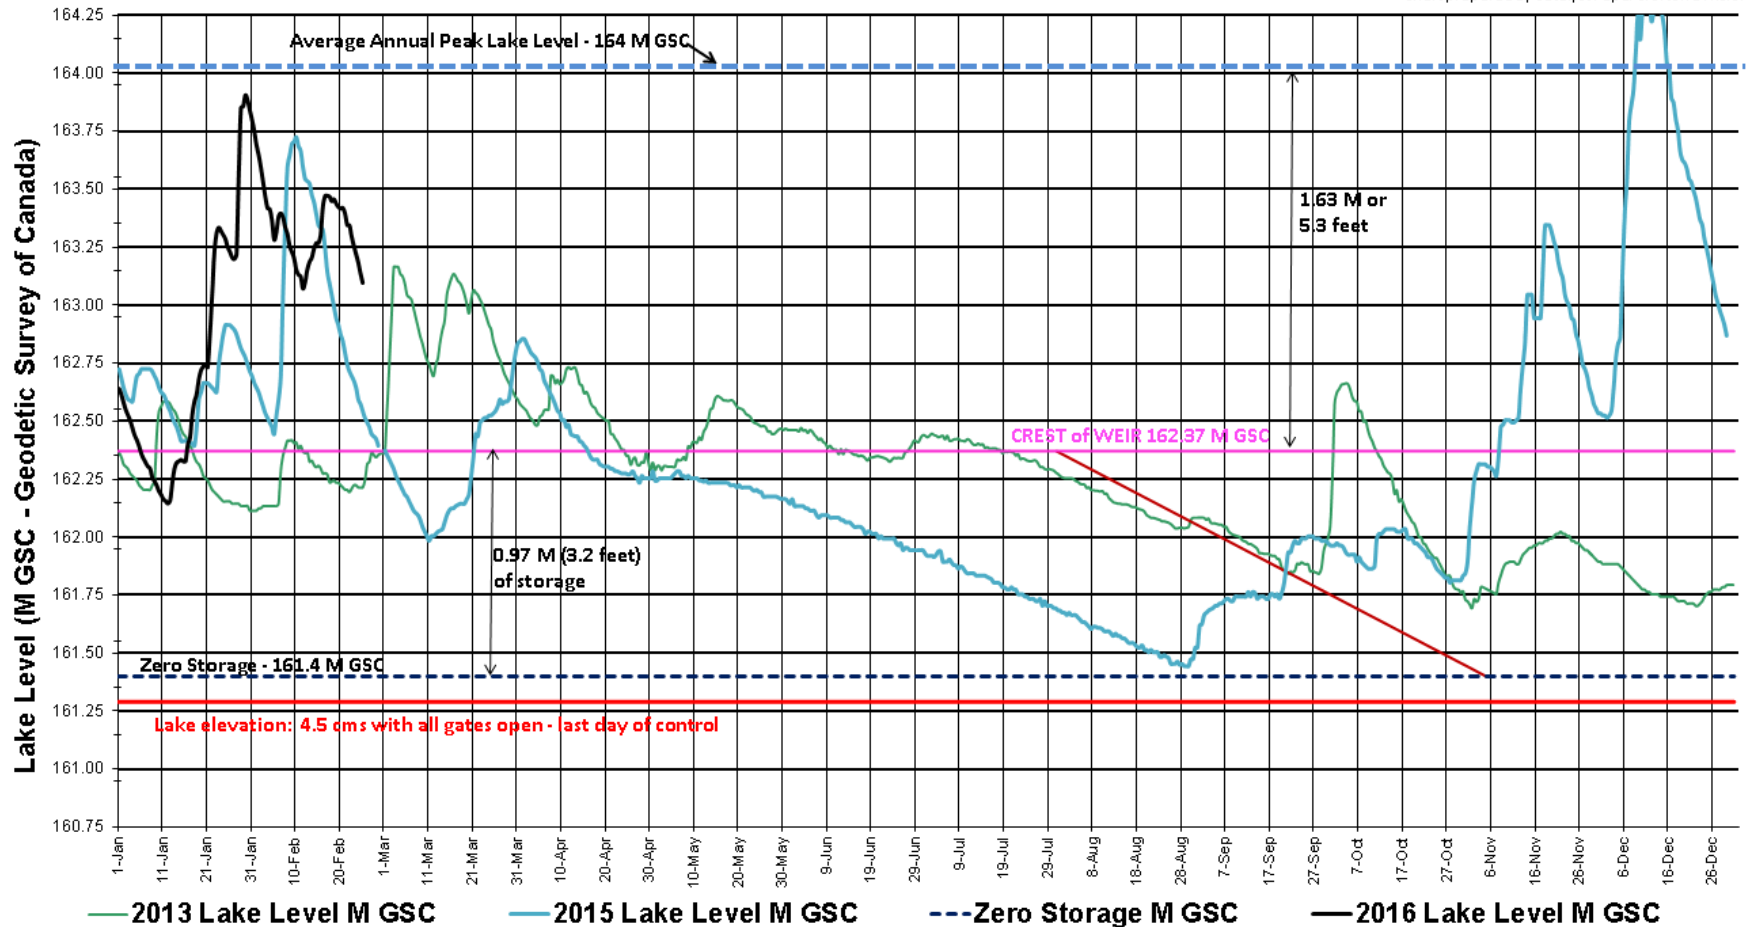
Wet winter weather keeping lake level high

2016 Cowichan Lake Level - 2016 (black) & 2013 (Green) & 2015 (Blue)

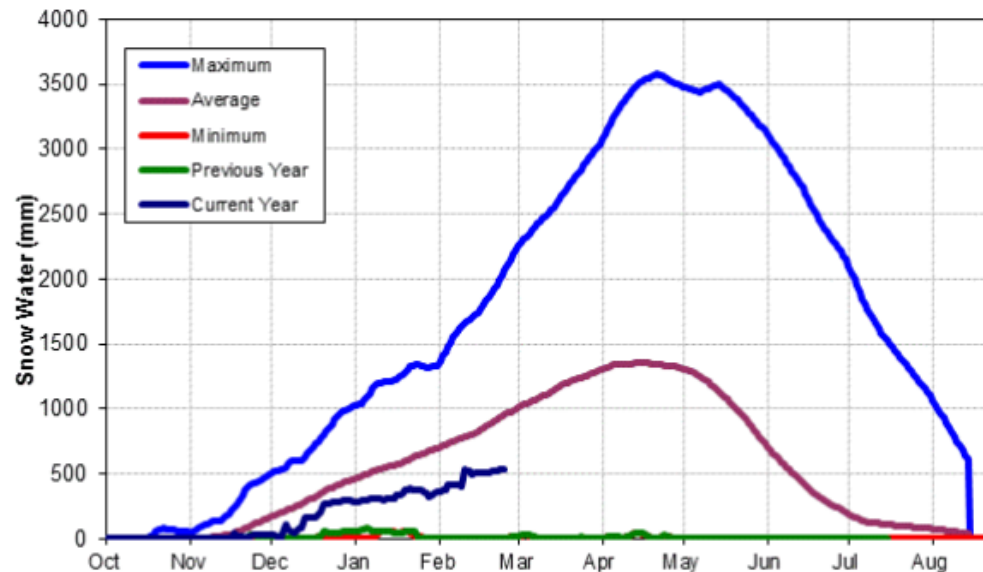
3B23P - JUMP CREEK

Jump Creek
(Nanaimo Watershed)
– while not confident with value – reporting >50% of normal snow pack

* **Note:** snow water equivalent between 2015-11-20 and 2016-02-09 is incorrect because of snow scale malfunction

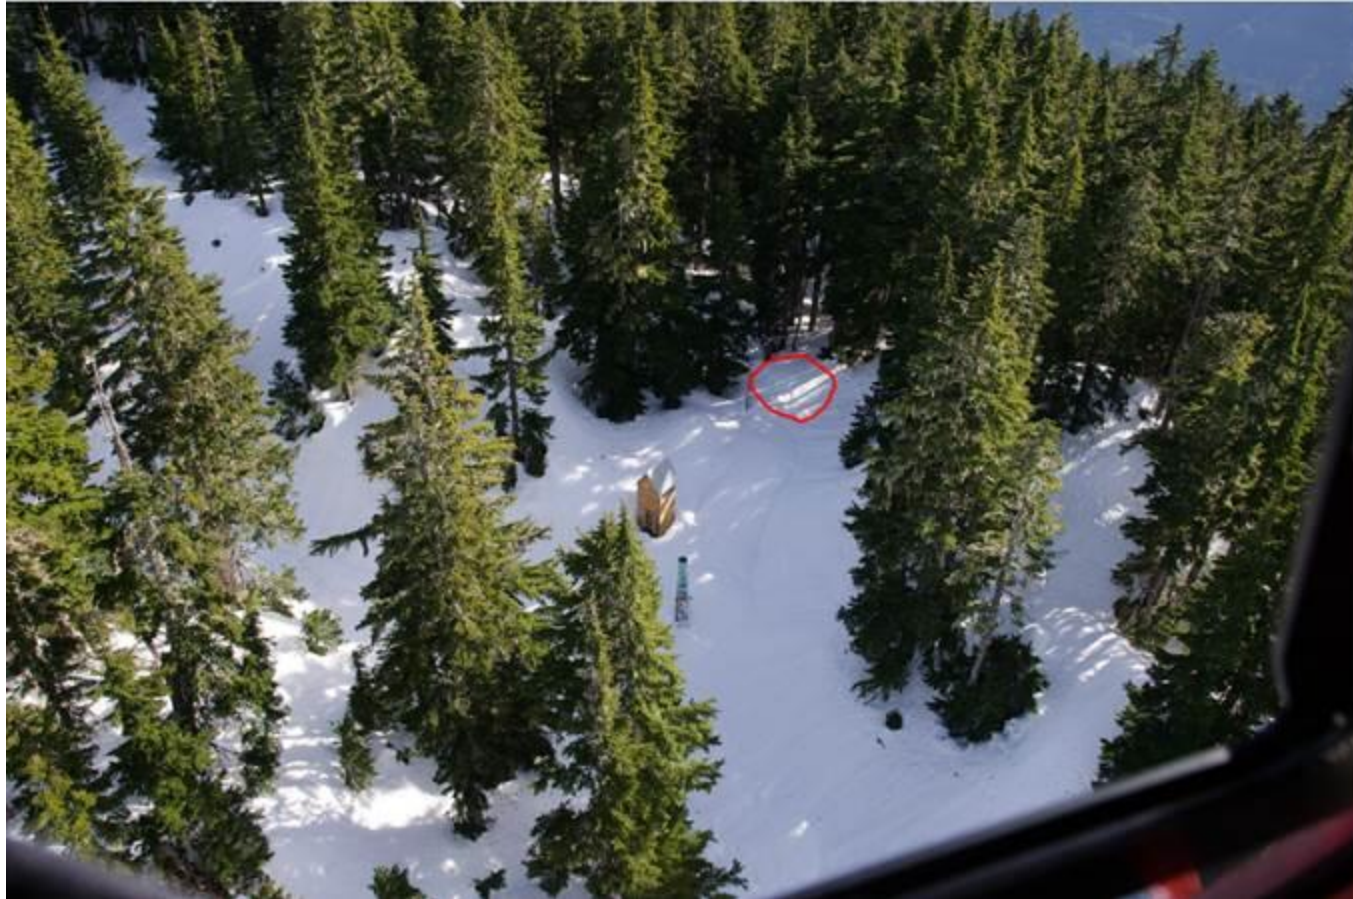
Heather Mountain Snow Pillow – photo taken about Feb. 11, 2016 by BC MOE

New Heather Mountain snow pillow has issues but manual measurement showed reasonable snow pack week of Feb 11

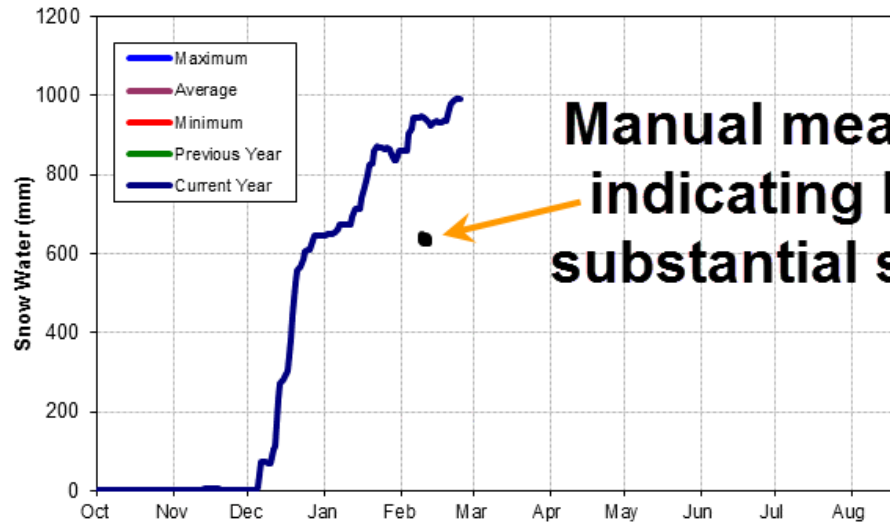
3B24P - HEATHER MOUNTAIN UPPER

Note: Reported snow water equivalent is incorrect (too high). Station is scheduled for maintenance at end of season

Manual measurement indicating less - but substantial snow pack
