British Columbia
Conservation
Foundation

Stoltz Bluff Sediment Remediation – 2017 Emergency Maintenance Proposal

**BC Conservation Foundation
Lantzville, BC
April 2017**

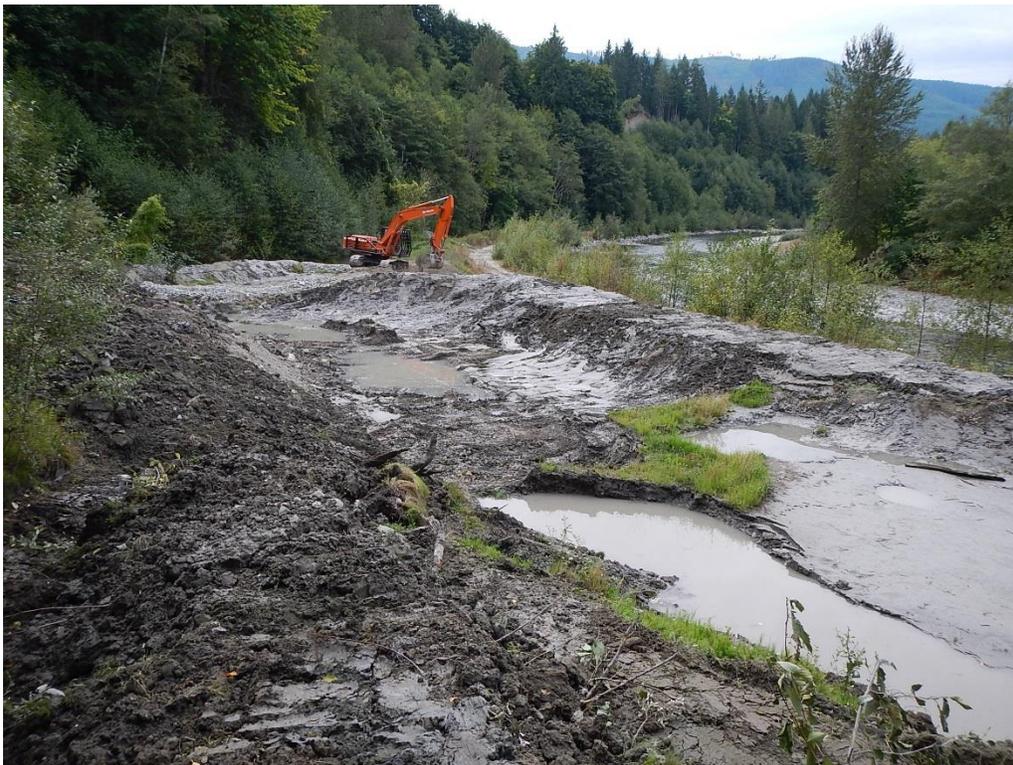
Figure 4. View looking downstream of primary sediment basin and uppermost check dam, near the end of maintenance excavation on September 17, 2014.

Since 2008, BCCF has led annual maintenance of Stoltz Bluff, in cooperation with the landowner, BC Parks (Fig. 4). This has generally entailed reinforcing and raising containment berms, excavating sediment ponds, clearing the project’s access road and preserving fixed drainage paths, particularly for ‘Clearwater Creek,’ the largest tributary to Cowichan River through the Bluff and project site.

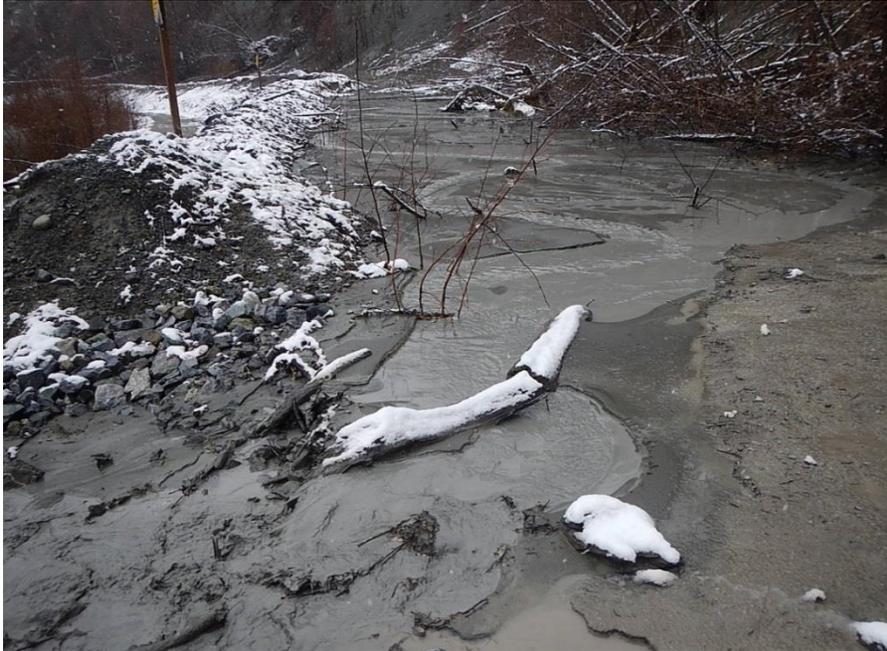
BCCF conducted two on-site inspections of the Stoltz Bluff project in March 2017. The first was on March 7th which indicated the very wet, cold and extended winter of 2016-17 was taking a heavy toll on slope stability and sediment generation at, and immediately upstream, of the bluff formation (Fig. 5). Sediment containment ponds were at or near capacity, and 'Clearwater Creek' was contributing a heavy, viscous slurry across the access road and into the Cowichan River (Figs. 6, 7). This was despite recent maintenance in September 2016.

Figure 5. Sediment containment pond draining 'Clearwater Creek' across Stoltz access road and into the Cowichan River on March 7, 2017.

The March 7th inspection confirmed that an interim 'fix' was urgently needed for 'Clearwater Creek' in particular. As a result, James Craig (BCCF) returned to the site on March 31st to obtain measurements for installation of a temporary hay bale dam at the head of the creek's primary drainage path across the Stoltz access road. This field trip led to a more ominous discovery.

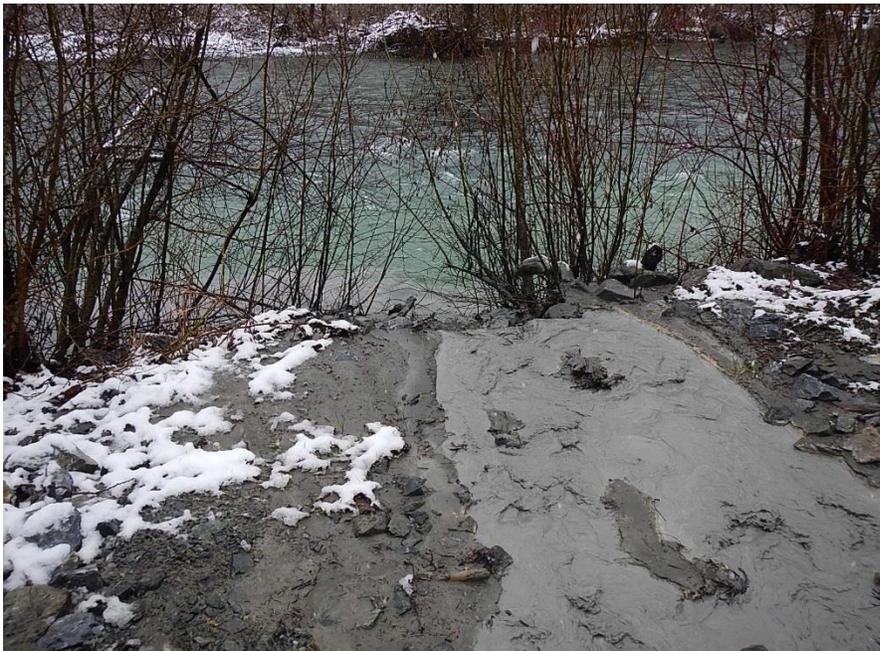
Figure 6. 'Clearwater Creek' as it entered the Cowichan River on March 7, 2017. The plume of silt-laden water coloured the river for the 27 km to tidewater.

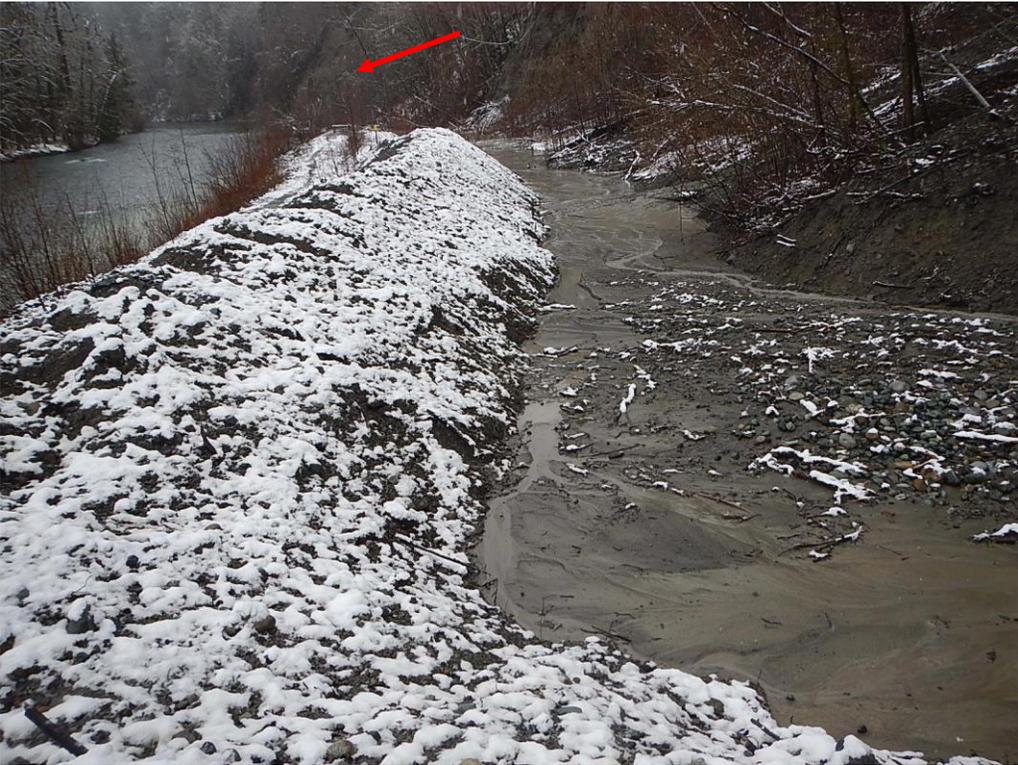
In addition, a new (left bank) slope failure immediately upstream of the Stoltz access road was also contributing fine sediment to the river. This new site threatens to become a growing source of water contamination beyond the 'reach' of the existing Stoltz Bluff road system (Fig. 8), complicating opportunities for future remedial treatment.

Figure 8. New slope failure (red arrow) is just evident in this photo's upper left, past the upstream end of the snow covered berm.

Assuming there remains strong support for an effective Stoltz Bluff project in future, we collectively need to investigate and better identify the primary causes for continued instability at the Bluff and adjoining slopes. This is particularly true for 'Clearwater Creek,' and likely for the new slope failure immediately upstream of the end of the Stoltz access road (refer to Fig. 8).

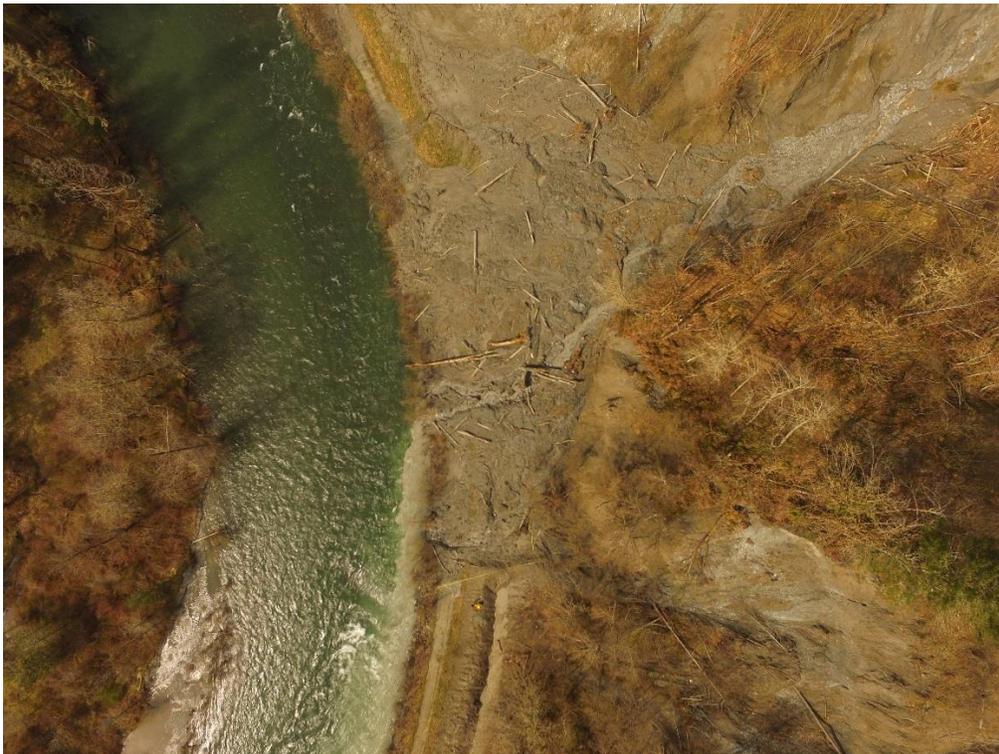
As indicated above, there has been a major slope failure involving the lower 'Clearwater Creek' gully which has deposited a preliminary estimate of 5-7 thousand cubic meters of fine sediment and woody debris on the Stoltz terrace, extending across the road and into the Cowichan River (Figs 9, 10). The sheer volume of slide material represents the largest single failure at the site since the project's initial construction in 2006. To put this into better perspective, the estimated slide volume represents from 625 to 875 standard dump truck loads of sediment!

As a result of the new slide, the primary drainage path of 'Clearwater Creek' shifted 30 m upstream, with the creek now cutting its way through the existing 2.5 m-high containment berm before entering the Cowichan River. New slide material on the Stoltz terrace and containment berm system ranges up to 5 m in height (over and above full containment ponds that were already 4 m+ in depth).

Figure 9. Aerial view from drone of 'Clearwater Creek' slope failure run-out zone, across the constructed terrace at the base of Stoltz Bluff. Plume of silty water is visible below the creek's new entry point into the Cowichan River (photo courtesy of Vadeboncoeur Consulting Inc.).

The most immediate problem facing BCCF, BC Parks and Stoltz project partners is acquiring a sufficient budget to largely remediate the effects of the 'Clearwater Creek' slide of late March. **Though volumes to be addressed need to be confirmed**, a preliminary estimate based on experience is that a minimum of \$50,000 will be needed by late summer (Labour Day) to mobilize 2 excavators and 2 tandem dump trucks to remove slide material and end-haul off-site and/or incorporate sediment into reconstruction of the containment berm/retention pond system along the Stoltz Bluff terrace.

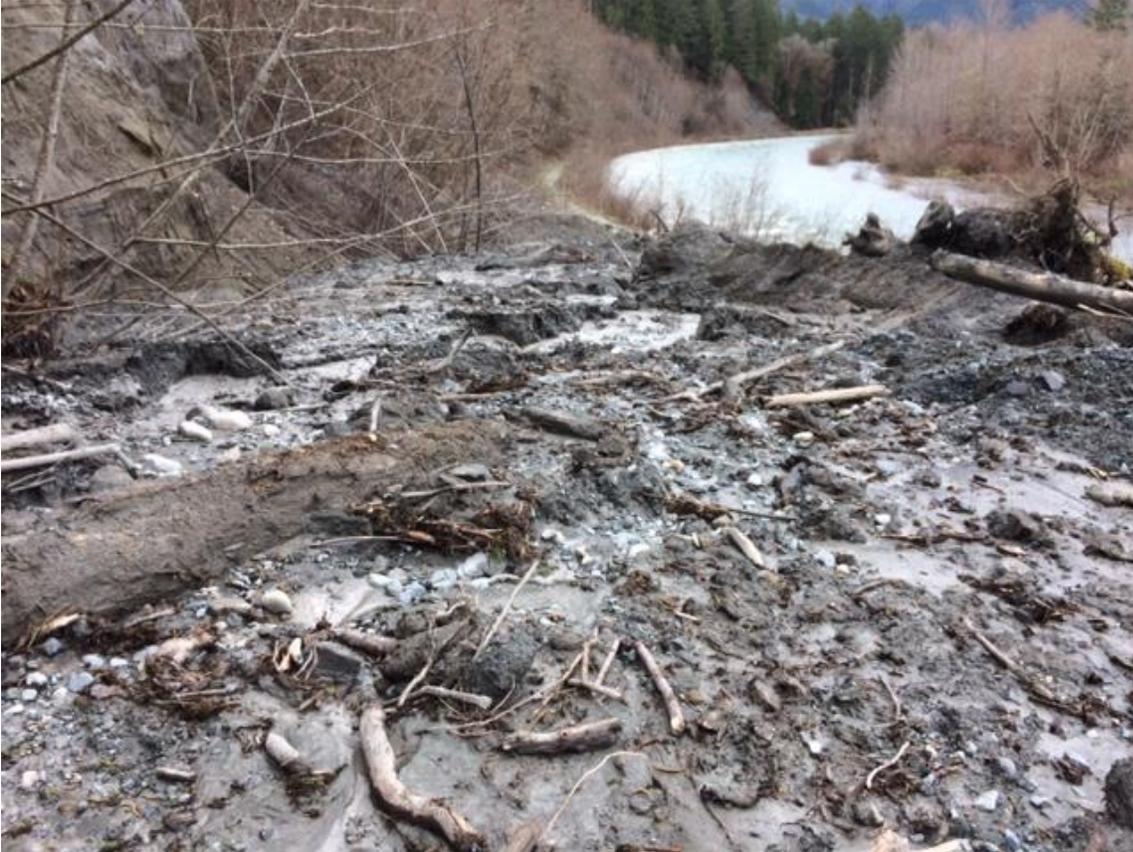
Figure 10. Close-up of slide material and debris deposited on the Stoltz Bluff terrace from suspected March 28th event.

LWD and whole trees are part of the slide debris now covering an 83 m long section of the Stoltz access road.
