Prepared By Gina Hoar, R.P.Bio.,  
Aquatic Stewardship Specialist

MUNICIPALITY OF NORTH COWICHAN SERVICE  
AGREEMENT WITH THE SOMENOS MARSH  
WILDLIFE SOCIETY  
ANNUAL REPORT 2022

Prepared for: Municipality of North Cowichan

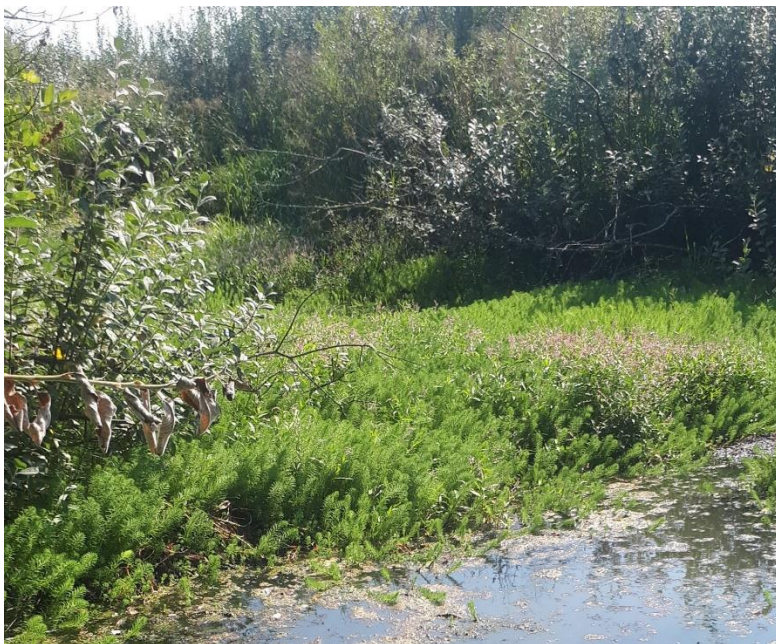
Photo 7: Typical Parrot’s Feather growth in Reach 1 covers the entire channel. 2022

Location	2021 peak growth (August)	2022 peak growth (August – October)
Reach 1	68%	44%
Reach 2	96%	67%
Reach 3	70%	63%
Overall Somenos Creek	73%	53%

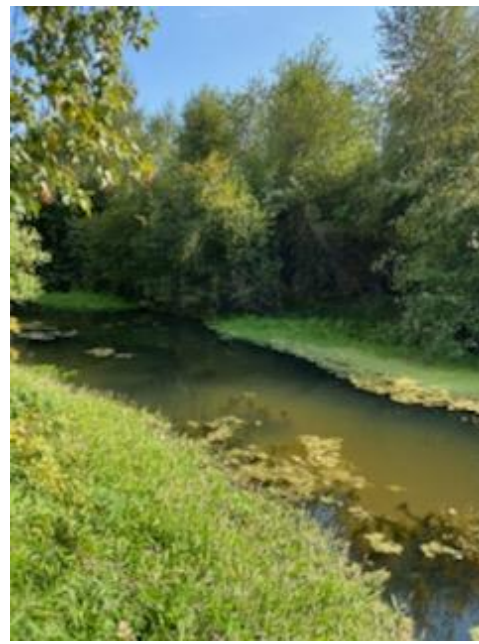
Photo 8: Parrot’s Feather coverage in Reach 1 of Somenos Creek. We are investigating why it has not spread across the creek in some areas vs others. 2022

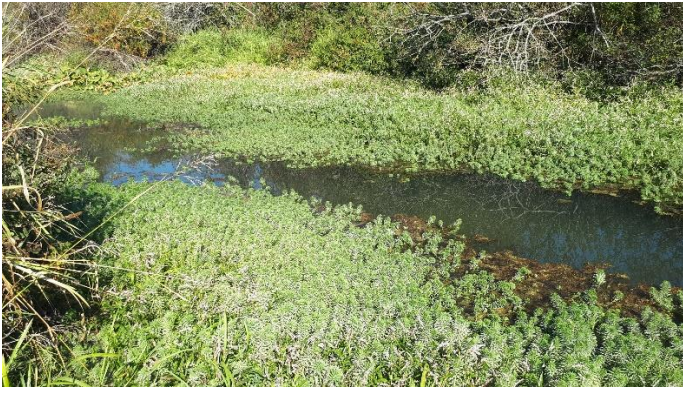
Photo 9: upstream view of typical Parrot's Feather coverage in Reach 2. 2022

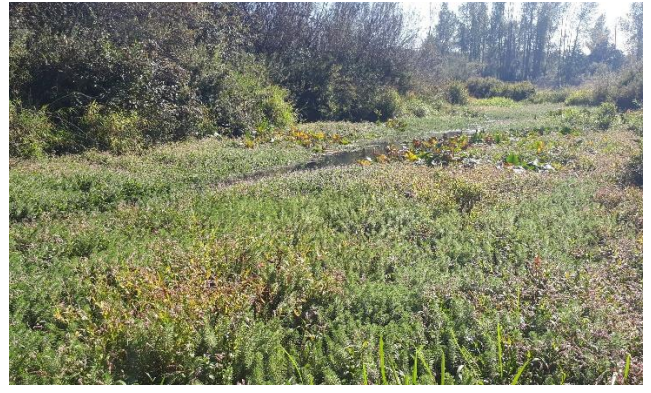
Photo 10: downstream view of typical Parrot's Feather coverage in Reach 2. 2022

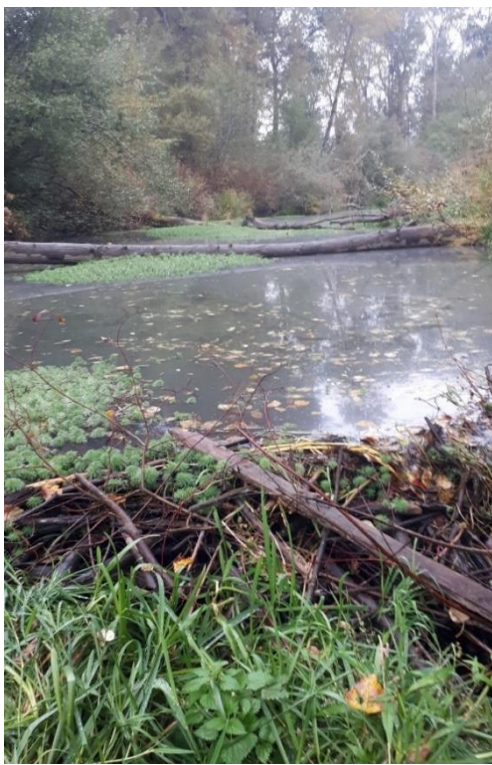
Photo 11: Upstream view of new 1.2 m high beaver dam (BD#2) barrier at the end of Reach 3. 2022

- A cold spring and high spring precipitation may have delayed initial Parrot's Feather growth
- In Reach 3 another beaver dam was built since the last survey and was blocking the Chum salmon run up into Fish Gut Alley by the October site visit (Oct. 21, 2022). By the time of the site visit on November 7<sup>th</sup> SMWS observed visible salmon waiting below the dam which was now passable for fish.

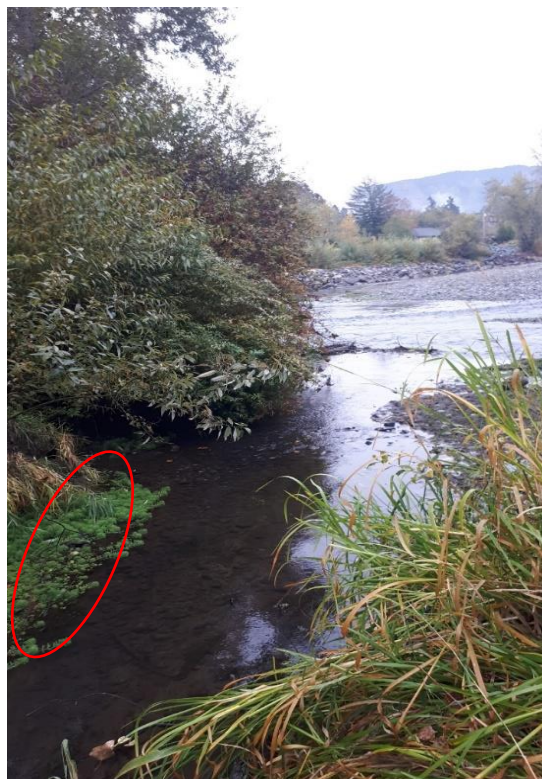
Photo 12: Downstream view from BD#2 to the Cowichan River confluence. Note: new areas of Parrot's Feather growth on Somenos Creek are reaching the Cowichan River. 2022

- Parrot's Feather has not migrated toward Somenos Lake; however, it has been found downstream in the Cowichan River in very small amounts.
- Other aquatic vegetation growth may help to clarify why Parrot's Feather grows in some areas and not in others. For example, Pond Lilies were observed growing where Parrot's Feather does not. The same was observed for Duckweed. Future mapping will include neighboring aquatic vegetation where the Parrot's Feather is growing while future studies will include measuring environmental parameters to determine if there are differences in these aquatic habitats that may inhibit Parrot's Feather growth.

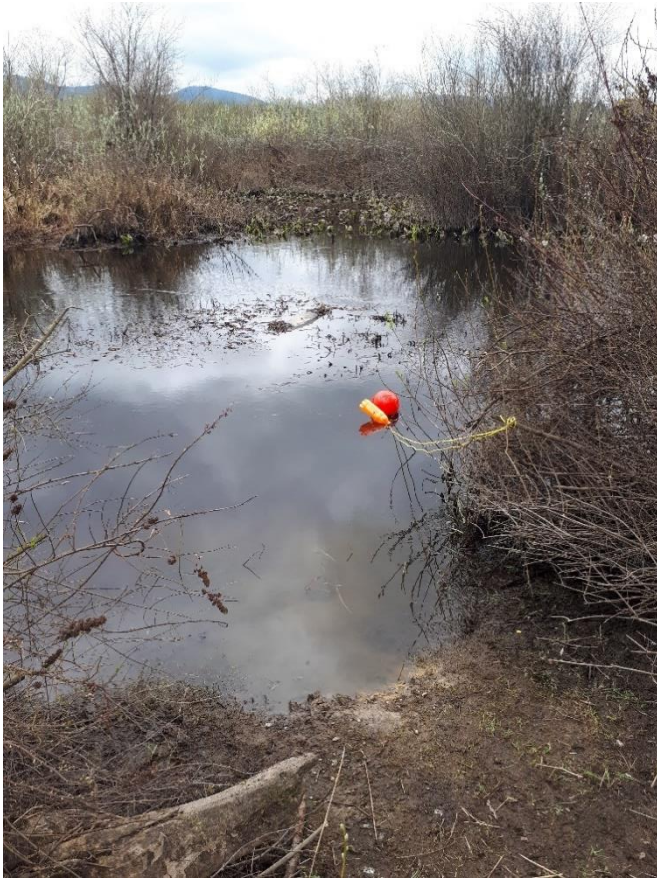
Photo 13: Pond liner inspection on April 1, 2022. Buoy is a temperature data logger at Station 3.

- Pond liner was inspected on April 1, 2022. High flows covered the pond liner and dead mats of Parrot's Feather were observed on the surface of the creek (Photo 13).
- On August 12<sup>th</sup> the first section of the pond liner was removed by SMWS staff (Photo 14-16)
- On August 30<sup>th</sup>, the last section of the pond liner was removed by SMWS staff with MNC Operations crew.
- The pond liner was removed from site and not redeployed, August 30, 2022.

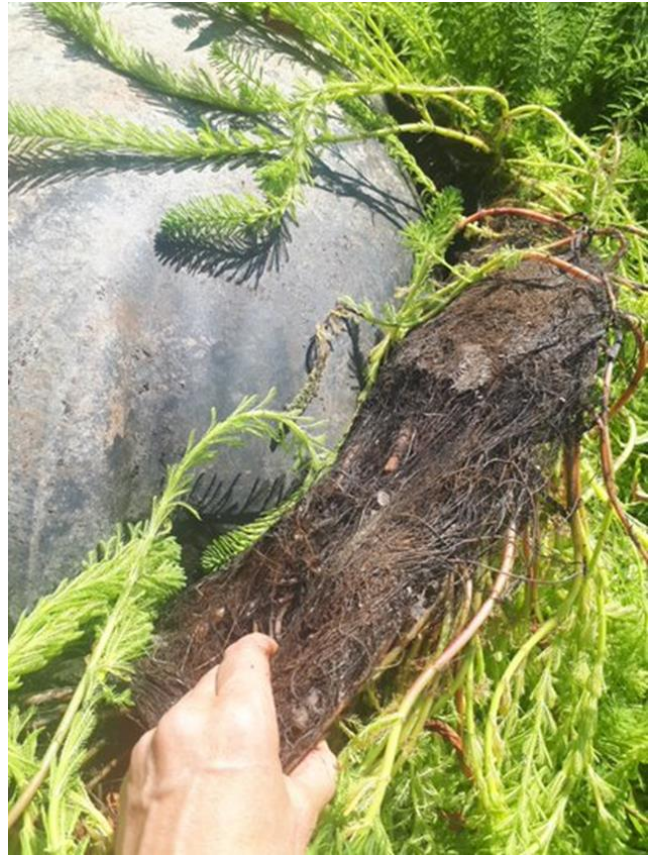
Photo 14: Parrot's Feather growing on top of the pond liner

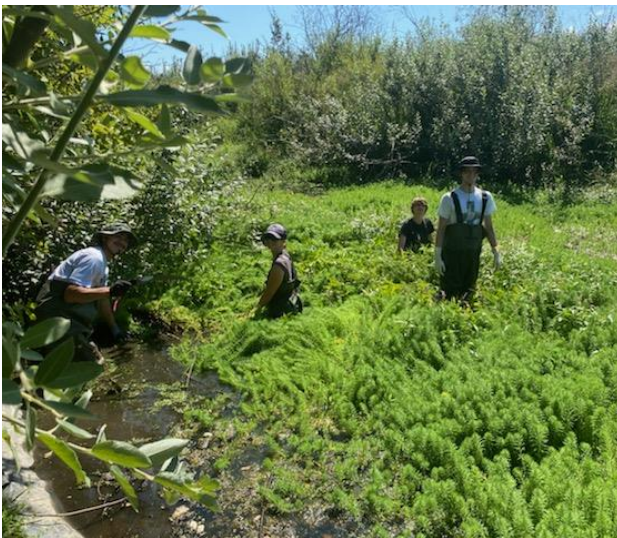
Photo 15: Before removal on August 12<sup>th</sup>.

- To remove the pond liner, the concrete anchor blocks were located, cut, and taken to shore.
- The edge of the liner, which was weighted down and zip-tied to rebar, was located then cut free. Each piece of rebar was taken to shore.
- the pond liner was covered in a thick mat of Parrot's Feather, which needed to be cut away to pull the liner to shore (Photo 14).
- Once the liner was pulled to shore the area was exposed for inspection of plant growth under where the liner was located from 2020-2022.

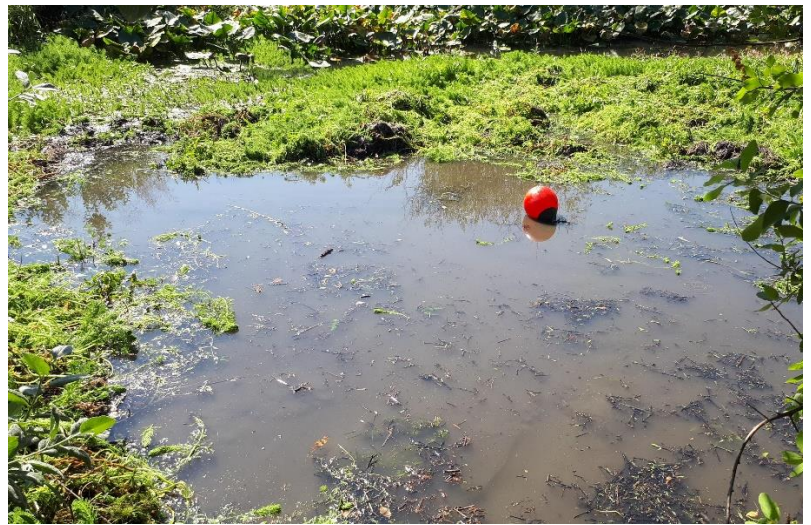
Photo 16: After removal on August 30<sup>th</sup>

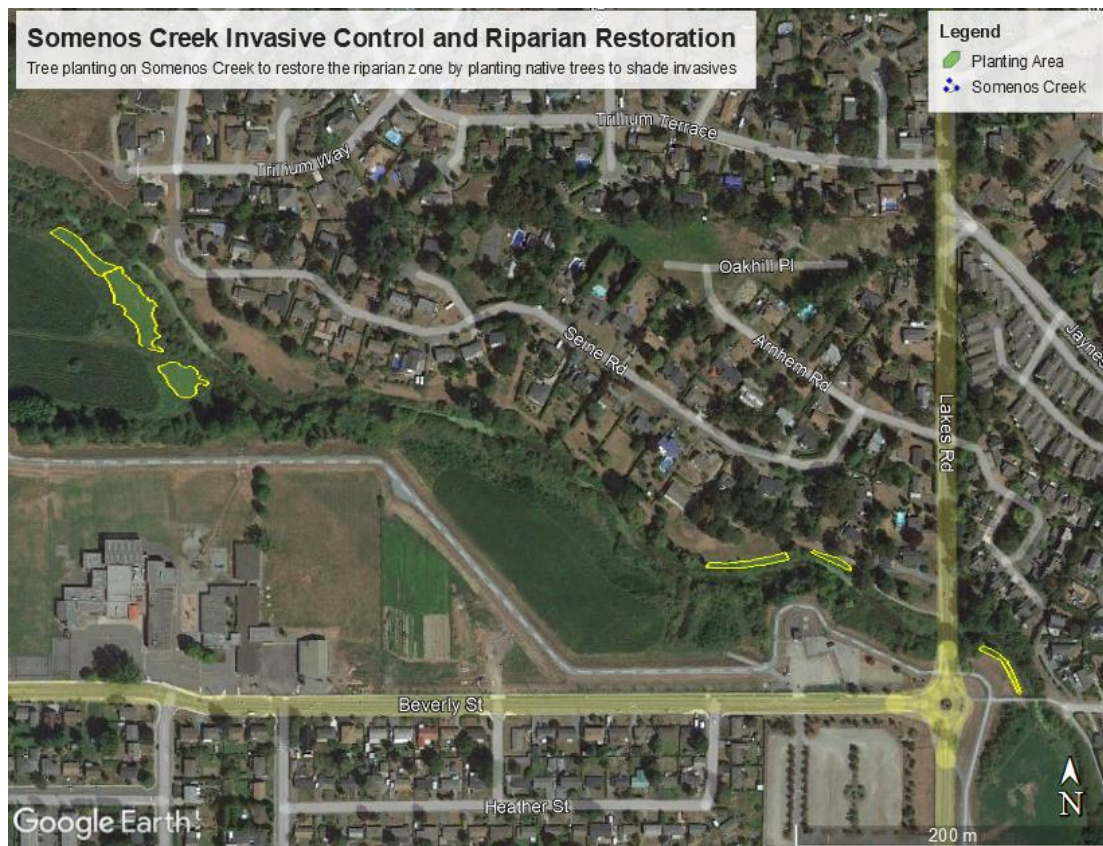
Three locations were chosen in 2022 to provide riparian shading (Figure 6). They include:

1. The south-west side of the Haycroft Chase Strata property and MNC right of way,
2. Nature trust property currently used as a corn field, and
3. East side of Somenos Creek near Lake Road

**FIGURE 6: THREE LOCATIONS CHOSEN FOR 2022 INVASIVE CONTROL AND RIPARIAN RESTORATION.**

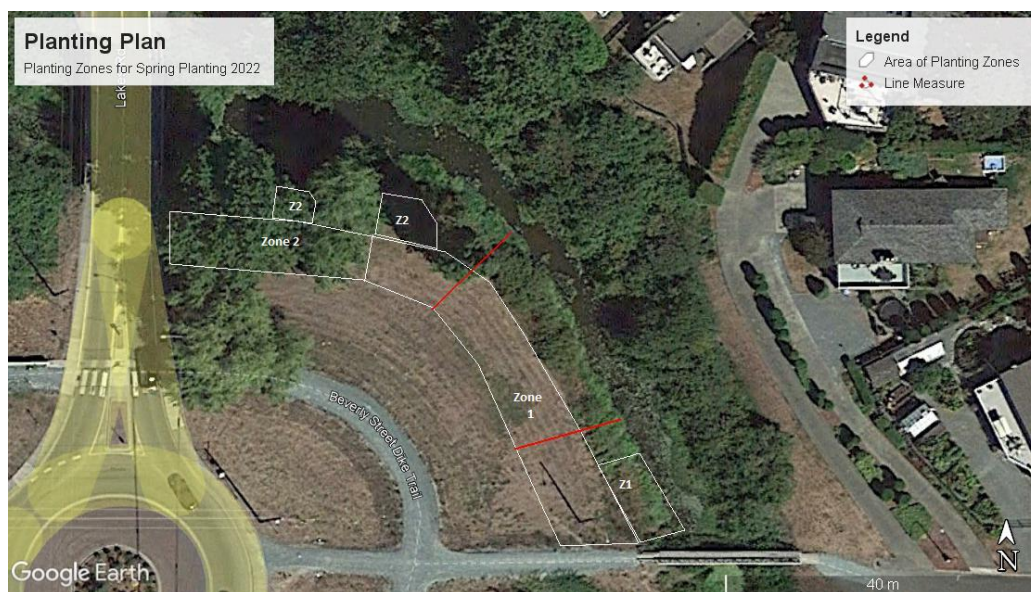
**FIGURE 7: RIPARIAN PLANTING ZONES ALONG SOMENOS CREEK.**

On May 13, 2022, a site visit was completed by the Somenos Marsh Wildlife Society (SMWS) and Keona Wiley, Manager of Parks, and Trails with the Municipality of North Cowichan. The area was assessed, and recommendations made by the Parks Manager were incorporated into the planting plan (See Figure 7).

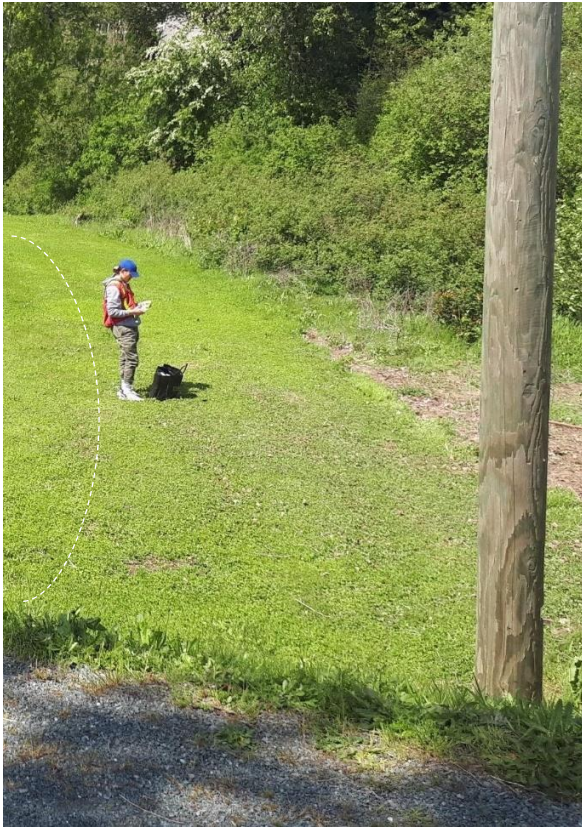
Photo 21: View looking north of the riparian zone to be planted within the 14 m setback (May 16, 2022).

We were informed by the Parks Manager, that the MNC Engineering team had recently completed a drilling project in Zone 2 which revealed their plans to expand the Lakes Road bridge by two meters next year. To plan for this, SMWS did not plant within this extent and a 5-meter distance from the toe of the dike will be avoided with room to spare (Photos 21 and 22). This still allows for a large area of mowed turf for public use, and planting within a riparian zone of 14 m; which is the minimal width for a healthy riparian zone.

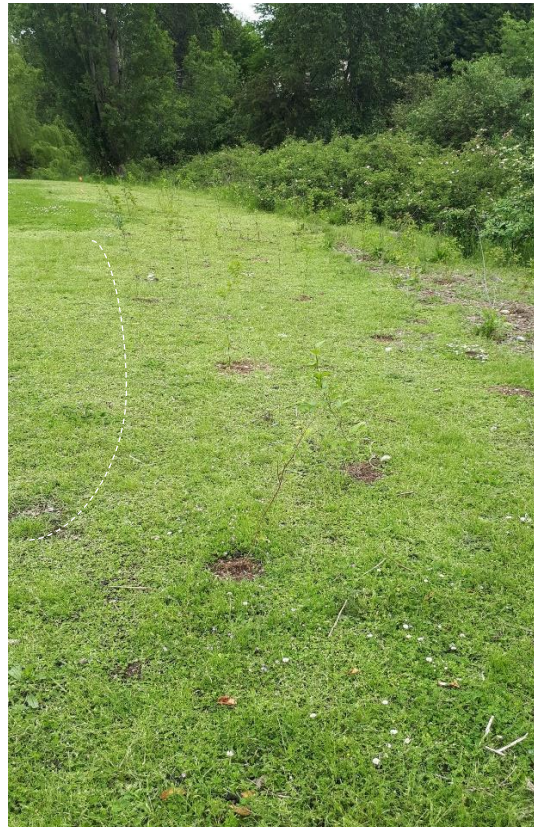
Photo 22: View looking north of the riparian zone planted within the 14 m setback (May 25<sup>th</sup>, 2022).

May 18<sup>th</sup>, 25<sup>th</sup>, and June 1<sup>st</sup> SMWS held three volunteer events to plant the trees on the property. Following the riparian restoration rule of thumb to plant one tree per square meter (DNV, date unknown). Native shrubs were planted in a row or two, close to the creek edge, and then a layer of trees was planted behind the shrub layer. The shrub layer provides increased bank stability and offers some in-stream cover and habitat features as it grows out of the bank. The subsequent tree layer will grow tall, providing shade for the creek's width.

This strategy used the Hardhack (*Spiraea douglasii*) which grows 2 meters tall, and Red-osier Dogwood (*Cornus sericea*) at 1- 6 m tall, as the shrub layer. This provided the first layer of protection along the creek. The tree layer follows as a mix of willows (*Salix scouleriana*) which grow between 2 - 12 meters, and six Sitka Spruce (*Picea sitchensis*) which can grow up to 90 meters tall providing future shade to the creek. Poplars (*Populus balsamifera*) grow up to 50 meters in height however they were not planted at the request of the Parks Manager due to concerns of an increase in area maintenance. These shrubs and trees were specifically chosen for the area because they are native species known to survive in wet conditions, such as during our winter rainy season that can lead to flooding in the area.

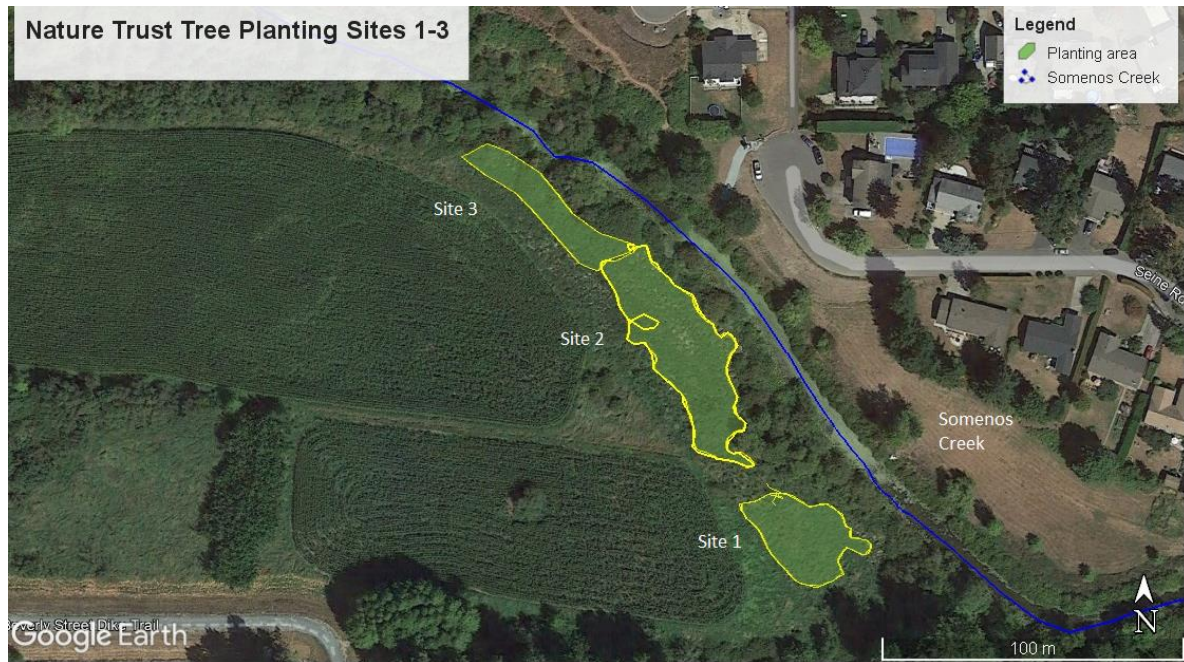
The goal was to increase shading of Somenos Creek, as this is a section of the creek that experiences significant Parrot's Feather growth. The plan was to plant trees that will grow tall enough to eventually shade the creek and seed the area over time with new growth. There are currently willows, Red-osier Dogwood, and Hardhack along the banks, and invasive Reed Canary Grass (*Phalaris arundinacea*) in open areas where planting is planned in Sites 1-3 (Figure 8).

**FIGURE 8: THE AREA TO BE PLANTED IS ON THE WEST SIDE OF SOMENOS CREEK BORDERING THE NATURE TRUST PROPERTY**

The planting area is a section along Somenos Creek, a low-lying wet area next to a corn field owned by the Nature Trust of BC. The land floods in the fall during high water until late spring; however, multiple areas have been treated with a 'rough and loose' method where holes were dug, and planting mounds remain. In Figure 9, the areas planted are shaded light green as Sites 1, 2, and 3 which are: 737, 1,414, and 618 square meters, respectively (measured with Gaia GPS and Google Earth pro).

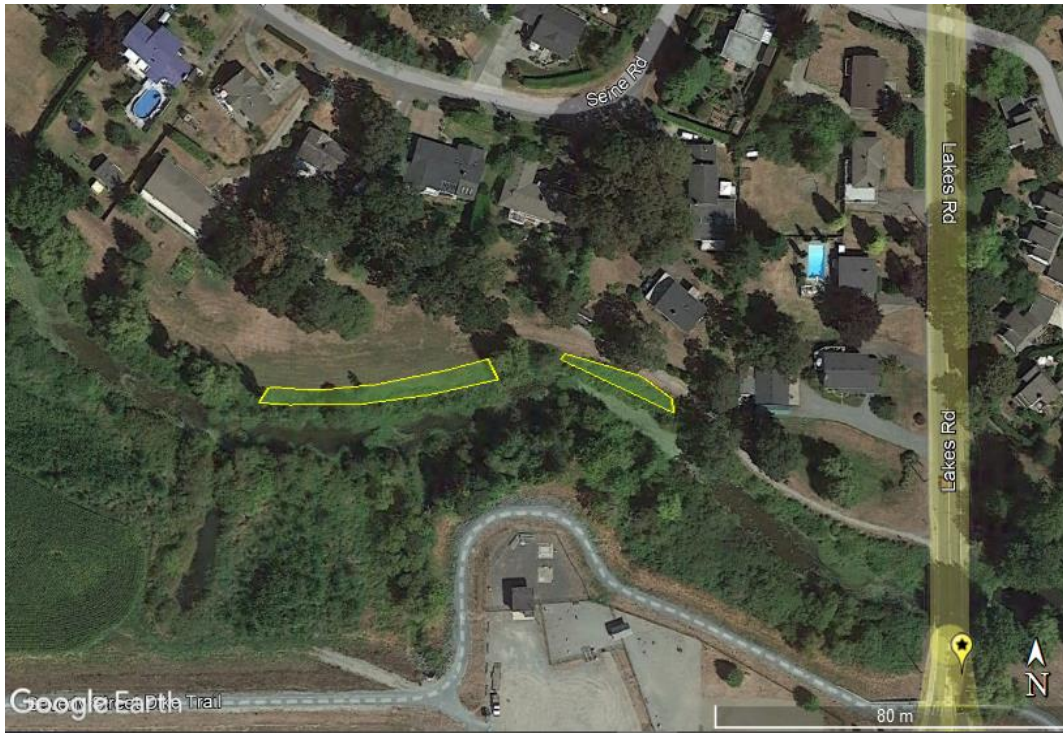
The planting area along the north side of Somenos Creek on the Municipality of North Cowichan property was selected and approved for riparian restoration and tree planting by the MNC Parks Manager (Figure 9). The purpose is to restore the riparian zone to its native vegetation and provide shading in the creek to reduce the instream Parrot's Feather growth.

**FIGURE 9: MAP OF THE RIPARIAN RESTORATION AREA ON THE NORTH SIDE OF SOMENOS CREEK, NEAR LAKES ROAD.**

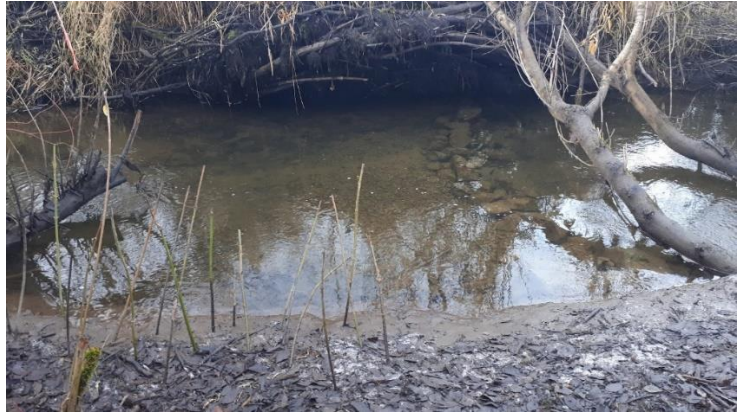
Photo 2: View looking across at left bank after restoration at Site 3. 1.5 tons of gravel and half ton of anchor rock were added to create spawning beds.

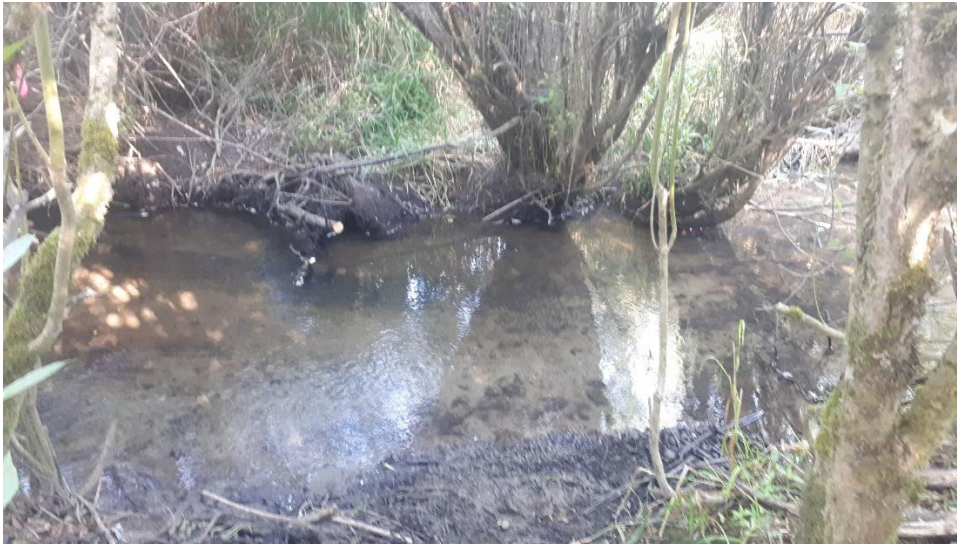
Photo 3: View looking at left downstream bank before restoration at Site 4. Habitat mainly was silt, sand, and organics.

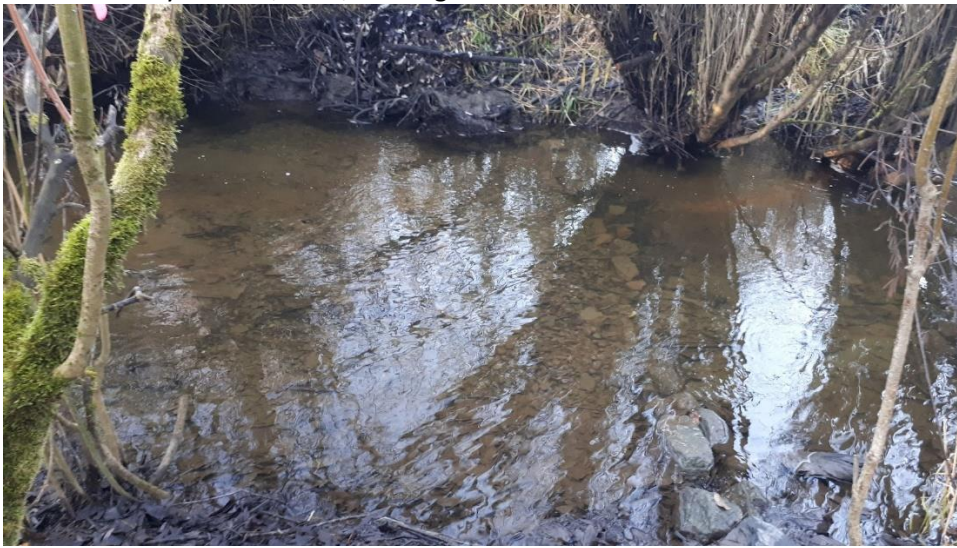
Photo 4: View looking at left downstream bank after restoration at Site 4. 1.5 tons of gravel and half ton of anchor rock were added to create spawning beds.

In the future, additional gravel may be needed to extend both spawning areas. This is because once the organic debris was removed the depth of the water increased which required more gravel to fill than anticipated.

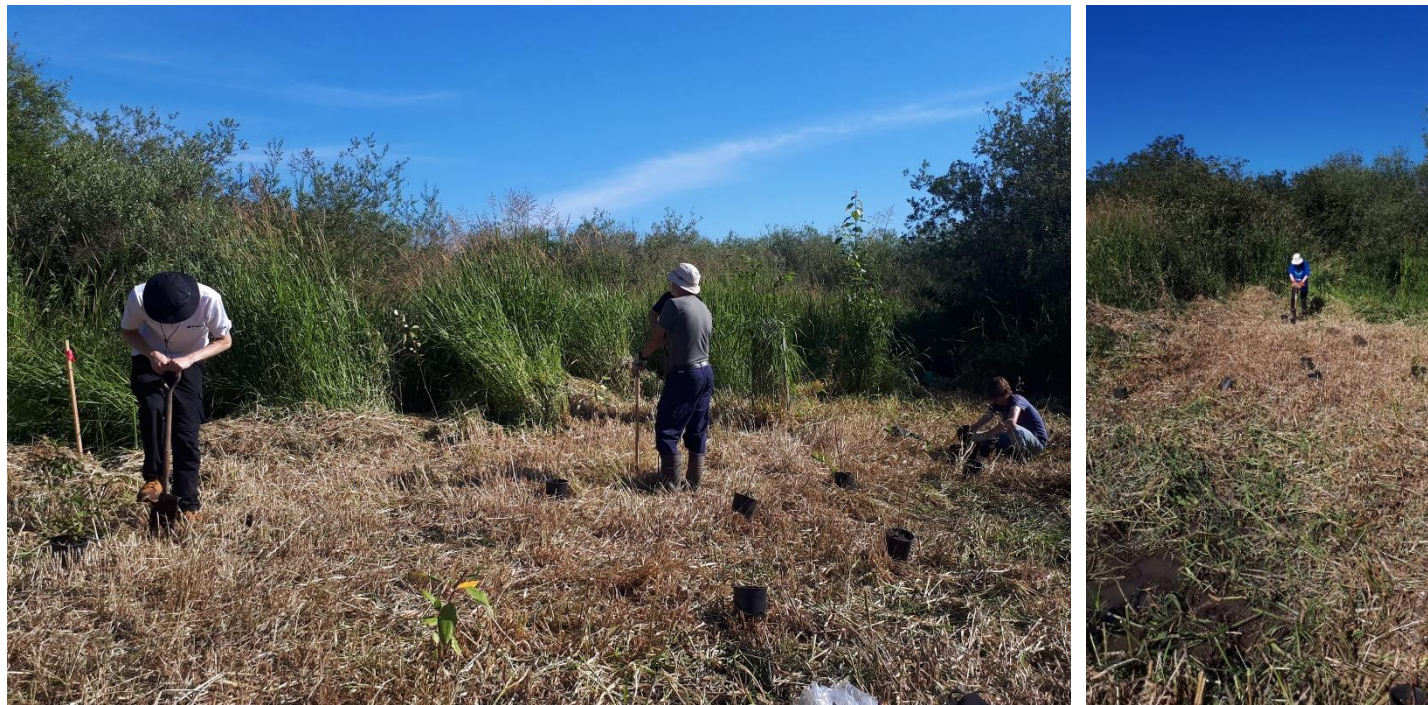
Photo 5: Riparian planting in Bings Creek Reach 1. Invasive Reed Canary Grass was removed, and 90 trees were planted. July 20, 2022

to provide protective mulch and reduce the growth of the grass around the base next season to allow adequate light to reach the seedling. Future monitoring will be required in 2023 to count surviving plants and cut grass around the seedlings in spring. Our belief is that this will be a successful planting area due to a few Poplar and Red Alder tree seedlings that were planted the year before that are thriving without any watering or invasive maintenance.

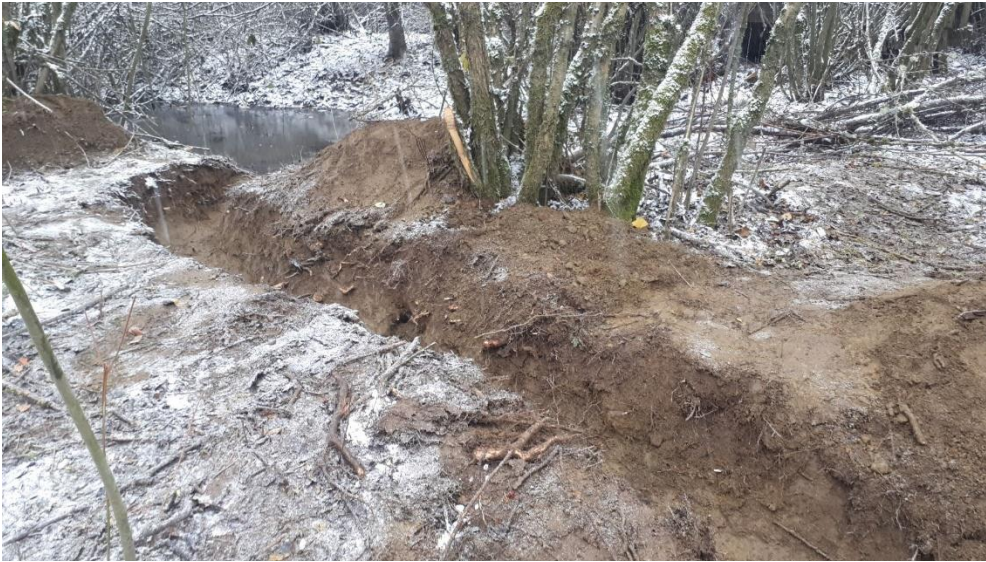
Photo 6: Bings Creek, Reach 1, immediately downstream of Site 4 a connectivity ditch was created to increase flows into an anoxic backwater pool to increase rearing habitat for fish in summer.

When Bings Creek was restored in 2000 (Burns 2000) a backwater pool was created that was originally designed to be fish rearing habitat. The backwater pool starts at the end of the boardwalk, is connected to Bings Creek about 60m downstream of Site 4 and has an approximate width of 2-3 meters. Currently in summer it is anoxic to fish in the creek; therefore, it cannot be used for summer rearing.
