DRAFT LOWER COWICHAN AND KOKSILAH RIVER BASIN

WATER QUALITY ATTAINMENT STUDY 2022

INCLUDING COWICHAN BAY MARINE SITES

FINAL DRAFT REPORT (V10)

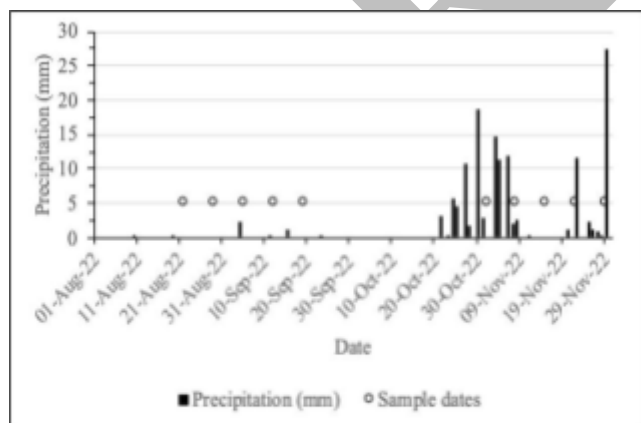
There was essentially no rain during the summer sampling period as shown in **Figure 4** where the data were taken from the North Cowichan Weather Station. Sampling days are indicated by the open circles in this figure. There was less than normal rainfall in the fall. As a comparison, **Figure 5** shows rainfall over a similar period in 2017. The summer of 2017 had little rainfall during the sampling period, whereas the fall of 2017 had a more normal pattern of rainfall.

Figure 4. Daily precipitation at North Cowichan Environment Canada Station and sample dates (open circles) in the summer and fall of 2022.

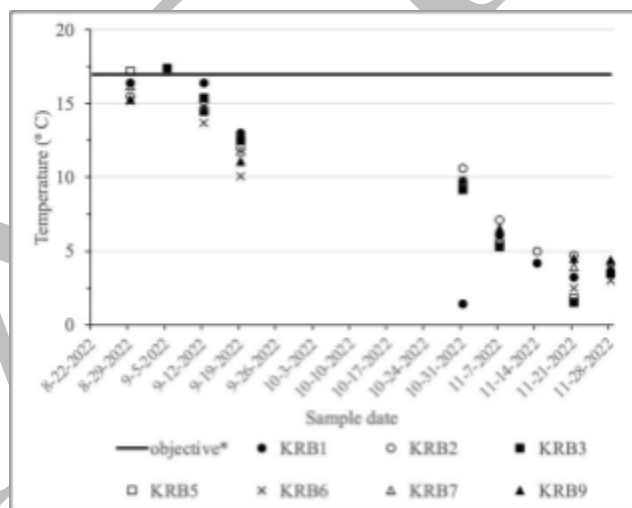
The water temperatures are given in **Figure 6**. In the summer or 2022, only two sites very slightly exceeded the Water Quality Objectives. These were KRB3 (Koksilah River at Koksilah Road) and KRB5 (Koksilah River at Bright Angel Park). The tributaries of the Koksilah River sampled all met the Objectives. In the fall all sites met the Objectives.

The Koksilah River is rather broad and shallow at these two sites with little shade. The fact that the tributaries met the temperature objectives was likely due to the tributaries had shade and that cool ground water was supplying the tributaries. Water temperatures were not reported in 2012 nor in 2017.

Figure 6. Summer and fall water temperatures of the Koksilah River Basin sampling sites, 2022

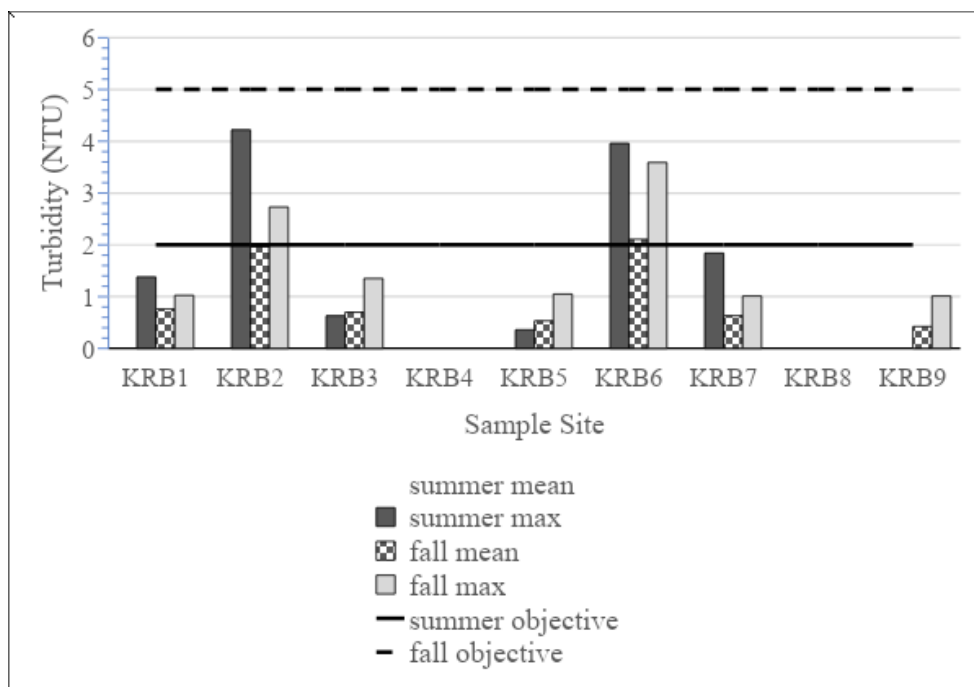
Figure 8 illustrates the turbidity levels at the Koksilah River Basin Sites. The horizontal lines indicate the Water Quality Objective maximums for summer (solid line) and fall (dished line). It can be seen that KRB2 (Petrolas Creek at Moss Road) and KRB6 Norrie Creek at Koksilah Road) did not meet the Summer Water Quality Objective of maximums no greater than 2 NTUs while all sites met the Fall Water Quality Objectives.

Figure 8. Turbidity levels in the Koksilah River Basin sites sampled during the summer and fall of 2022. The summer and fall objectives are maximum levels. The means are included to give an indication of the mean relative to the maximum values.

In the summer sampling period of 2012, KRB2, KRB6 and KRB9 did not meet the Water Quality Objective. In the fall of 2012, only one site met the objective: KRB3 (Koksilah River at Koksilah Road). In 2017, not one of the Koksilah River Basin sites met the Summer Water Quality Objective. Furthermore, in the fall only one site met the Fall Water Quality Objective (KRB3). One explanation for why all the Fall Water Quality Objective was met in the fall of 2022 is that there was very little rain.

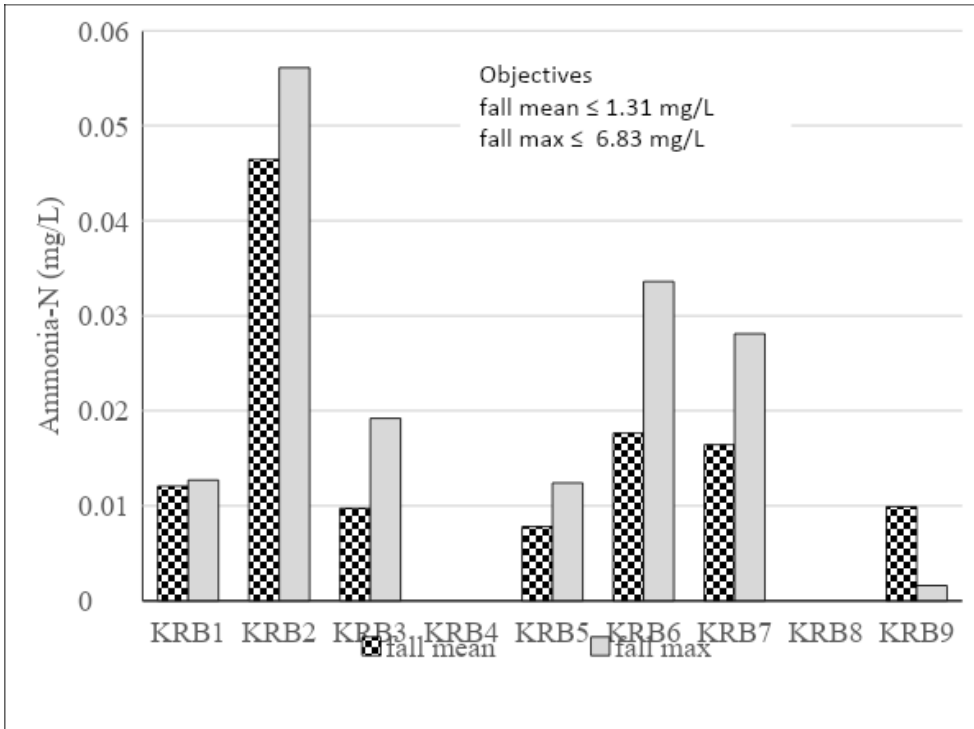
Ammonia-N was only measured in the fall of 2022. **Figure 9** illustrates the fall ammonia levels. All sites met the Fall Water Quality Objective for Ammonia-N. In 2012, fall ammonia levels met the objective as well. Ammonia also met the summer objective during the summer sampling period of 2012.

Figure 9. Fall ammonia-N levels at the Koksilah River Basin sites sampled in 2022.

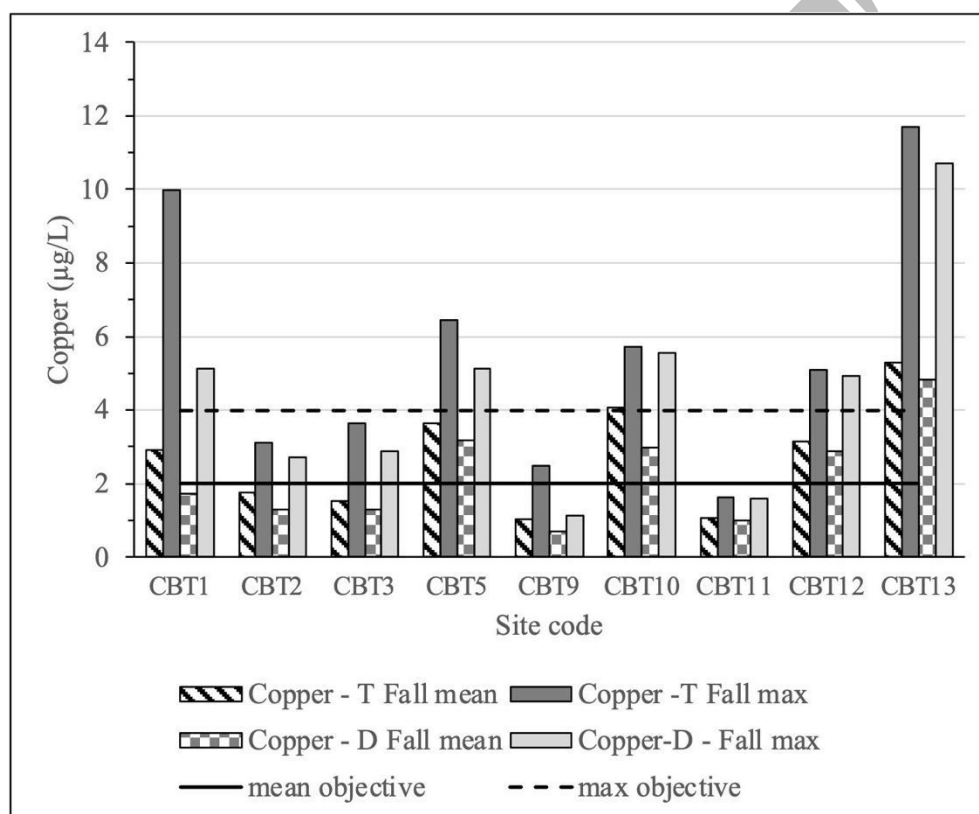
Only CBT2 (Speirs Creek at Cowichan Bay Road), CBT3 (Wessex Creek at Wessex Inn), CBT9 (Garnett Creek at Cherry Point Beach) and CBT11 (Manley Creek at the end of Hatch Point Road) met the summer and fall provisional mean and maximum objectives for copper (**Figure 20**). CBT5, CBT10, CBT12 and CBT13 failed to meet the summer provisional mean objective for copper. CBT1, CBT5, CBT10, CBT12 and CBT13 also failed to meet the summer and fall maximum provisional objectives.

One possible reason for the high copper levels is that the unconsolidated and bedrock materials that underlie Cowichan Bay have high levels of copper (Barroso and Melnechenko, 2019). The unconsolidated materials had a mean groundwater level of dissolved copper of 1.65 µg/L ranging from 0.05 to 8.61 µg/L. The bedrock had a mean groundwater dissolved copper level of 1.36 µg/L, ranging from 0.15 to 5.15 µg/L.

Figure 20. Mean and maximum concentrations of total (T) and dissolved (D) copper in Fall (31-Oct-22 to 28-Nov-22) at 10 sites on tributaries to Cowichan Bay. The objectives for the mean ($\leq 2 \mu\text{g/L}$) and maximum ($\leq 4 \mu\text{g/L}$) concentrations are the horizontal lines.

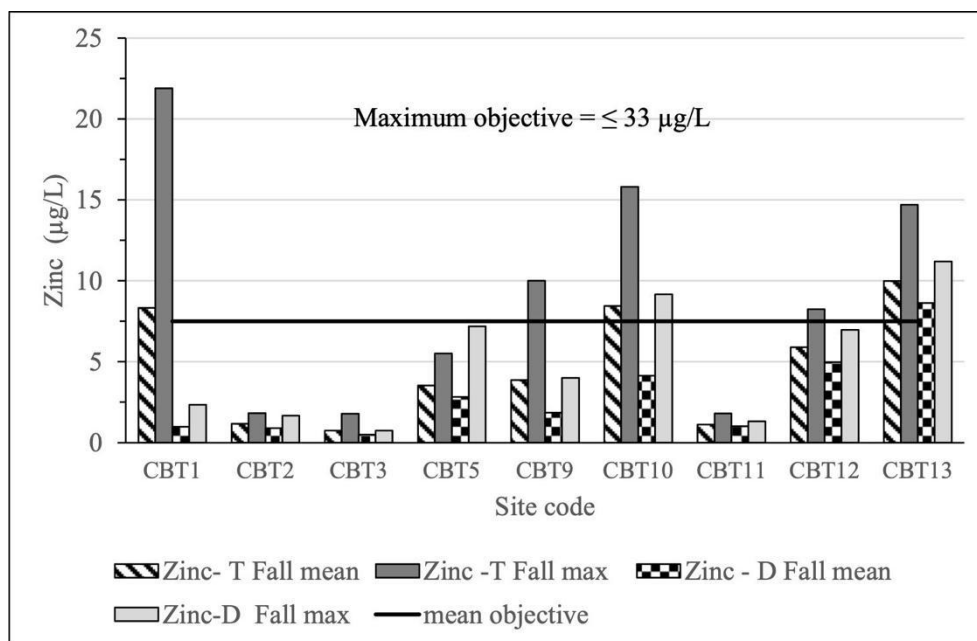
CBT1, CBT10 and CBT 13 failed to meet the summer mean and maximum provisional objectives for zinc (**Figure 22**). CBT9 and CBT 12 failed to meet the provisional maximum objective. As to the fall provisional objectives CBT13 failed to meet the mean and maximum provisional objective while CBT10 failed to meet the provisional maximum objective.

The only tributaries that met all provisional objectives for the summer and fall were CBT2 (Speirs Creek at Cowichan Bay Road), CBT3 (Wessex Creek at Wessex Inn), CBT5 (Storm drain at Botwood Lane) and CBT11 Manley Creek at the end of Hatch Point Road).

Figure 22. Mean and maximum concentrations of total (T) and dissolved (D) zinc (µg/L) in 10 tributaries to Cowichan Bay, 2022.

One possible reason for the high zinc levels may be that the unconsolidated and bedrock materials that underlie Cowichan Bay have high levels of zinc (Barroso and Melnechenko, 2019). The unconsolidated materials had a mean groundwater level of dissolved zinc of 15.3 µg/L ranging from 2.8 to 219 µg/L. The bedrock had a mean groundwater dissolved zinc level of 74.7 µg/L, ranging from 6.4 to 680 µg/L.

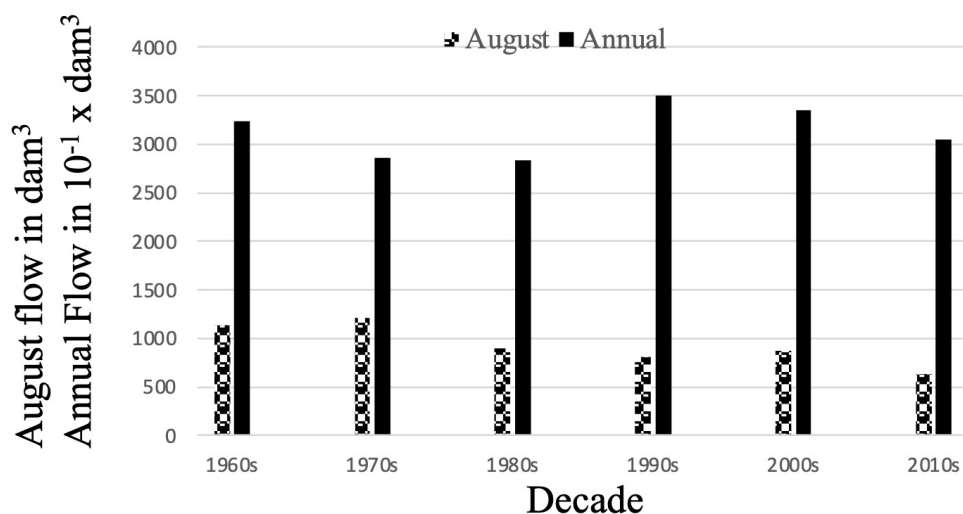
Figure 22 shows that there has been increased flashiness of flow in the river over the past six decades. Note that total annual flow has changed little over time, but August flow has markedly decreased. Unless there are changes in the upper Koksilah River watershed, we will see that water temperature and dissolved oxygen content will likely worsen with climate change.

Figure 23. Koksilah River mean annual decadal flow as well as mean August water flow at Cowichan Station. Data taken from Hydrometric Station 08HA003.

The decreased August flow noted in Figure 22 correlates with the large loss of old growth forest in the Koksilah River watershed in the 1970s as noted in Pritchard *et al.* 2019.
