South Coast Salmon **Strait of Georgia Stock Assessment**

Final 2023 Escapement Bulletin- Area 18 Cowichan River

Updated May 2024

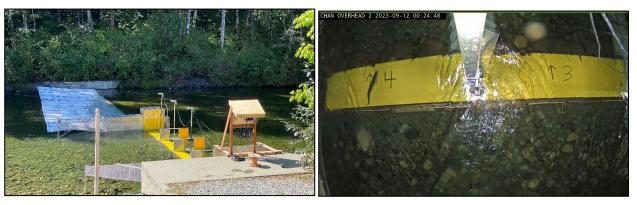
Figure 3: Traditional two-passage counting fence design used since 2019 (top) compared to the new low-flow design with four open passageways and overhead camera views (bottom).

General operations at the counting fence in 2023 incorporate a new low-flow design at the start of the season to increase fish passage when discharge is below baseflow. The design involves four 8 ft passageways with underwater and overhead cameras in half the river, while the other side still utilizes the traditional fence panels. Once river flow increases the regular two-passage configuration will be installed, with one passageway located against the bulkhead and one mid-river (Figure 2).

The counting fence is located 150 m downstream of the Allenby Road bridge crossing and is accessed via Church Road on Cowichan Tribes land. The fence funnels migrating fish through two passages where species, size and origin can be evaluated. Cameras are set to record each migration event based on a motion trigger such that periods of inactivity can be skipped efficiently. Crews are present at the fence 24 hours per day to enumerate fish as they move past the cameras as well as to clear debris and maintain equipment as required. The floating panels pivot based on water levels and are expected to remain operational through mid-October. The fence is not designed to withstand high flows and will be removed when the discharge exceeds 30 m³/s.
