Prepared By: Gina Hoar R.P. Bio,  
and Phaedra Douglass.

**MUNICIPALITY OF NORTH COWICHAN  
SERVICE AGREEMENT WITH THE SOMENOS  
MARSH WILDLIFE SOCIETY PARROT'S  
FEATHER CONTROL REPORT**

Prepared for: Municipality of North Cowichan

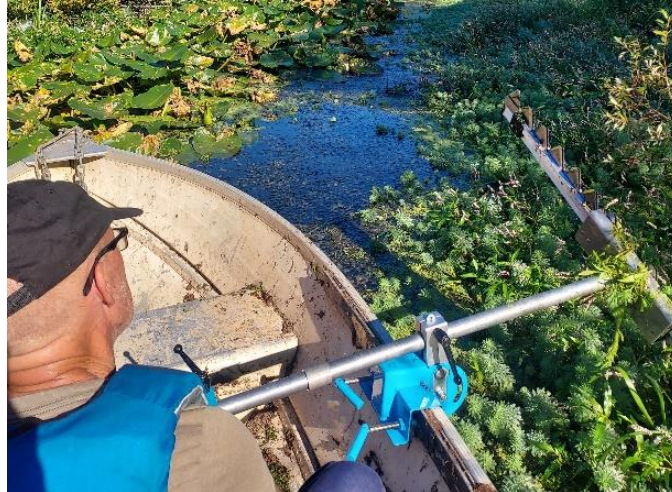
Figure 2: The aquatic weed mower attached to the gunwale of the boat.

Parrot's feather cutting took place on 8 dates, shown in Table 1. In addition to the gear described above, life jackets, waterproof shoes and paddles were used during cutting (see Appendix B). Cutting personnel were; a boat driver, mower operator, and one to two support workers for boatwork and sampling. The aquatic mower was mounted on a reinforced gunwhale on the starboard side of the boat (see Figure 2).

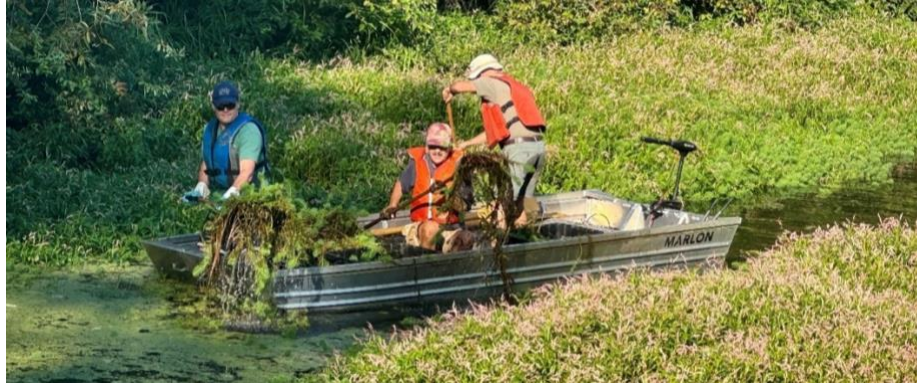
Figure 3: Parrot's feather collection in Somenos Creek.

The project had three main aspects: cutting, collecting, and water quality monitoring. The growing edge of the parrot's feather was cut with an underwater electric aquatic weed mower; the cut sections were then collected with a boat into 102 liter totes (see Figure 2, 3 and Appendix B) and removed from the Creek to dry and compost on the bank above the high-water mark. Water quality was monitored with two Onset Hobo U26 Dissolved Oxygen Data Loggers that tracked temperature and dissolved oxygen variation at a control location and in the project area. Turbidity (NTU) was also monitored to ensure instream work stayed within provincial water quality guidelines to prevent impacts on fish. Two boats equipped with electric motors (Minn Kota Endura Trolling Motor) were used for all work in the creek (see Appendix B). To prevent downstream movement of parrot's feather fragments, a containment boom was installed across the creek under the Lakes Road bridge, Figure 4. The dissolved oxygen loggers were left in the creek until December to capture data on the fall flush.

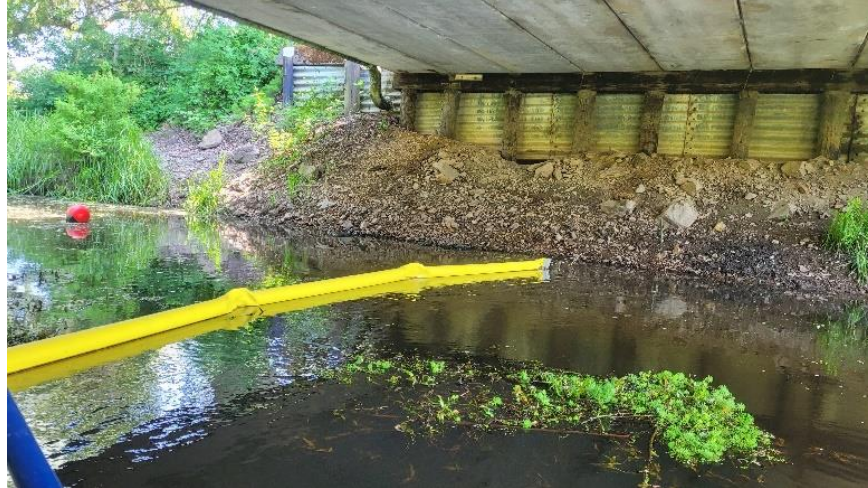
To meet requirements laid out in the 2024 permits for work in the creek, a boom was installed to catch parrot's feather fragments floating downstream between work events. Accumulation of the parrot's feather at the boom was only observed during the early stages of the project in June and when the Creek began noticeably flowing in October. Staff did note an accumulation of common duckweed (*Lemna minor*) at the boom which suggests that when the Creek was flowing the boom was effective at stopping material from being carried downstream from the project area.

Figure 4: Boom placement under the lakes Road bridge with a mat of cut parrot's feather.

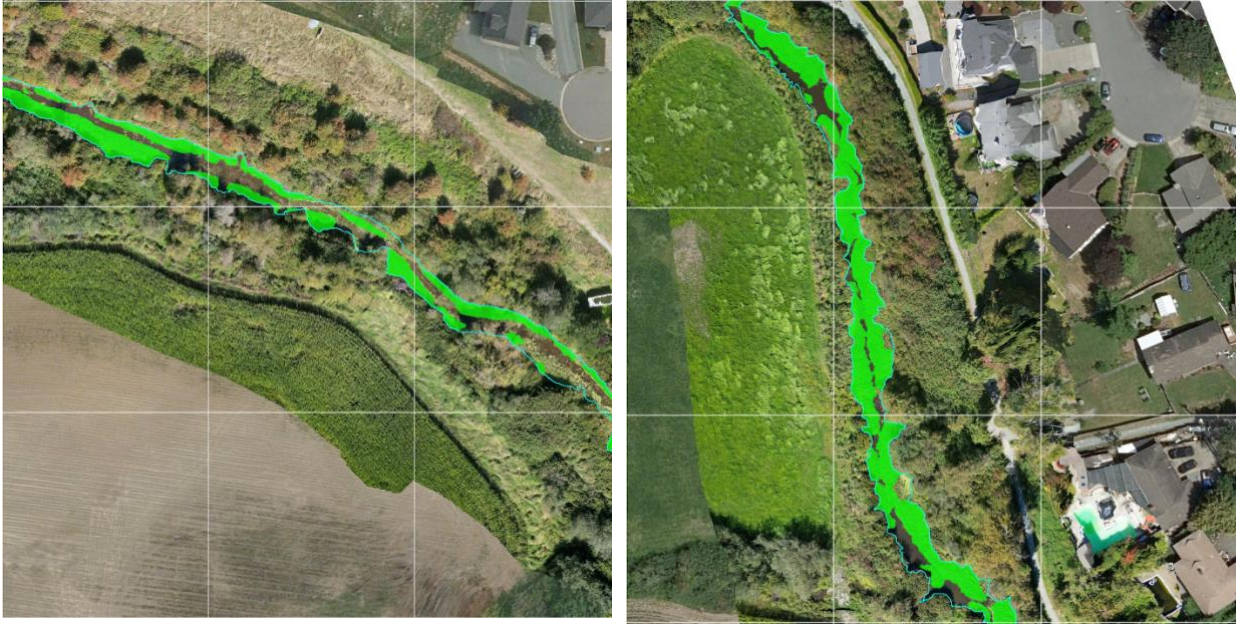
The kayak based parrot's feather surveys of 2023 were replaced by an aerial drone survey of the creek on the 12<sup>th</sup> of September 2024. The drone survey imagery suggests that the 2024 cutting noticeably reduced parrot's feather coverage in the middle of the creek compared to the uncut reach, below the project area. See Appendix A, Figure 2, for the full parrot's feather survey results.

Figure 5: Images of parrot's feather coverage in the project area (left) and below the project area (right). The cleared channel can be seen clearly in the project area photo.

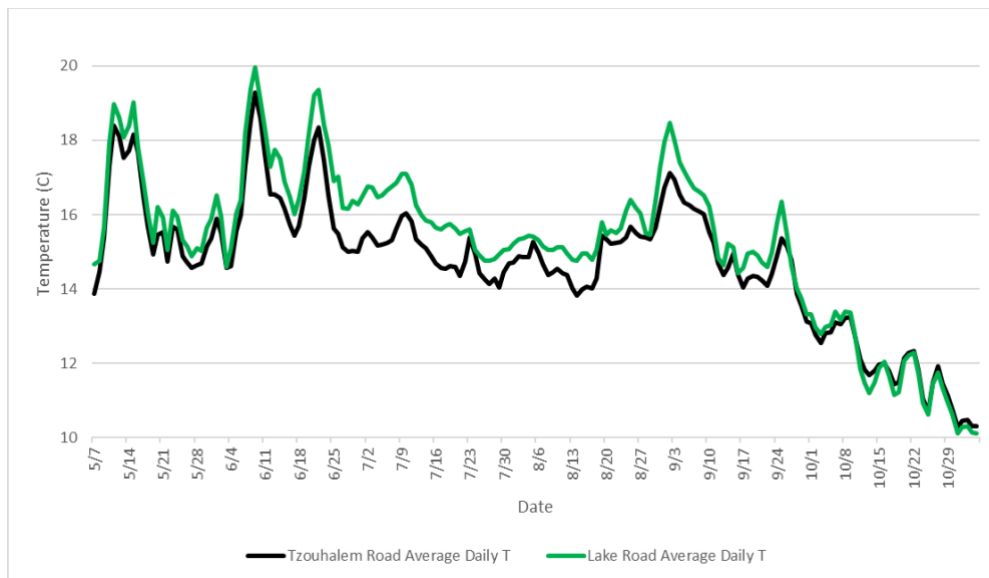
Figure 6: Average daily temperatures of Somenos Creek at the control (Tzouhalem Road) and protect site (Lakes Road).

Data shows that both dissolved oxygen and temperature were greater at Lakes Road than at Tzouhalem Road, see Figures 6 and 7. T-tests on the observed difference between temperature and DO at the two sites suggested that they were significantly different, with  $P < 0.05$ . Further investigation is required to determine the cause of the difference. Detailed water quality data is available from the authors upon request.

Two dissolved oxygen/temperature data loggers were installed in Somenos Creek, which recorded measurements every ten minutes. The first data logger was placed at the Lakes Road bridge to capture water quality directly below the project area. The second data logger was placed at the Tzouhalem Road bridge (Appendix A, Figure 1), around 660m downstream from the Lakes Road bridge, to act as a control site. Data loggers were cleaned weekly as algal growth was noted to impact the data quality. The graphs in Figures 6 and 7 show the average daily temperatures and dissolved oxygen levels.

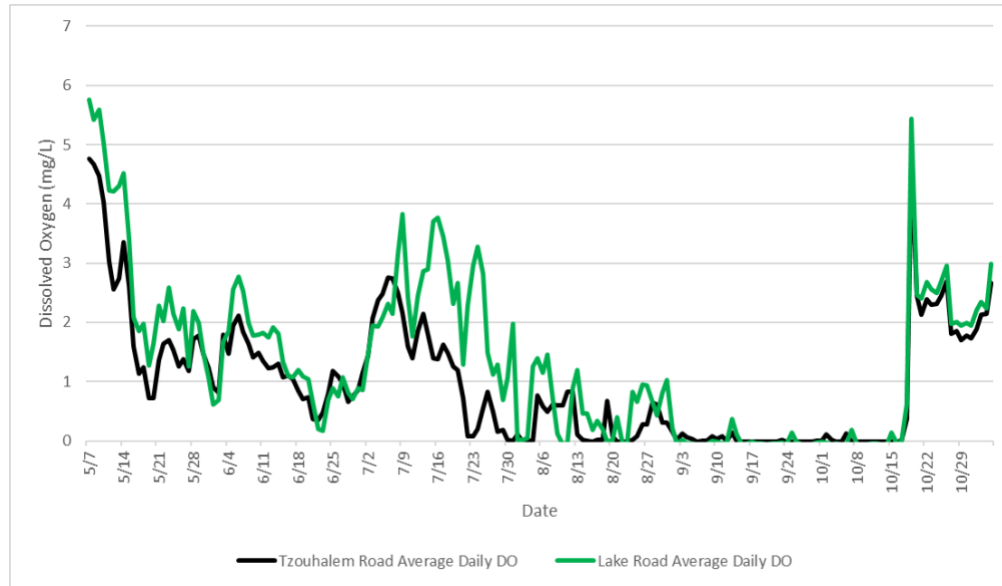
Figure 7: Average daily dissolved oxygen of Somenos Creek at the control (Tzouhalem Road) and project site (Lakes Road)

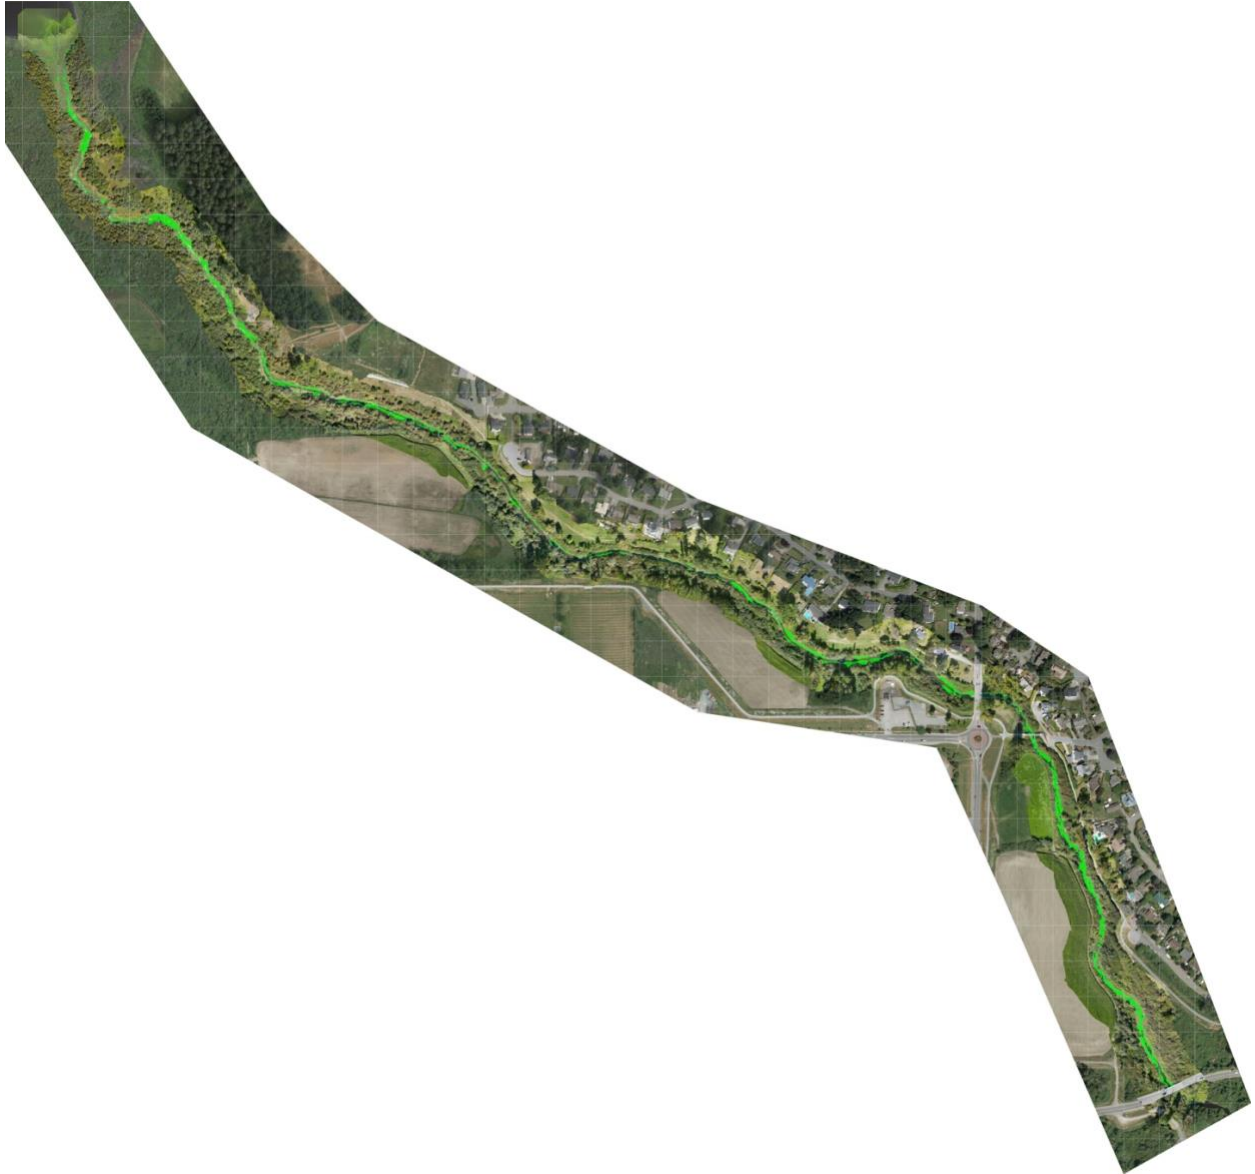
Figure 2: Full image of the parrot's feather survey completed by the Municipality of North Cowichan on September 12<sup>th</sup>, 2024.

Cutting and removal of parrot's feather in Somenos Creek created a 2-to-4-meter-wide clear channel, and resulted in the removal of 58.45m<sup>3</sup> of parrot's feather to decompose on the bank overwinter. The drone survey completed by the Municipality on September 12<sup>th</sup>, clearly shows the cleared channel in the project area. Society staff and volunteers worked in the creek on 27 different days through the summer, an increase from 19 days in 2023, and volunteer hours more than tripled from 2023 at 185 hours in 2024. Work in the creek was not observed to increase turbidity levels for more than two hours or disrupt fish populations. While water quality did show a statistically significant difference between the project and control sites, it is not clear whether this is due to the project impact or natural processes.

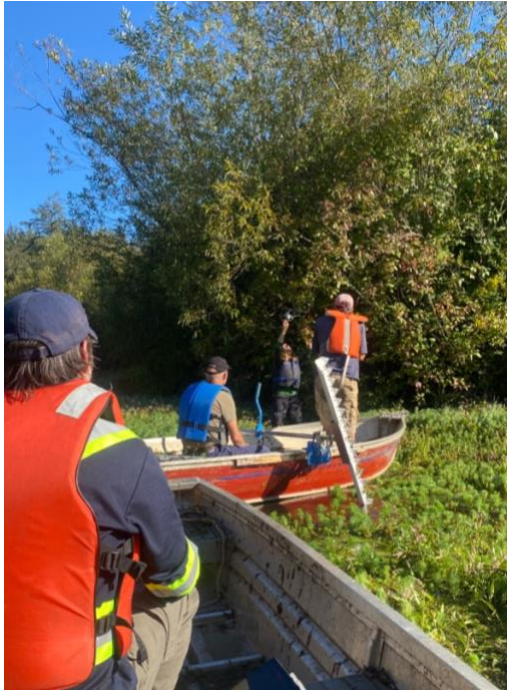
Figure 1: One of the boats with the aquatic mower attached to the gunwale.

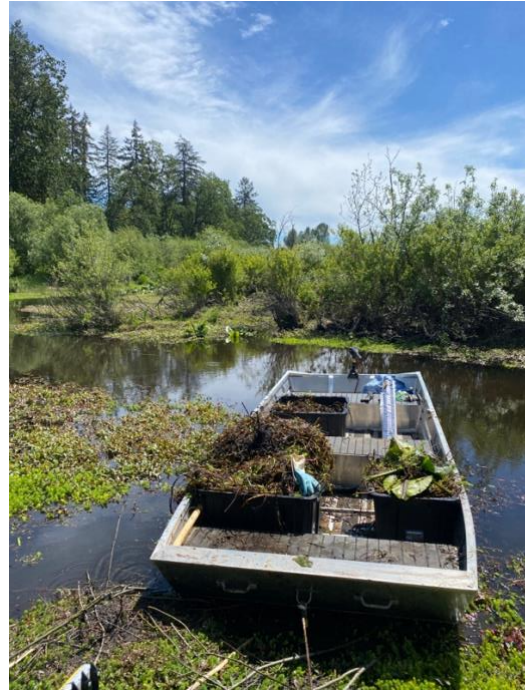
Figure 2: One of the boats with collection totes full of parrot's feather.

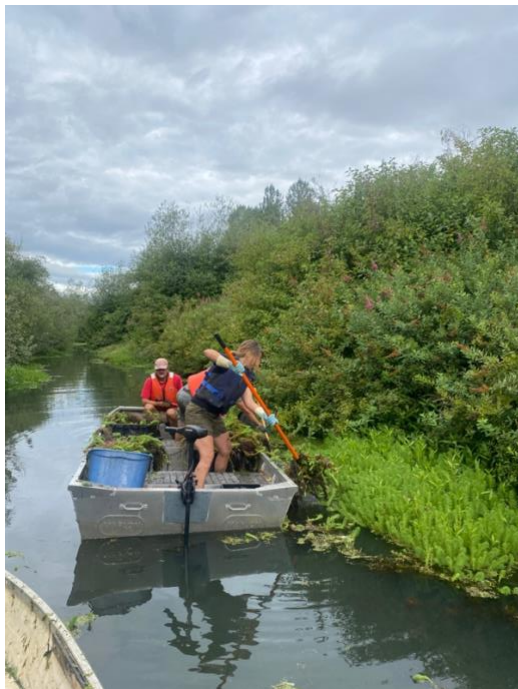
Figure 3: Parrot's feather collection from one of the boats with the collection tools and motor.

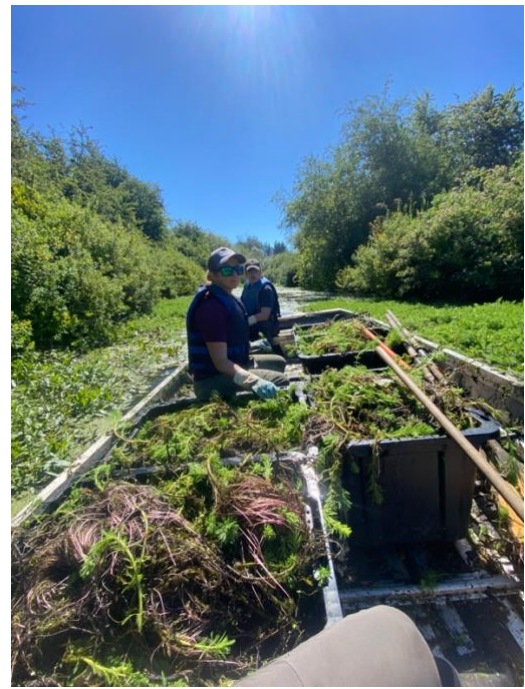
Figure 4: Totes full of parrot's feather in one of the boats.
