A Summary of the Water Quality Attainment Grab Sampling Activities Conducted in the Cowichan River Watershed: Summer/Fall 2024

Prepared by: David DePape Prepared for: Cowichan Watershed Society March 11, 2025 Cover Photograph: Sandy Cumming, Robertson River. November 19, 2024 Photo Credit: B. Greenway

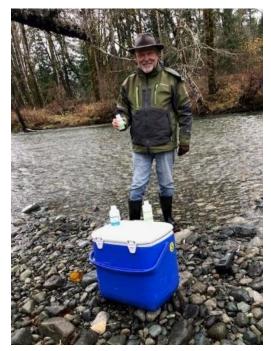
Photo 7: A volunteer taking a dissolved oxygen reading with a YSI meter at Nixon Creek

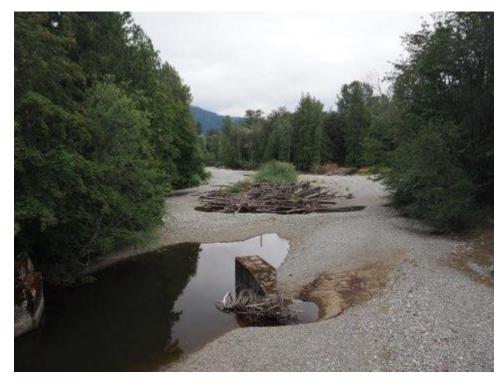
Photo 10: Robertson River, August 20, 2024

Very low to no flow conditions are not unusual for these small creeks during the heat of the summer (Appendix I, photo 10). As such, earlier discussions with ENV had confirmed that no samples would be collected (as opposed to collecting a sample at another location on the creek) under these conditions (R. Barlak, pers. comm. July 25, 2024). The site highlighted in red in Table 2 i.e. CR15, located under the Island Highway bridge crossing the Cowichan River in Duncan, was not sampled after initial ground truthing revealed site-specific safety concerns. That site was replaced with the sample site at Rotary Park. The list of sample sites for 2024 WQA grab samples including site code, EMS site description, EMS identifier, and location (latitude, longitude) is presented in Table 2.
