**2019 Cowichan Lake Pumping  
Weekly Report #2  
September 8 – 13, 2019**

Catalyst Paper Corporation  
8451 Hay Rd  
Crofton, BC V0R 1K5

**EDI Environmental Dynamics Inc.**  
208A – 2520 Bowen Road  
Nanaimo, BC V9T 3L3

19N0163  
September 2019

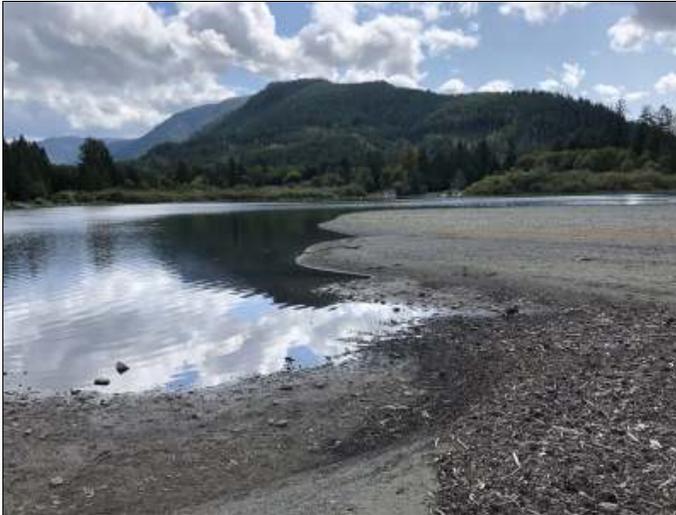
**Photo 11.** Looking west at the lake shoreline near Robertson Creek. Sep 3, 2019.

Robertson Creek	Good lamprey habitat – small gravels and organics. Little risk for stranding – steep banks, one lake area that may become isolated. No swimming lamprey observed.	Sampled for lamprey larvae in areas where they were previously observed – none found. Receding water line did not expose different habitat type nor created isolated pools or increased risk for stranding fish.
Utility Creek	Poor lamprey habitat – compact or organics dominated. Low risk for stranding due to gentle slope; no isolated pools. No swimming lamprey observed.	Receding water line did not expose different habitat type nor created isolated pools or increased risk for stranding fish. Area not sampled for larvae.
Hawes Bay	Sub-optimal/poor lamprey habitat – sand/organics and cobbles dominated. Low risk for stranding due to gentle slope; no isolated pools. No swimming lamprey observed.	Stranded three spine stickleback ( <i>Gasterosteus aculeatus</i> adults) observed on the fine sand beaches at this location. Sampled for lamprey larvae – none found. Receding water line did not expose different habitat type nor created isolated pools or increased risk for stranding fish.

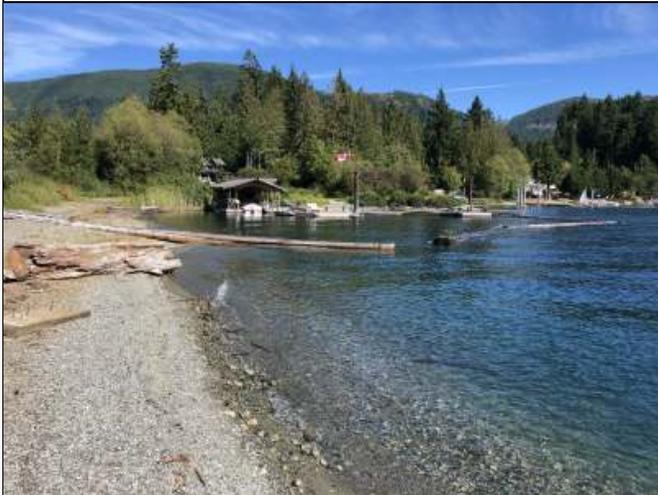
**Photo 15.** Looking north at the lake shoreline near Meade Creek. Aug 28, 2019.

Site	Aug 28, 2019 (pre-pumping)	Sep 10, 2019 (during pumping)
Meade Creek (N)	Good lamprey habitat – small gravels and organics. No risk for stranding due to steep lake banks. No swimming lamprey observed.	Sampled for lamprey larvae – none found. Receding water line did not expose different habitat type nor created isolated pools or increased risk for stranding fish.
Miracle Creek	Poor lamprey habitat – compact or organics dominated. Low risk for stranding – gently sloped banks; no isolated pools. No swimming lamprey observed.	Sampled for lamprey larvae – none found. Receding water line did not expose different habitat type nor created isolated pools or increased risk for stranding fish.
Sutton Creek	Poor lamprey habitat – compact or organics dominated. Low risk for stranding – gently sloped or steep lake banks. No swimming lamprey observed.	Receding water line did not expose different habitat type nor created isolated pools or increased risk for stranding fish. Area not sampled for lamprey larvae.
