Just letting you know that Paul Grant (DFO Science, Species at Risk) and I were out in Cowichan Lake just before the pumps were turned on and found a recently deceased female lamprey with eggs in an isolated pool at the mouth of Robertson River.

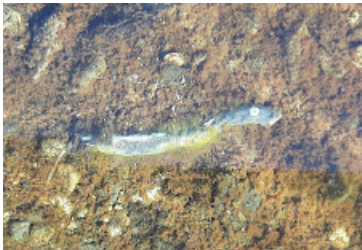
Dead female Sept 18 2023 Robertson.jpg
783K

For example, on September 18th, 2023-prior to the pumps being turned on, we went to the mouth of Robertson River to assess the amount of known spawning habitat available for lamprey. The entire alluvial fan was perched above the surface of the water and had been for many months. In one pool, disconnected from any surface stream flow, a dead gravid Cowichan lamprey was found (see photo attached). Eggs were clearly visible and the body was decomposing. The fish had likely only been dead for a few days. This is concerning because this means at the end of September, lamprey in spawning condition can be found, also, that this individual had been isolated in this pool for likely many months given the position of the pool on the alluvial fan and height of the fan from the water's surface. For whatever reason, perhaps lack of environmental cues, this female did not spawn.
